ACOUSTIC EMISSION EXPERIENCE WITH AE MONITORING OF NEW VESSELS DURING INITIAL PROOF TEST

This paper looks retrospectively at experiences with the AE monitoring of new vessels during initial proof-test and discusses the implications for applying the proposed European Standard for AE monitoring of proof tests.

VERTICAL REACTOR SHOP HYDROTEST

STORAGE SPHERE INITIAL HYDROTEST

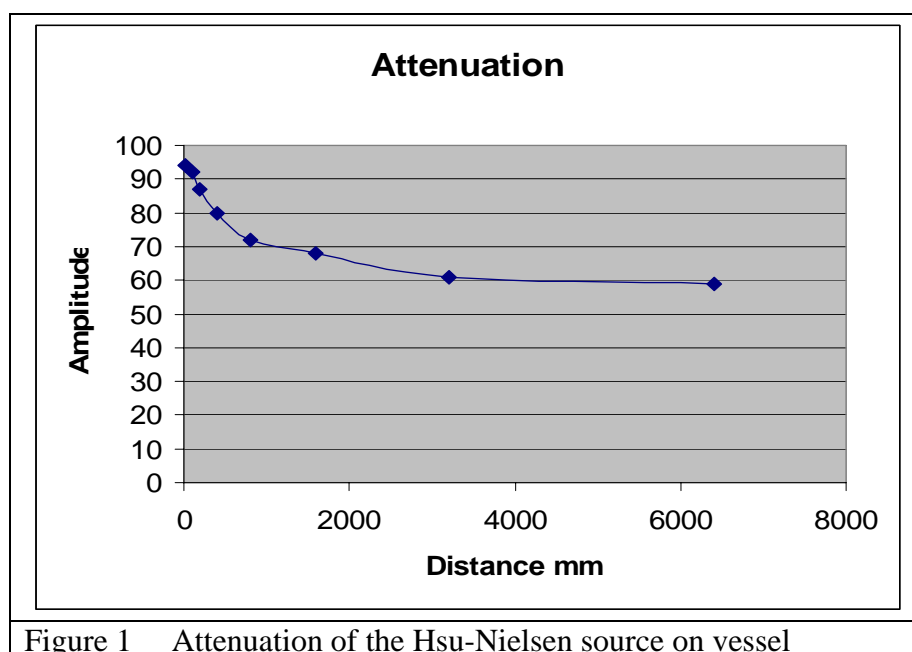
Seventeen integral pre-amplifier sensors were used to monitor this vessel, from the signal attenuation measurement (see figure 1) this was far more than required according to ASME, however, planar location was used to aid interpretation of the emission, particularly useful for the first loading of a new vessel, and this requires many more sensors as each emission must reach three sensors to be located. Planar location highlights specific areas, comparison of relative emission density from welds over the entire vessel gives an indication of which areas might be growing defects or have material problems, allowing follow-up NDT to check these out efficiently.

Figure 1 Attenuation of the Hsu-Nielsen source on vessel

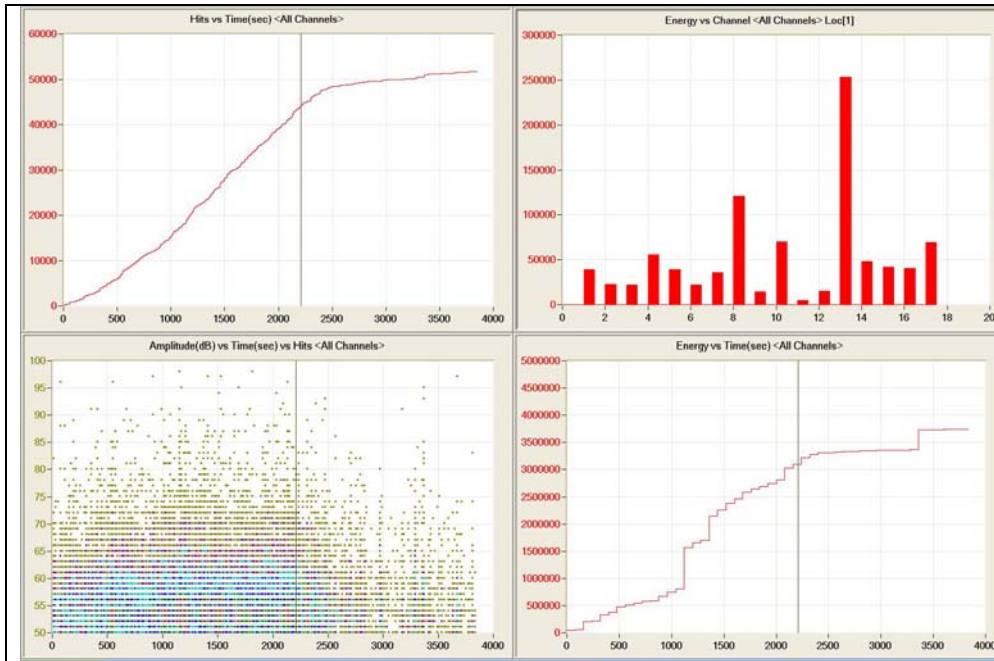
The first pressurisation initially appeared quite normal, with emission starting from low loads as expected as a result of stress relief (figure 2 shows the history of hits, energy and amplitude for the entire vessel, the vertical black line is the start of the final hold period), it became clear that a large amount of emission was from a single weld, the one around the catalyst loading man-way, sensor 13 was adjacent to this weld where it was close to the top head circumferential weld. This emission was so pronounced that the weld drew itself out on the location plot (figure 3a, 3b), the first cluster appeared at a small % of test pressure, and had a total of >200 events by the end of the first loading, (figure 4) by which time clusters had appeared around that entire weld circumference. At the time this test was carried out there was no official CEN location code, had the test stop criteria from the code been applied the test would have been repeatedly stopped for NDT of these and other cluster locations (>26 in total). Emission continued to the end of the final hold period, predominantly from the top man-way area.

Figure 2 History of hits, energy and amplitudes for the first loading (vertical black line is start of final hold period)

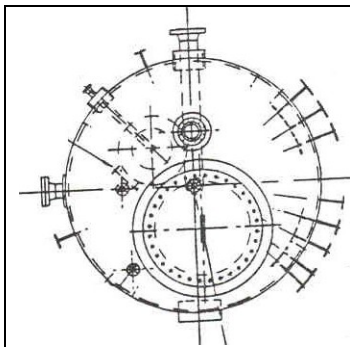
Figure 3a Top head of vessel showing large catalyst loading man-way.

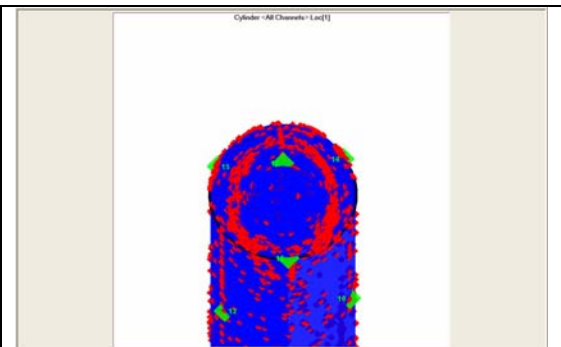
Figure 3b Location of emissions around top man-way weld during first loading.

MONPAC™ analysis of the first pressurisation produced grade “E” for the sensors around the man-way area, this activity reduced to “C” on the second loading resulting in a recommendation for further evaluation and possible follow-up NDT.

Post test, extensive NDT was carried out to the man-way weld area, both from inside and outside, no reportable indications were found. Since 90% of the emission from the vessel had come from the one weld there were still questions and an investigation into the manufacturing process ensued. The outcome of this was the discovery that a much lower weld pre-heat had been used on the man-way weld than on any other weld on the vessel, resulting in higher residual stresses, clearly not fully relieved after even two cycles to proof pressure. The reason given for the lower pre-heat was that from a design standpoint the man-way had been treated as a pipe, allowable under the codes, despite this clearly being the most highly stressed part of the vessel.

It is interesting that despite emissions with source amplitudes well in excess of 80dB (usually associated with cracking) no reportable indications were found by NDT. One possibility is that micro-cracking was distributed around the weld and there was as a result no individual “big crack” for NDT to find. Localised inspection may not be sensitive to micro-cracking distributed around a large area; however this can still be a threat to integrity.

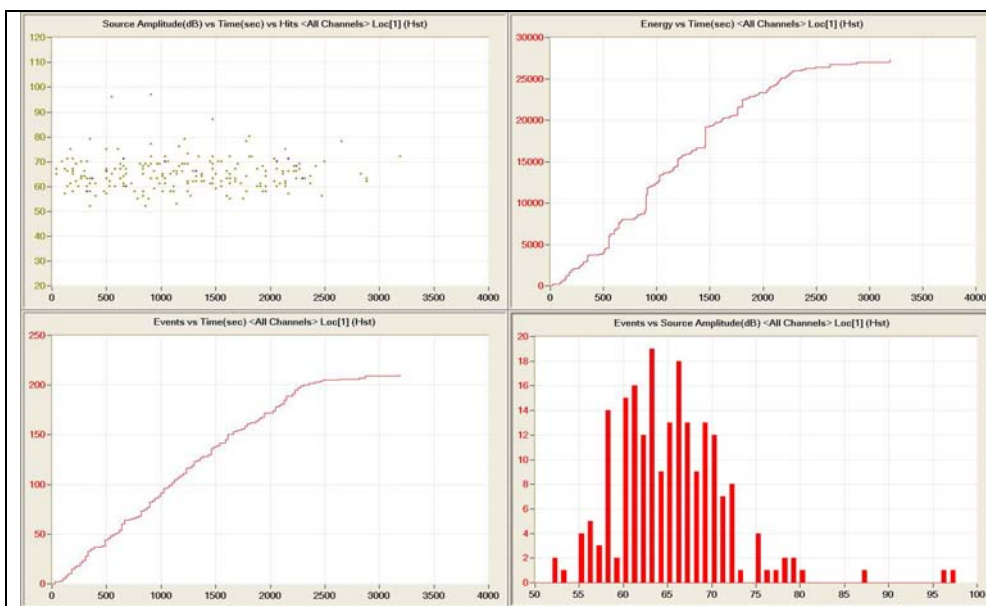
Figure 4 Cluster history from small section of the man-way weld.

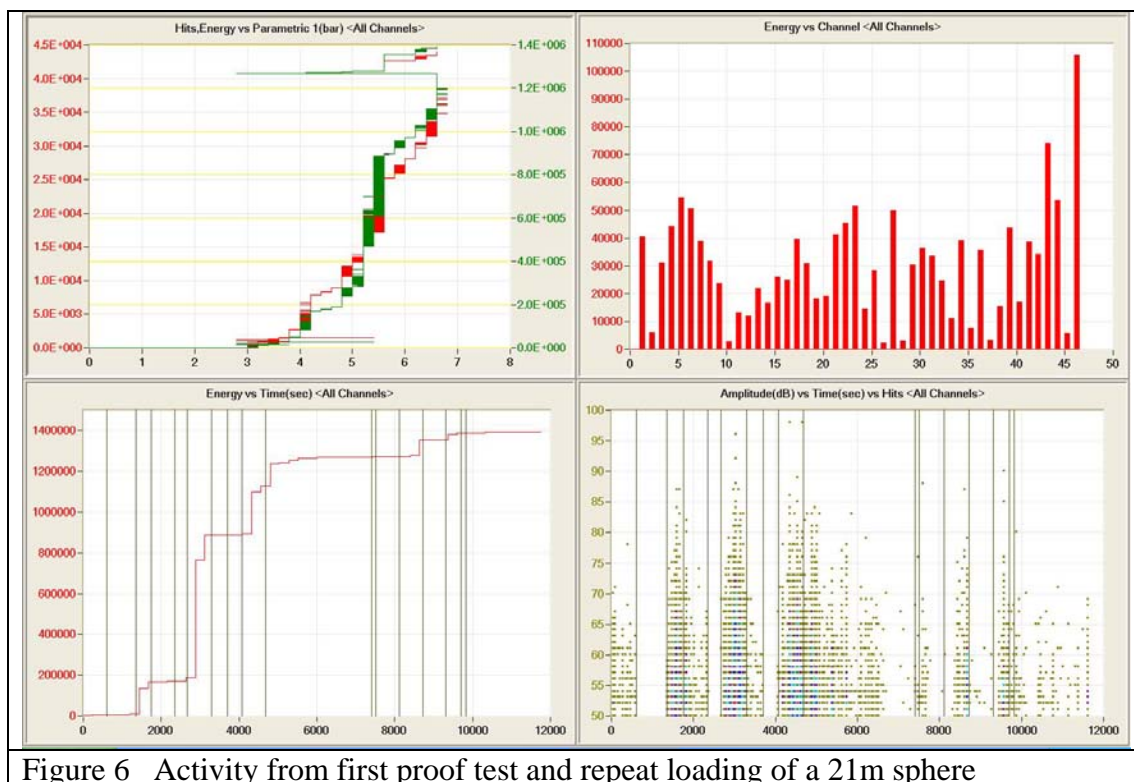
The first loading produced high levels of activity from all areas of the sphere, (figure 6) suggesting extensive yielding, and high amplitudes indicated possible micro-cracking, activity exceeded the evaluation criteria many times over.

Figure 6 Activity from first proof test and repeat loading of a 21m sphere

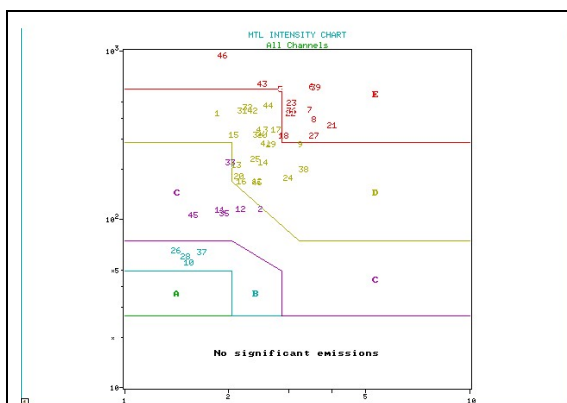
Zone intensity location analysis of the initial loading produced nothing less than a “C” grade, with eighteen “D” zones, and five “E” zones (figure 7). Planar location was carried out but the located data represents only 3.7 % of the total emission, and did not identify active clusters (figure 8).

Figure 7 1st Load Zone intensity analysis

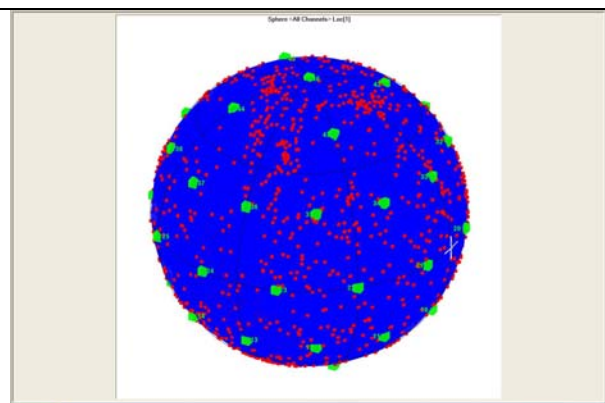
Figure 8 Planar location, typical view.

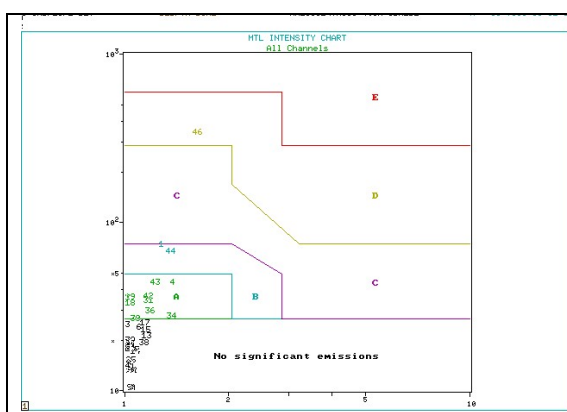
The second loading was relatively inactive; however there was still one “D” grade near the top head pressure relief valve stack, (fig 9,10), follow-up NDT found no indications.

Figure 9 2nd Load Zone intensity analysis

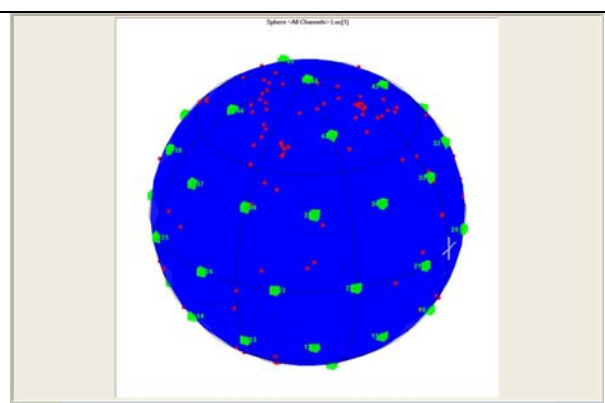
Figure 10 2nd Load planar location.
