The Katholikon of Osios Loucas Monastery: In situ investigations

Elizabeth N. Vintzileou¹, Ioannis G. Konteas¹, Aikaterini-Anna E. Manoledaki¹, Vasiliki A. Palieraki¹, Androniki E. Miltiadou-Fezans²

Abstract

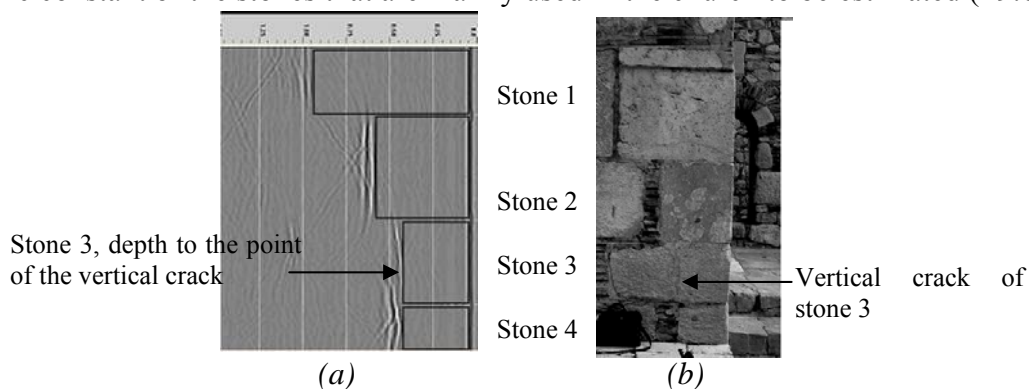
In the case study presented here, preliminary trial measurements were made in regions where the geometry of the stones is known (e.g. in the corners of the walls). The results were very accurate (Fig. 2), and allowed both for adequate settings for the radar, and for the dielectric constant of the stones that are mainly used in the church to be estimated (~ 9.0).

Figure 2. *(a) Vertical profile in the south-west corner of the church, (b) Picture of the same region.*

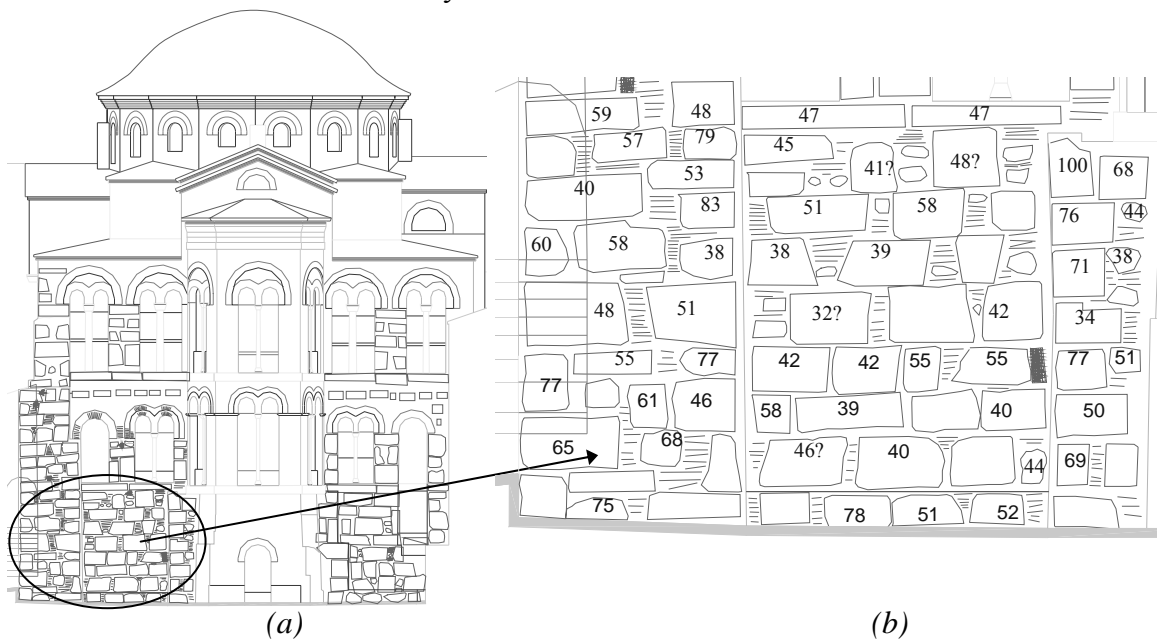
Three different construction types are identified on the eastern façade of the Katholikon (Fig. 3a), according to the percentage of bricks used between stones, the size and the level of elaboration of stones. Those differences can be taken as indication of different masonry construction methods in-depth as well. Radar measurements also seem to confirm this hypothesis: In the lower part of the church, between the east-south corner and the hexagonal niche of the Sanctuary (Figure 3b), there is a region where the thickness of stones does not present significant variability, and it does not exceed 55-60cm, whereas to the right and to the left of this zone, (a) the measured thickness varies significantly from stone to stone and (b) there are stones as thick as 80-100cm. This geometrical observation is still to be interpreted, on the basis of historical data as well. On the contrary, the varying thickness of stones of masonry left and right of this intermediate region is in agreement with the usual form of the external leaf of a three-leaf masonry.

Figure 3. (a) Eastern façade of the monument, (b) Indication of the stone thicknesses of the outer leaf (in cm) at crypt level.

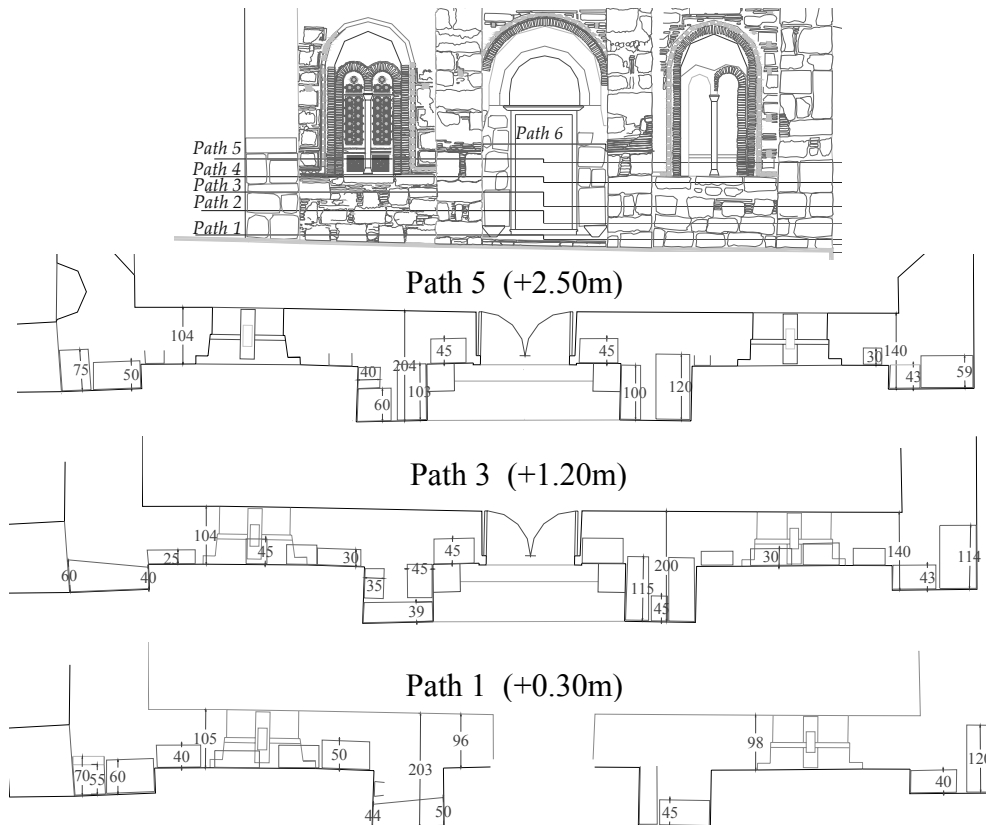
Figure 4. The western façade of the monument. Results of the radar measurements (in cm) along three different paths (ground floor level).

Due to the limitations mentioned above, the construction type of perimeter masonry was investigated mainly from the exterior of the monument. In Figure 4 (where the thickness of stones is given in cm), typical results obtained by radar are shown for the west façade of the church. The results indicate a three-leaf masonry, given that the thickness of the stones of the inner leaf of masonry is always smaller, or at maximum equal, to the thickness of the stones of the external leaf. As measurements from the interior are not available, the entire geometry of masonry of perimeter walls cannot be reproduced. Actually, if one assumes that the stones of the internal face of masonry are of approximately equal thickness with those of the exterior face, the region of filling material in the three-leaf masonry results to be of rather limited thickness. If, on the contrary, an internal leaf similar to that detected in the Katholikon of Dafni Monastery [7] is assumed, a completely different picture of the masonry should be adopted. As the differences in geometry have significant effect on the mechanical properties of masonry, the results show an urgent need for further investigation of perimeter masonry from the interior (for instance by locally removing the already detached marbles or plaster).

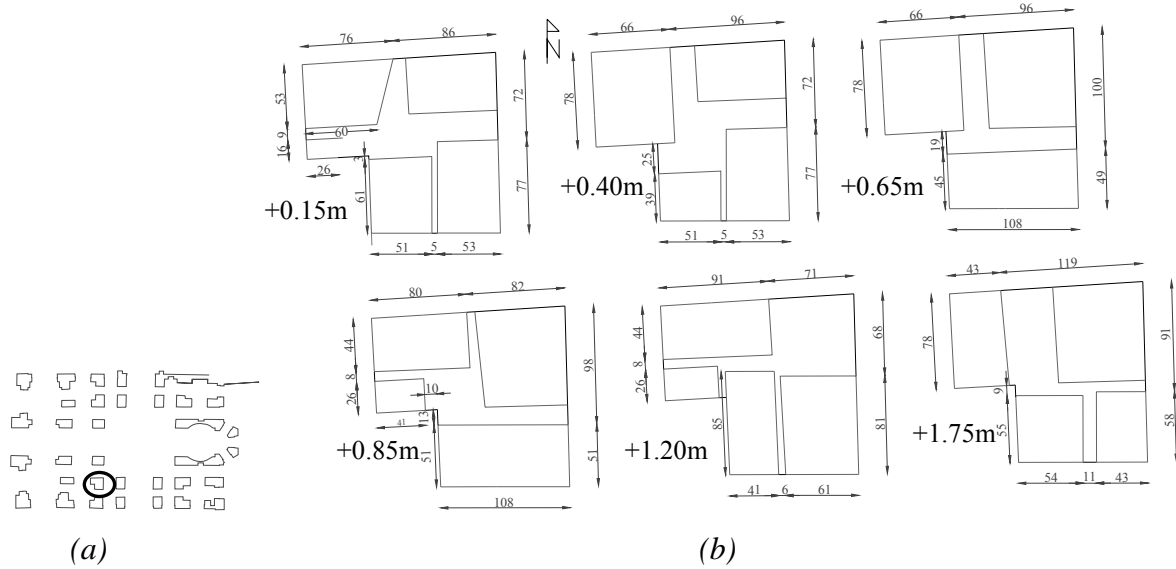
Figure 5. (a) Position of the pier Y32 in plan, (b) Horizontal sections of the pier Y32 (gallery-Yperoon), at various heights measured from the floor level.

The reliable results obtained for the pier Y32, in the level of the gallery (Yperoon), as well as its position, are summarized in Figure 5. One can clearly see a solid construction with large size cut stones, carefully interconnected along the height of the pier. The nature of the space between the stones is not known. It is, however, of limited volume; hence, of limited effect on the mechanical properties of the pier, even if the most unfavourable assumption of a poor quality filling material is retained.

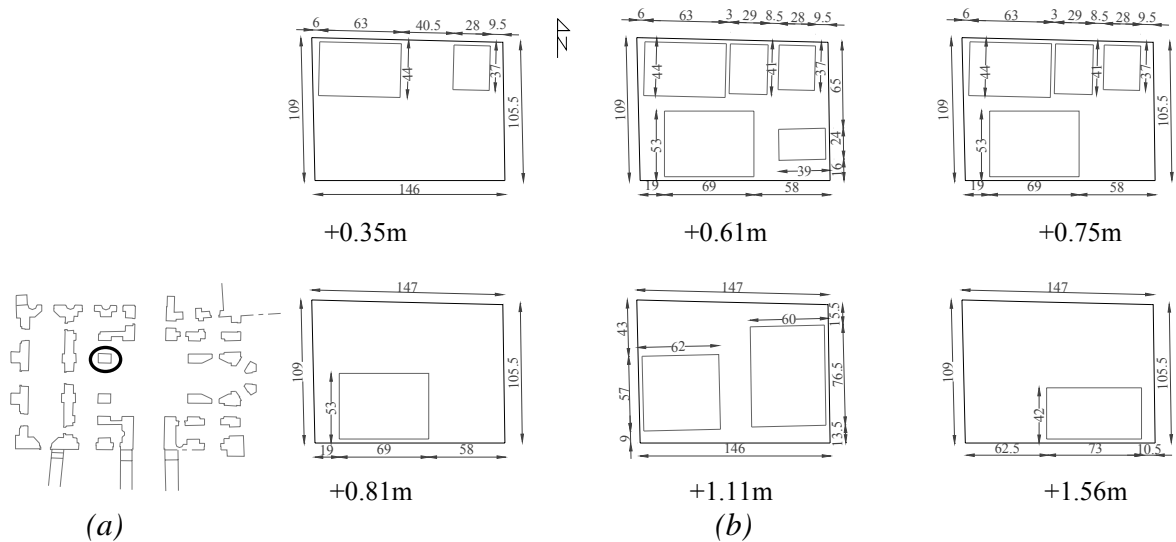
Figure 6. (a) Position of the pier I34 in plan, (b) Horizontal sections of the pier I34 (Ground floor), at various heights measured from the ground level.

The reliable results of radar measurements taken in the pier I34, in the ground floor of the church, are summarized in Figure 6. It has to be mentioned that in pier's I34 case, the results were reliable to a somehow limited extent. The profiles taken in some regions (that remained blank in the sketches) allow for the assumption of extensive use of bricks to be made.

In general, the construction type of pier I34 seems to be of lower quality than that of pier Y32 (smaller size stones, not carefully overlapping in subsequent layers). This difference in quality of construction seems to be in contradiction with the fact that the pier of the lower

storey is subjected to higher actions than the pier of the higher storey. In a monument of the importance of the Katholikon this cannot be attributed to conceptual or to construction errors, thus, there is an obvious need for further investigation.
