GUIDED WAVE ULTRASONIC INSPECTION & VERIFICATION STUDIES OF BURIED PIPELINES

S. Lebsack

Lebsack & Associates, The Woodlands, Texas, USA

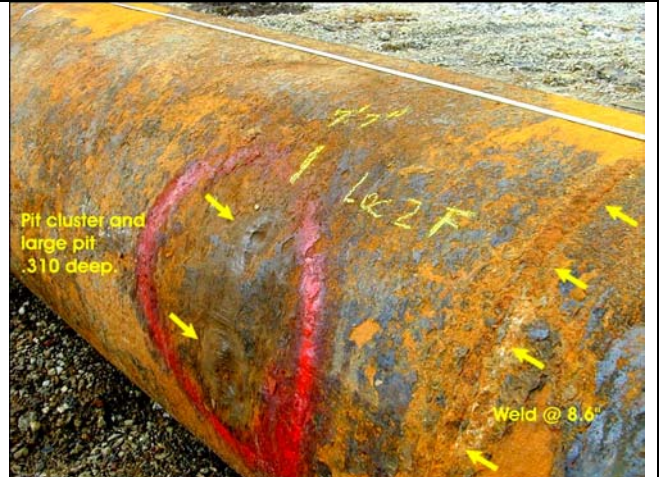
The interpretation of data from this line was difficult in that signal responses from corrosion were numerous; sometimes overlapping (Figures 3, 4 & 6). The combination of the poor pipe condition combined with the soil condition (cohesive clay in the lower sections)

Figure 3. Large isolated pits in front of a weld. See Figure 6 showing signal response from this area – 7 to 9 feet.

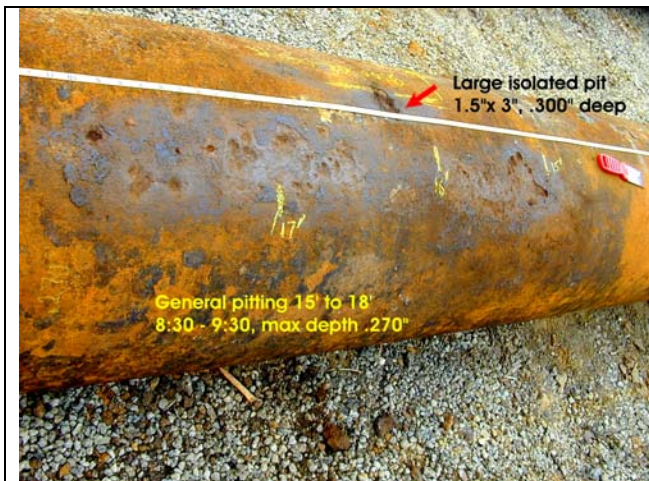
Figure 4. Severely corroded area approximately 3 feet in length with numerous isolated pits and areas of general corrosion. Included in the section was a very larger isolated pit (marked by arrow at top right). See Figure 6 showing signal response from this area – 14 to 18 feet.

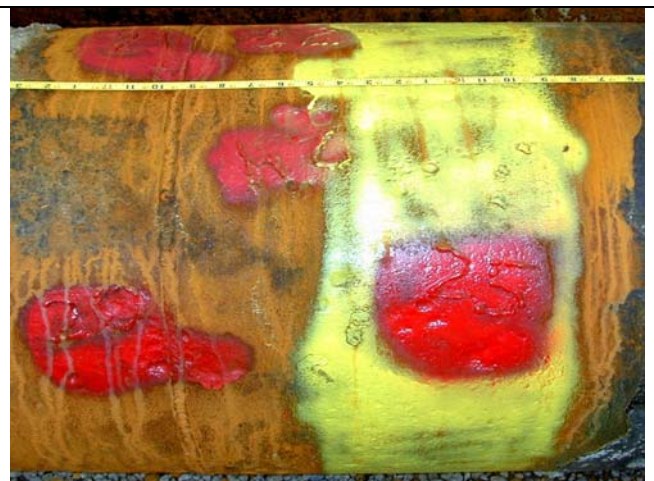
Figure 5. Isolated pitting and general corrosion 360° around the pipe and on either side of the weld. Yellow paint indicates area identified by GWUT; red spots were from smart pig data and were marked where they exceeded 50% of nominal wall. See Figure 7 showing signal response from this area – 16 to 17 feet.

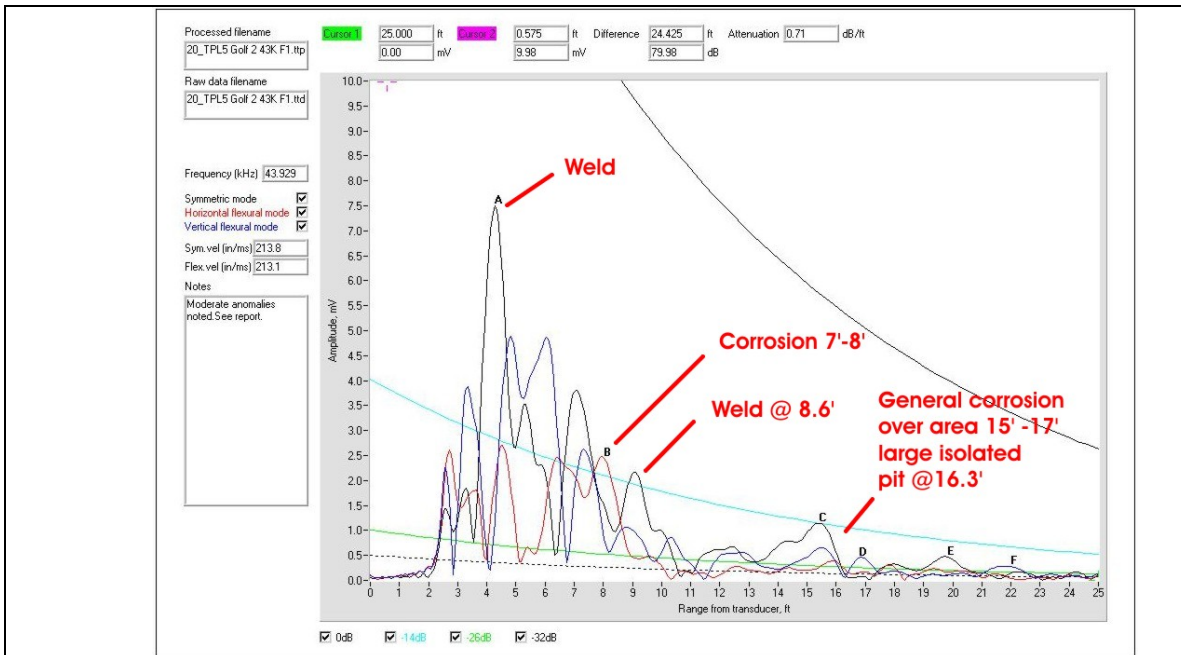
The extent that coating anomalies produced GWUT signal responses was unanticipated. Areas such as those shown in Figures 9 and 10 where the coating adhesive failed produced reportable signal responses (shown in Figure 12). The signal responses at “G”, “J”, “M”, “N” and “O” were just at or below the 9% reporting threshold indicated by the green reference line (the 1st line above the dotted black line which indicates the noise level and minimum reporting threshold). Most reportable metal loss anomalies will exceed this reference line. The signal responses from actual metal loss areas can be seen in Figure 6 at “B” or “C”, both representing significant metal loss as is apparent in Figure 3 and 4.

Figure 6. Signal response data corresponding to Figures 3 and 4. Signal marked at “B” represents the two large pits seen in the left-center of the picture. The weld signal follows as marked at 8.6’ and is visible on the lower left side of the picture. Signals designated “C” & “D” above corresponds to Figure 4. The general area of corrosion between 15 and 17 feet is indicated @ “C” while the large isolate pit @ 16.3” aligns with “D”. The long axial extent of this area can be seen in the wave form along and apparent masking of signals due to the axial alignment of the area.

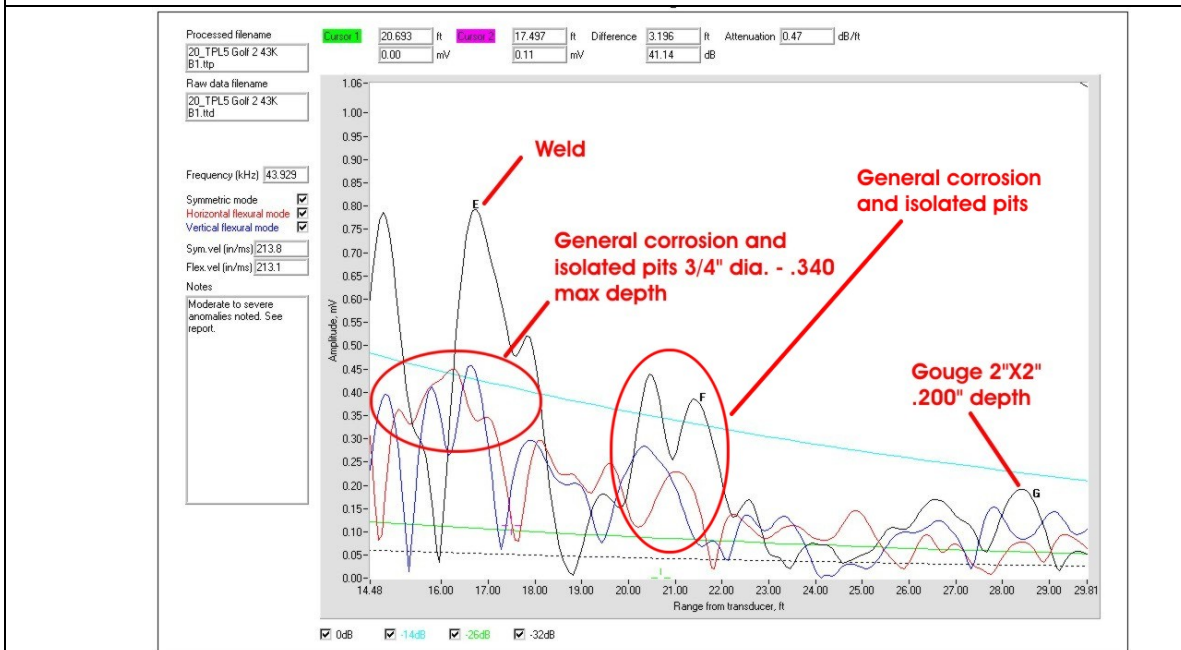
Figure 7. Signal response data corresponding to Figure 5. Signal marked at “E” represents the weld. Note amplitude of red and blue (flexural) signals under the weld signal below “E”. These represent the pitting condition that was present around the weld. Numerous pits were > 50% through wall as indicated in Figure 5. Flexural signals close to or associated with a weld can be difficult to characterize.

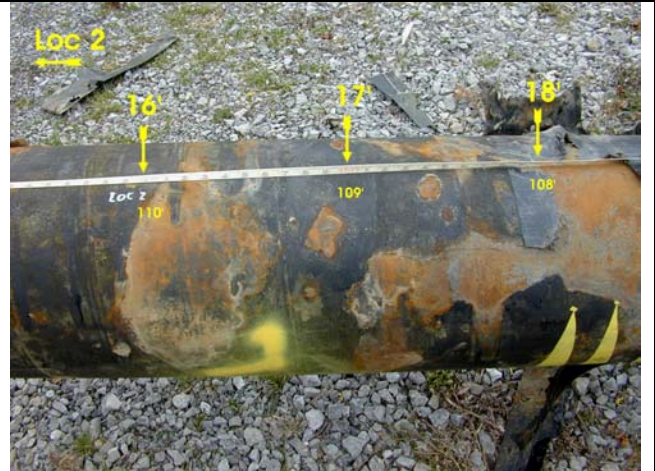
Figure 9. Surface corrosion delineates areas where coating has separated from the pipe. Good coating adhesive is represented by black areas remaining after stripping the coating material. Areas such as this indicating water migrating under the coating correlated with many of the signal anomalies.

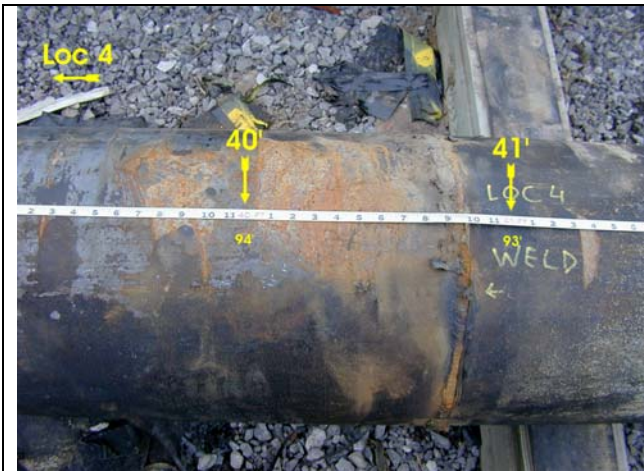
Figure 10. Dis-bond and minor surface corrosion over 180° between 40' and 41'. Similar areas corresponding to anomalies I, J & K (Figure 12) from Location 4 were noted between 35' and 39'. The weld is visible just before the 41' mark and corresponds to the typical weld signal @ "L" in Figure 12.

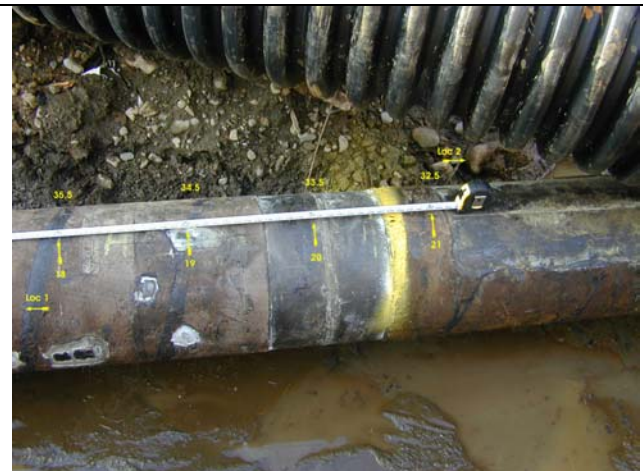
Figure 11. 18 to 21+ feet from datum @ Location 1 showing weld just past 20' and bare pipe on either side of the weld. Signal responses for the coating transition to bare pipe were present but at low amplitude from Location 1. From Location 2 the transition from bare pipe to factory wrap coating @ 34' (yellow band – right center) corresponds to the arrow marking an undesignated signal peak in Figure 13. Note coating patches missing lower left on pipe. Signal trace data representing this area is shown in Figure 13.

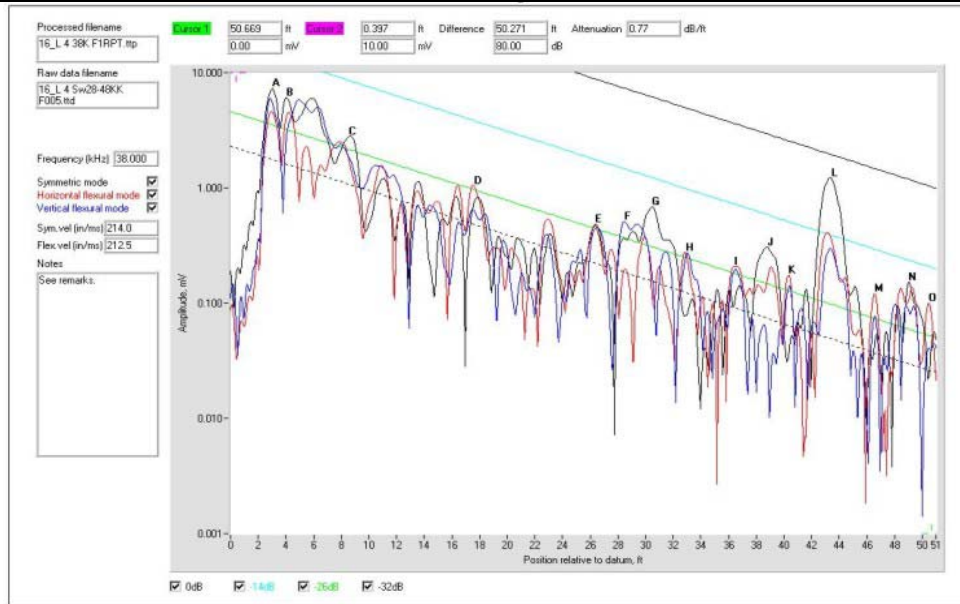
The coating shown on the pipe in Figure 13 is factory applied fiber impregnated asphalt whereas the coating on the pipes in Figure 12 is a plastic wrap bonded to the pipe with an epoxy tar as was most likely applied in the field. Both coatings produced signal responses that were above the reporting threshold. Even so, the technician was able to interpret the results correctly in that metal loss was not called.

Figure 12. Signals trace data corresponding to Figure 10. Area of interest is @ “L” (41’) showing signal response from the weld visible in Figure 10. Signals marked I, J & K represented coating dis-bond areas similar to that which can be seen in front of the weld in Figure 10.

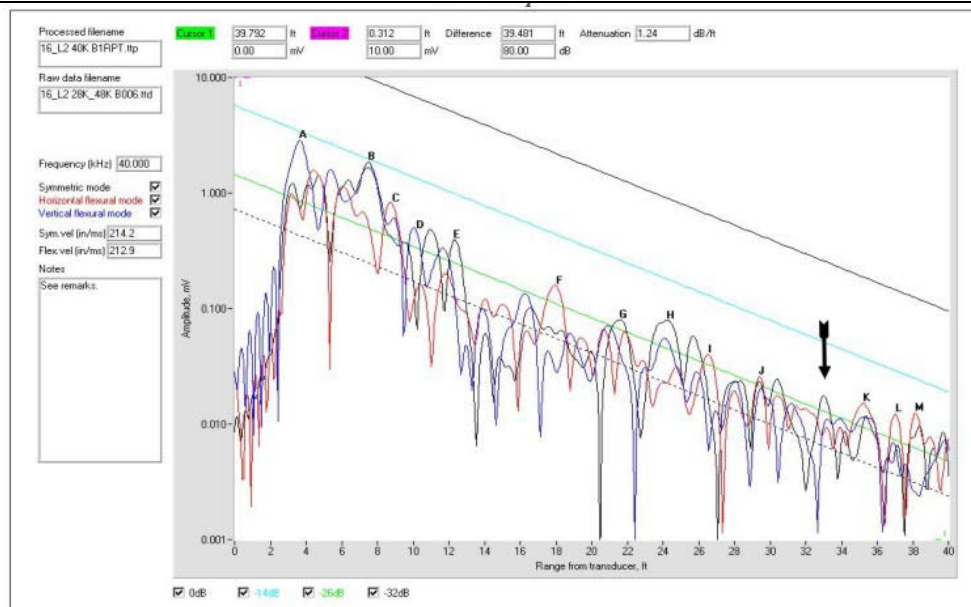
Figure 13. Signal traces corresponding to Figure 11. Arrow at 31.5’ marks signal from the coated to uncoated pipe marked by the yellow paint band in Figure 11. The weld seen in Figure 11, which was not marked during the inspection, may be associated with this signal response. Signal peaks designated “K” and “L” are thought to be associated with the coating damage visible to the left of the weld in Figure 11.
