17th World Conference on Nondestructive Testing, 25-28 Oct 2008, Shanghai, China

## Computed Radiography and Microtomography of Riveted Lap Joints of Glare™ Subjected to Constant Amplitude Loading (CAL) Fatigue

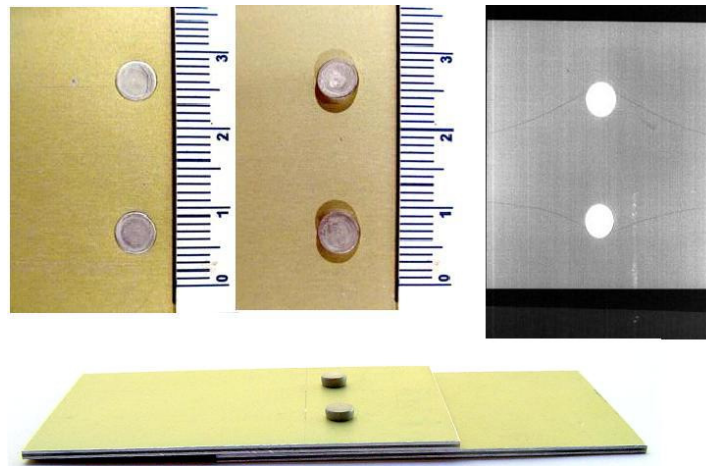
**Figure 2 - Test specimen photography and conventional radiography<sup>[3]</sup>. From left to right: countersunk rivet heads, bottom rivet heads, radiography and test specimen full image. Those were taken after more than 1,000,000 cycles of CAL. Scale in centimeters.**

inspected and, although visually intact, cracks were found at the faying surfaces of the aluminum sheets by conventional (film) radiography (Figure 2).

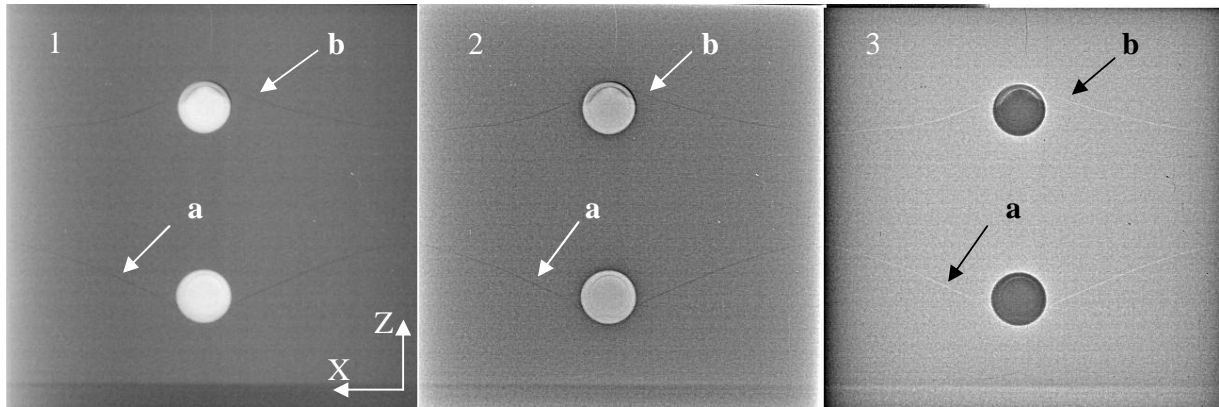
Figure 3- CR1 radiographies

Figure 3 shows the results for experiment CR1. Frame 1 represents the radiography as recorded, with little image manipulation, mainly in gray levels. A subtle change in contrast can be seen near and around the upper rivet head (**b**), which represents a discontinuity of the material in the rivet head itself. The crack, on the other hand, is barely visible. A Fourier Transform high pass filtering was performed at frame 2 to enhance details. Cracks (arrows **a** and **b**) have better contrast against the image, as well as the rivet head damage. In frame 3 a negative image was created in order to give a different view of the cracks.

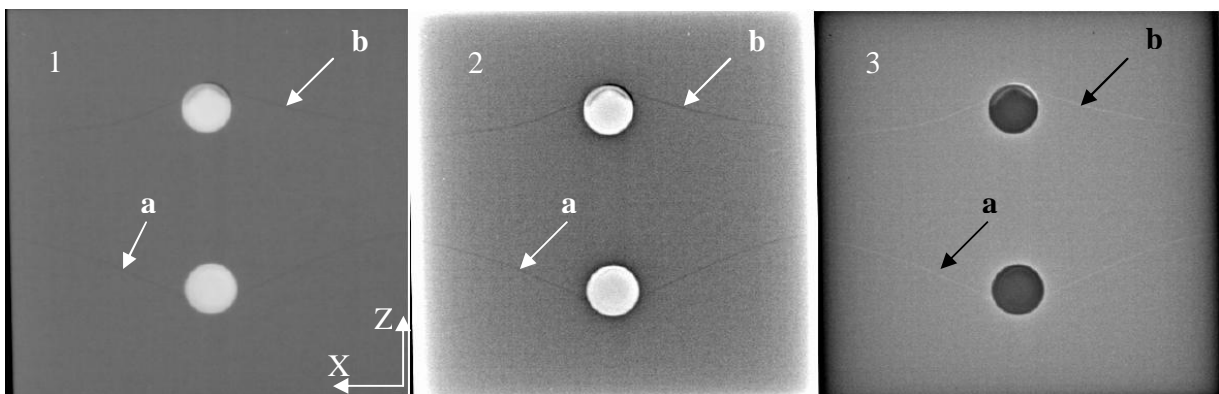
Figure 4 - CR2 radiographies

The experiment CR2 has its frames shown at Figure 4. The same features described for CR1 can be seen. Nevertheless, as a penalty for lower resolution, a little granulation can be seen at the frames. Again, Frame 1 has the untreated image, at Frame two a Fourier transform was performed and Frame 3 has a negative image of the latter.

Comparing the two experiments above, it is clear that even using different CR systems with different basic spatial resolutions, it is still possible to detect these cracks with very good contrast. However, the cracking pattern cannot be solved in terms of which aluminum sheet contains each crack. This is caused by the loss of depth resolution if a 3 dimensional object is projected on the image plane as in standard radiographic inspection.

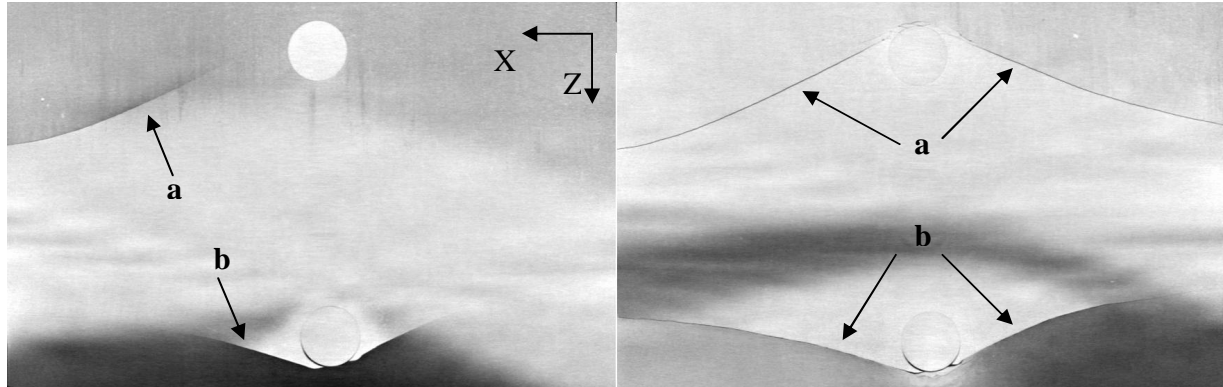
Figure 5 – First  $\mu$ CT sequence along Y axis (XZ plane cuts)

Figure 5 reveals the same cracks as shown by CR, but details are much more visible. It is important now to start trying to figure out in what aluminum sheet each crack has propagated. As the left hand side image of Figure 5 suggests, a slight misalignment of the Glare™ joint with respect of the table where it was placed may have occurred. The arrow **a** indicates an upper crack that is not completely visible, while the crack pointed by arrow **b** is well defined. This is sufficient for one to suspect that the cracks do not belong to the same plate. Moving on in the tomography, the right hand side image now shows the upper and lower cracks fully propagated. Also noticeable are differences in gray intensity before and after the crack limits. This effect can be caused by small displacements between the two portions of the cracked plate. It is also possible to see that the region above the upper rivet has suffered additional damage.

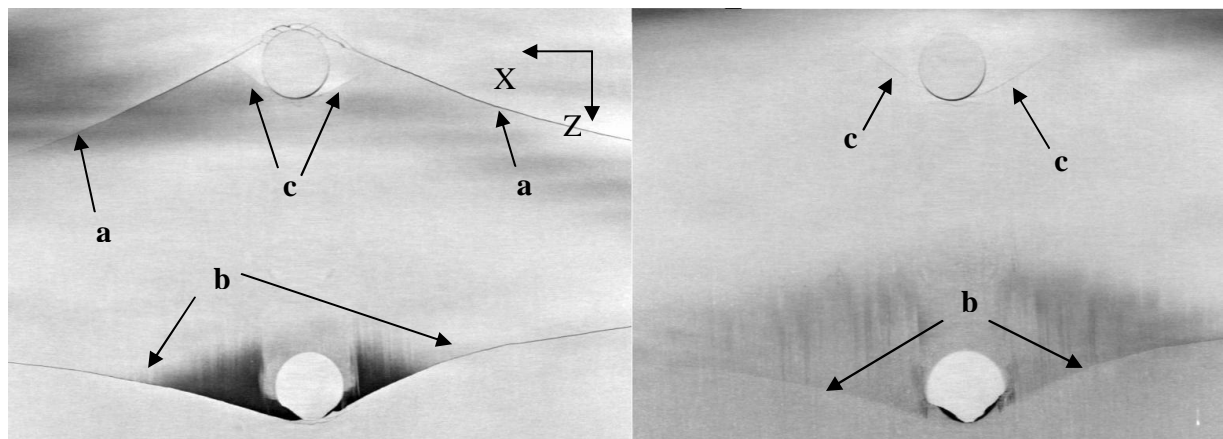
Figure 6 - Second  $\mu$ CT sequence along Y axis (XZ plane cuts)

The tomography has continued through Y axis, as seen by Figure 6. The left hand side image now reveals the cracks around the rivets, just like shown by CR, but an additional small crack around the upper rivet can be seen (arrow **c**), with an orientation that is reverse to that expected

to happen in this kind of joint<sup>[3]</sup>. Also noticeable is a seriously damaged region above the upper rivet, created due to the fatigue process. The right hand side frame of Figure 6 shows the small crack and a slight difference in contrast at the lower end of the picture. Both figures clearly show the failed countersunk head of the lower rivet, which cannot be seen with this quality in the CR images.

- a. By CR projection technique alone it is not possible to define in what plate each crack is;
- b. CR did not show the small crack (arrow **c** at Figures 6 to 8);
- c. Damage in the plate, above rivet head (e.g. Figure 6), was not visible in the CR images. The aluminum mass of the rivet head may have formed a barrier that caused the X-ray to be absorbed and, consequently, denying the damage to be shown;

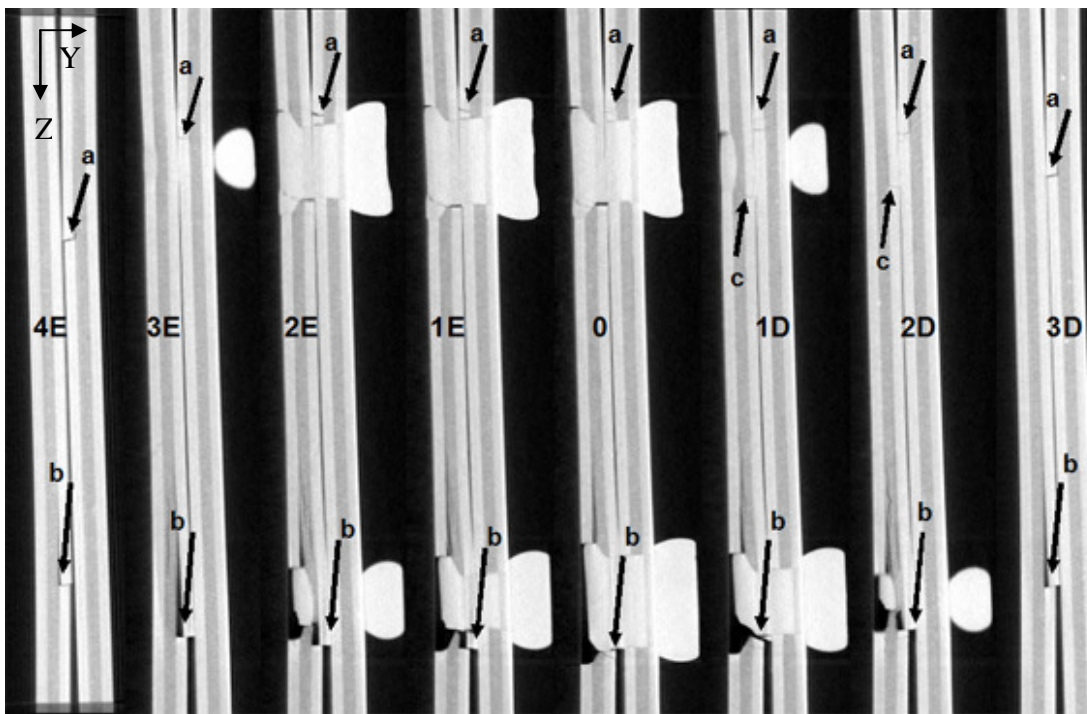
Figure 7 -  $\mu$ CT images of the riveted joint along the X axis (YZ plane cuts)

One of the most powerful tools of the  $\mu$ CT is that images are recorded of several planes throughout the entire specimen and along three axes. Figure 7 shows a sequence of images taken from XZ planes of the lap joint along the Y direction (refer to Figure 1). The arrows **a**, **b** and **c** refer to the same cracks discussed above. It becomes clear now that crack **a** belongs to the inner aluminum sheet of the flat bottom hole plate, while cracks **b** and **c** belong to the inner sheet of the countersunk plate.

Also noticeable is the failure of the countersunk head of the rivet at the lower part of image below, with serious loss of mass. The other countersunk rivet head have also been cracked, but did not separate from the body.

The fatigue process caused the fiber glass bonding to fail. It is possible to see separation between the aluminum sheets and the core as well as failure throughout the fiber glass layers themselves. Separation occurs until considerable distances from the cracks are reached to the direction of the center of the riveted lap, suggesting great loss in mechanical performance of the plate.

The misalignment mentioned when analyzing Figure 6 is confirmed throughout Figure 7, especially where the countersunk rivet have failed and lost part of its head.

- d. CR shows that one of the rivet heads is broken and the other may have developed some cracking, although not clearly shown. This is confirmed by the  $\mu$ CT (e.g. Figure 7, 1E and 2E images);

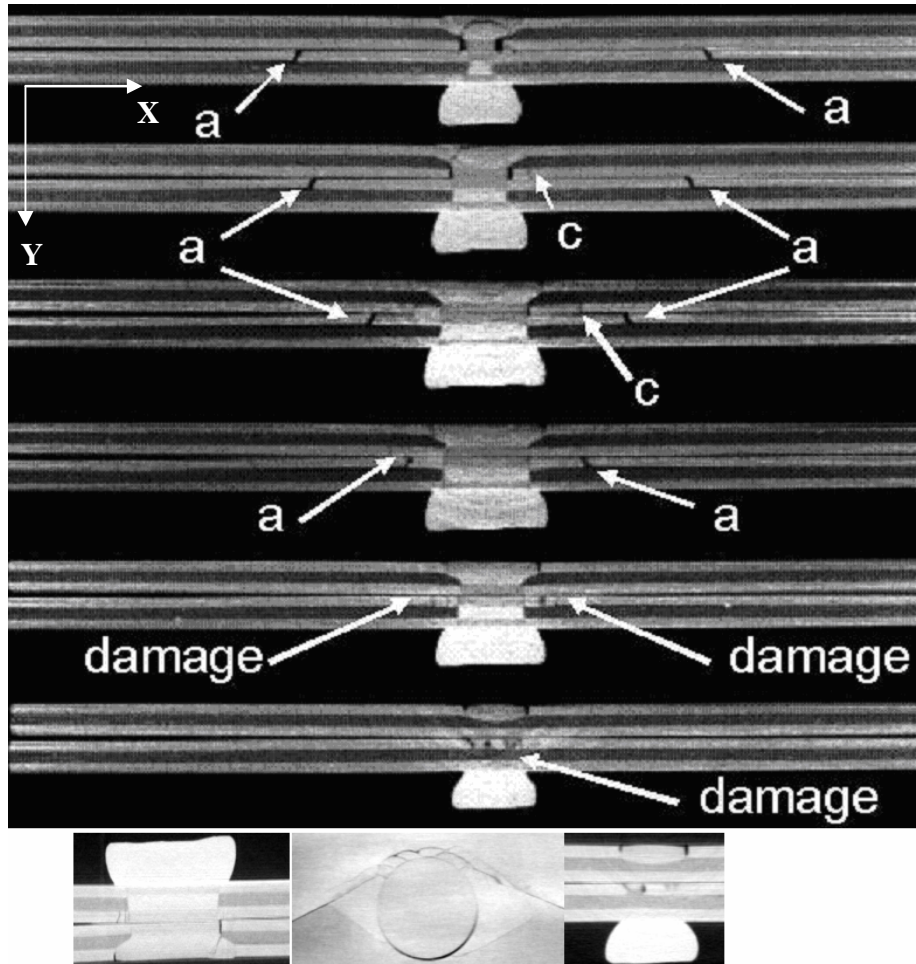
In order to have a better understanding of the damaged suffered by the joint near the upper rivet head, images of the XY plane (Z direction) are presented in Figure 8, showing only cuts of this area. The cracks **a** and **c** are marked and it can be noticed again that the latter belongs to the countersunk plate while the former is in the flat bottom plate.

**Figure 8 -  $\mu$ CT images of the riveted joint along the Z axis (XY plane cuts). Below is an insert showing three axes images of the region with serious damage around the rivet head**

The damaged area is visible in Figure 8 and it is also possible to see that small cracks have occurred around the rivet head (insert), in the flat bottom aluminum sheet.
