EVALUATION OF DEFECTS AND CRACKS IN CARRIAGE AXLES USING NON-DESTRUCTIVE TESTING

ABSTRACT

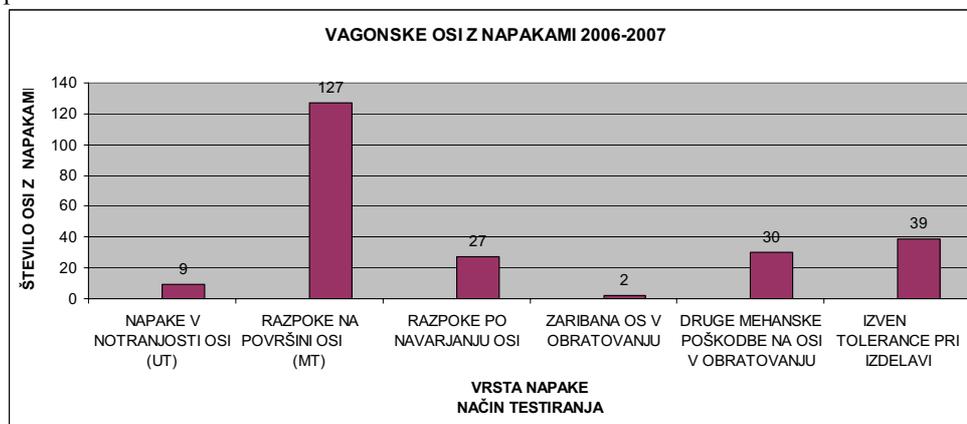
Figure 2 shows a column chart giving results on the defective axles found in the period from June 2006 to July 2007. A total of 2363 carriage axles were inspected. A large number of the defects found with the magnetic particle testing method at the axles/shafts are, to our mind, a consequence of low-quality surfacing performed by the producer in order to repair the defects present.

Figure 2. Defects found at carriage axles in ultrasonic and magnetic particle testing.

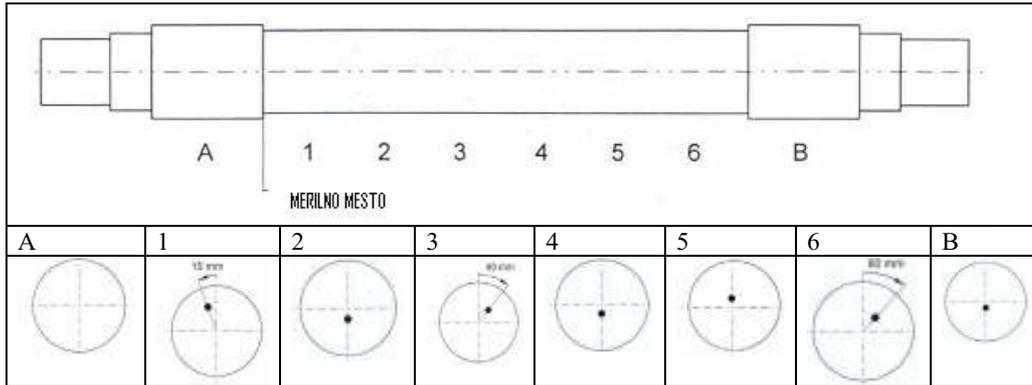
A detailed ultrasonic examination showed defects inside the carriage axle of »a« type at eight locations. Figure 5 shows the carriage axle with locations marked 1 through 6. In testing, defects in the depths between 43 and 82 mm were detected. The locations with the wheels mounted at the carriage axles are marked A and B. Defects were found at location B in the depths between 39 and 57 mm.

Figure 5. Location of defects inside carriage axles.

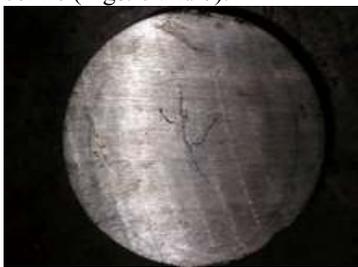
In railway axles and shafts the most frequent defects are cracks. They are mainly due to dynamic loads they are subjected to. There may be also forming defects that remain in the material such as non-forged oxidised shrinkage cavities or gas cavities in the axle or shaft centre (Figs. 6 and 7).

Figure 6. Radial cracks in axle centre

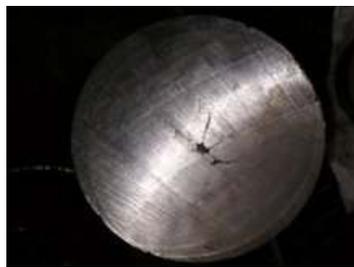
Figure 7. Volume defects and radial cracks in axle centre

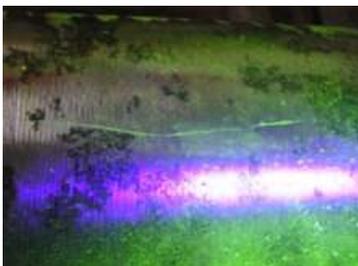
a

Figure 10. Photos of carriage-axle surface in testing with fluorescent magnetic powder. Longitudinal crack (a) and transverse crack (b).

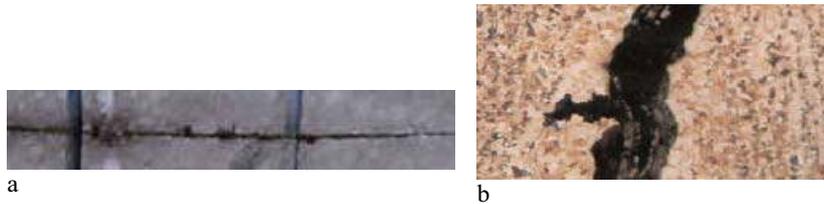
The detailed metallographic and micro-chemical examinations of the surface around the crack showed that the crack slowly propagated in depth and ran mainly through crystals (columnar crystals). It was additionally found that the crack surroundings from the surface to a smaller depth were also decarburized to pearlite-ferrite microstructure [16]. The decarburization found indicates that the crack occurred due a too high temperature, which is confirmed by the crack initiation during heat treatment, which was done with inappropriate surface protection. Figure 13 shows the entire, relatively long longitudinal crack at the carriage axle (a) and the appearance of the magnified crack (b) showing obvious decarburization at the surface next to the crack.

Figure 13. Longitudinal crack at axle (a) and a surface section with crack and visible decarburization (b).

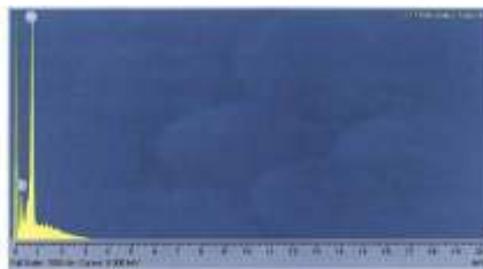
Figure 14. EDS analysis in crack surroundings.

Figure 14 shows the energy dispersion spectroscopic analysis (EDS) of the crack surroundings, which confirmed the presence of pearlite-ferrite microstructure and an additional influence of oxygen at the elevated temperature with the oxide layer and decarburization of the surface in the crack surroundings. The decarburized steel in the crack surroundings has a stronger tendency to material fatigue and cracking leading to the final carriage-axle failure due to lower strength of ferrite. Ferrite has lower dynamic strength; therefore, the axle portion surrounding the crack is more sensitive to alternating load and micro-deformations, which increase material fatigue. This phenomenon around the crack may be very dangerous at those

axle locations where a high notch effect is produced by the crack, which produces rapid crack propagation or even carriage-axle fracture. The study and material analysis made in the crack surroundings show that the carriage axles having cracks deeper than 3 mm shall be rejected because a momentary, increased load close to the crack may produce additional increase in stress concentration and, consequently, a fatigue fracture.
