COMPREHENSIVE ANALYSIS OF HEAT EXCHANGER FAILURE

Miloslav Procházka

Tediko, s.r.o., Pražská 5487, 430 01 Chomutov

November 07–09, 2007, Prague, Czech Republic

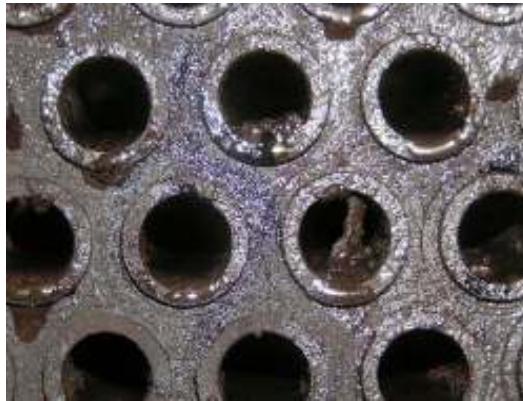
The condition after the primary cleaning was from the point of visual inspection significantly worse than optimal. We drew a conclusion that no relevant non-destructive testing was possible under the given condition. However, we did not find any fundamental signs of damage. The only possible non-destructive testing was radiography. The following photo clearly defines the condition

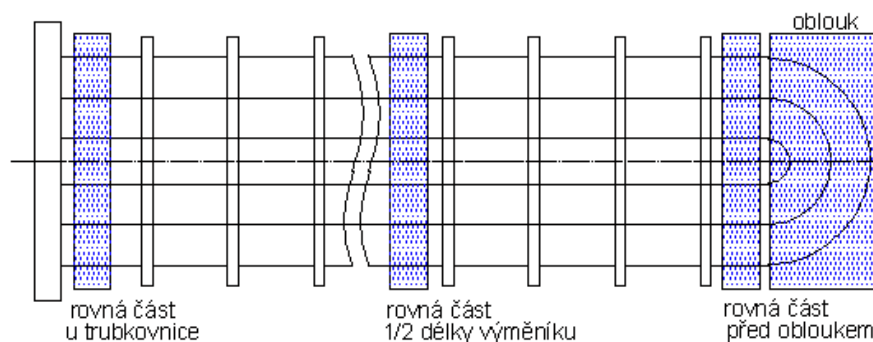
Radiography of randomly chosen spots – bends and straight sections was performed on-site after primary cleaning. The locations were chosen with regard to accessibility and representativeness (see the following picture). The radiographs did not show any signs indicating extensive corrosion or erosion attack on the surfaces. The inspection did not find any systematic damage of the exchanger and the wall thickness did not show any anomalies.

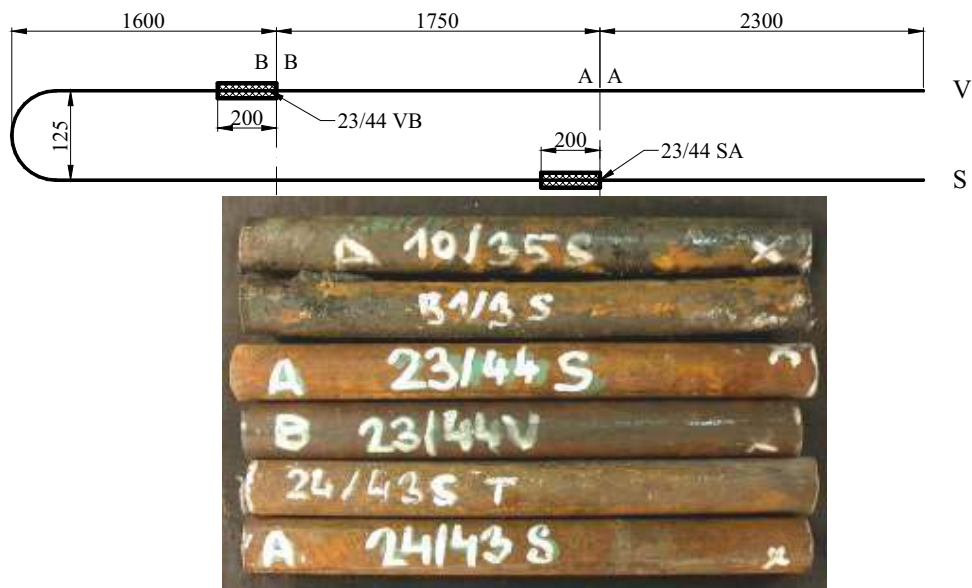
Samples each 200 mm long were cut out of the removed tubes. The picture below shows the layout of locations where the samples were cut out. This „cutting layout“ shows how the tube was cut after it had been removed from the exchanger. The following photo illustrates the cut-out samples.

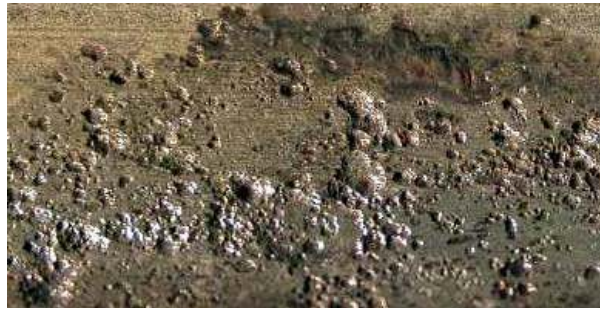
No signs of the process medium were detected on the inner surface of any of the samples. Chemical cleaning of the samples in Clark's solution did not reveal any significant defects or corrosion attacks. The outer surface shows a uniform corrosion attack and the loss in wall thickness was estimated to be max. 0.1 mm. The inner surface was smooth with a lot of pittings with depth of mostly 0.20 mm, in once case even 0.60 mm (i.e. less than 25 % of nominal wall thickness). Regarding the distribution of smaller pittings on the inner surface we can say the pittings probably appear in tiny heterogeneities in the material which do not create conditions for further attack or they may appear during shut-downs. Bigger pittings may be caused by conditions on the side of environment, i.e. a product of oxygen corrosion or improper composition of the water (corrosion on the boundary between phases).

Samples for metallographic analysis were cut-out on the basis of visual examination findings – the worst looking locations (for example with corrosion pits). Typical appearance of the surfaces is shown below.

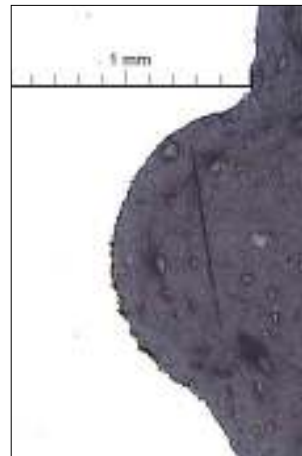
The samples were analyzed to determine the depth of corrosion attack and type of steel structure. The structure is formed by ferrite matrix with precipitated carbides which corresponds with expected condition. Outer surface is attacked by corrosion only to the depth of 0.2 mm, on inner surface the depth of corrosion is up to 0.55 mm (pitting) – see the picture.

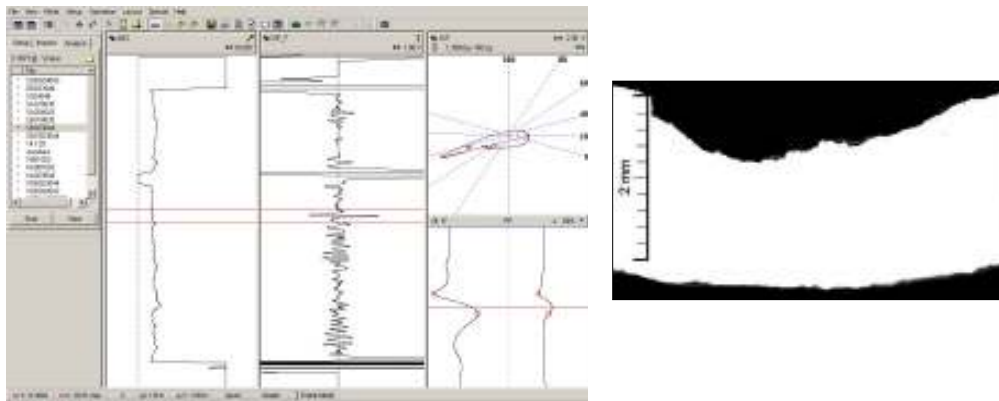
approx. 40% of wall thickness were identified – see recording of the measurement. These locations were cut out and visual examination was performed after the samples had been cut longwise. A sporadic defect 0.72 mm in deep (30% of wall thickness – original wall thickness in this place was 2.56 mm).was found.

Comparison of findings of non-destructive RFT measurement and metallographic verification shows quite good harmony within the range of expected accuracy 10-20 % of nominal wall thickness. In the case the depth of damage was a little overestimated when measured by non-destructive RFT examination. Probability of detection of defects such as pitting with diameter of 2 mm and bigger and deeper than half of the wall thickness is in diferential channel relatively good (apart from tube sheets where the probability of detection is very limited.)

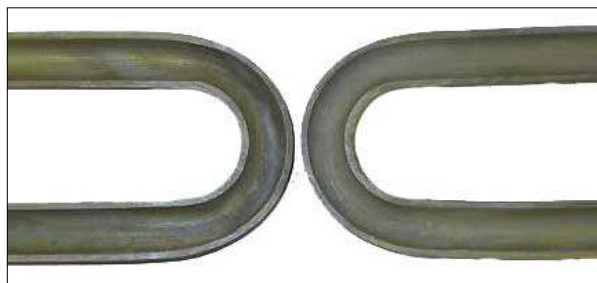
The inner surface was covered with about 0.3-0.4 mm thick fine-grained non-magnetic layers. When the layers had been removed and the surfaces cleared off, it was visible that the outer surface was attacked by uniform corrosion in the form of tiny pits of negligible depth while inner surface showed neither corrosion nor manufacturing defects. An example of one of the tube bends is shown below.

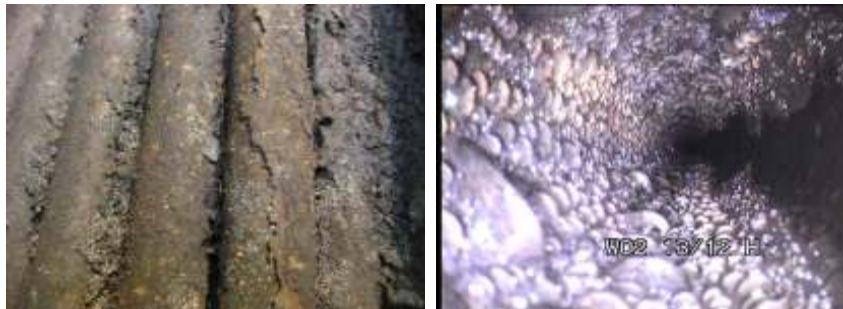
Two tubes were inspected by ViZaar videoendoscope. One of these tubes was after the pressure test considered to be leaking. This inspection showed that there were some free sediments and some which adhere firmly to the inner surface of the inspected tubes. Some sediments were corrupted by corrosion process. Water in tubes (approx. 1/5 of the cross section) made the inspection rather difficult. We failed to find a highly damaged location with a leak. The sediments that adhere firmly to the surface might have covered possible damage causing the perforation of the tube.

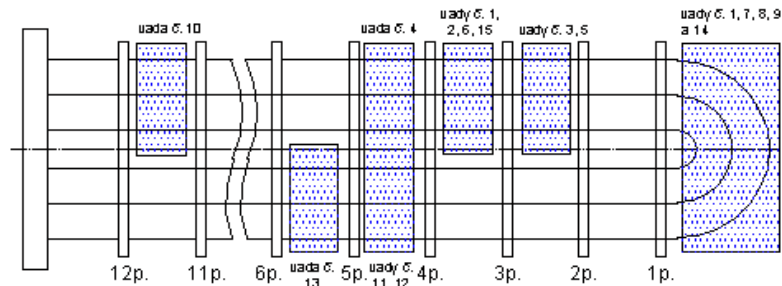
In total, we detected 15 tubes with indications of defects with extent of damage 40% and bigger. The following picture shows the location of defects along the exchanger longitudinal axis..

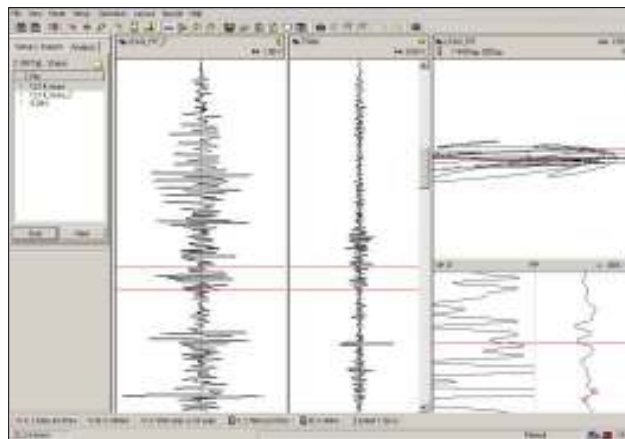
All in all nine tubes showed indications of defects in the range of 60 to 80 %, one defect exceeded 80 %. The following picture shows the MFL inspection record of a tube which was supposed to leak.

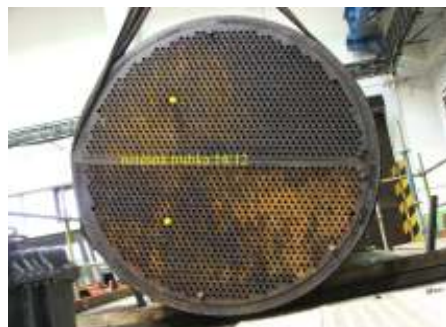
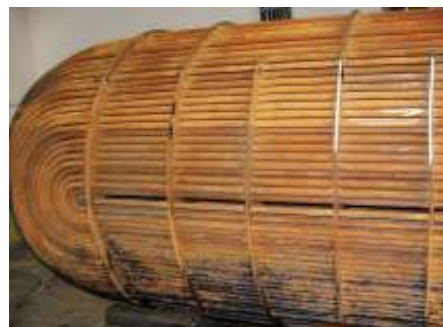
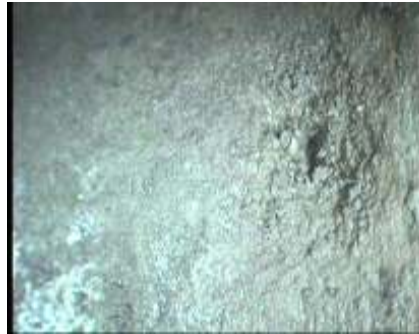
Visual indirect examination (VTn) of the inner surface was performed again together with testing by electromagnetic methods. Leaking tube with indication of defect over 80% was checked again. We succeeded in finding the exact location of the damage thanks to detecting the approximate location of the leak. The following photos show the condition of the tube bundle after the last cleaning. Next photo from videoendoscope shows the discovered defect – leak in the tube.

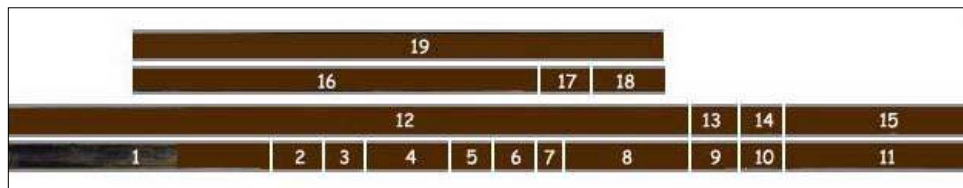
Sections of the tube showing defects were cut out and analyzed. This tube was chosen because it was located on the edge and easily accessible and there was defect to the indicated depth of 60-80% of wall thickness. The following picture shows the „cutting layout“.

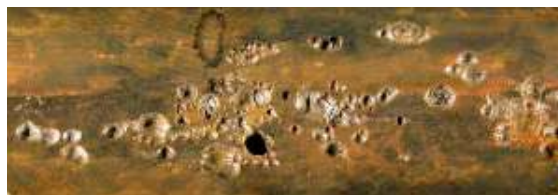
The condition of both surfaces was examined in detail. The outer surface was covered with uninterrupted coat of rust and chemical cleaning revealed that the outer surface was attacked by corrosion up the depth of approx. 0.10 to 0.15 mm. There was an uninterrupted thin layer of brown sediments on the inner surface together with scattered isolated pittings with diameter up to 3 mm but there were also clusters of pits. The depth of defects was 0.60 to 1.20 mm. The following photos illustrate corrosion attack and sections through the wall showing the depth the damage in the given sections.
