KEEPING IT TOGETHER - HYDRO GENERATOR LEG TRANSPLANT

Abstract

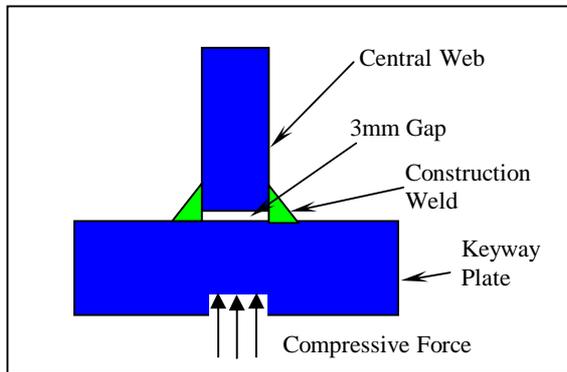
The discovery of these additional defects caused some alarm once it was identified that there was a 3mm gap between the central web and the keyway plate. The presence of this gap allowed the construction welds to be loaded in pure shear by the heavy compression forces of the heat shrunk rim.

Figure 3 Detail of construction weld and 3mm gap

The UT was predominately used to determine the depth of the defects and the fabricated design of the arm. It was through UT that the critical 3mm gap was identified that placed the construction weld into pure shear.

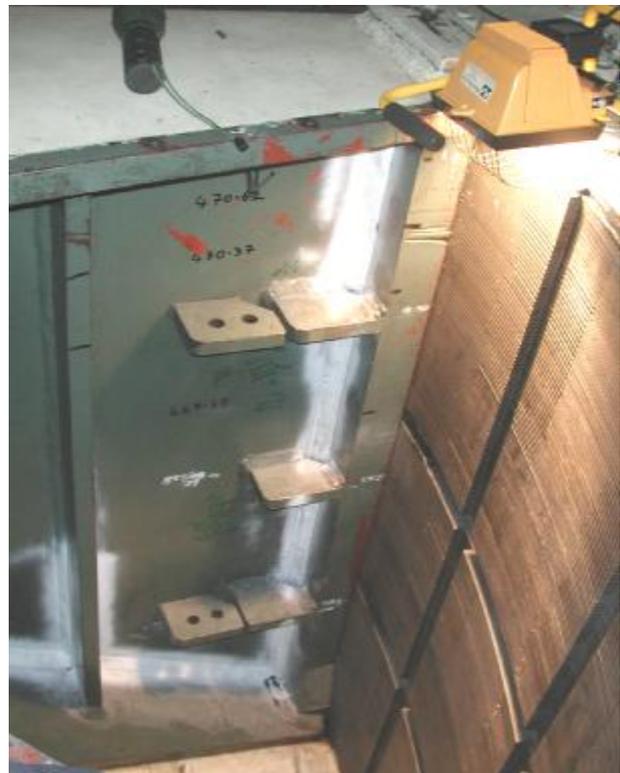
During the first Non Destructive Testing (NDT) of the defect, known as defect 1, three additional cracks were found, defects 2, 3 and 4. The three new defects were all discovered in the same construction weld between the central web and keyway plate.

Photo 2 MPI of defective rotor arm

The first reaction was to carry out a weld repair on the cracks, but the construction of the rotor caused the engineers to stop and think.

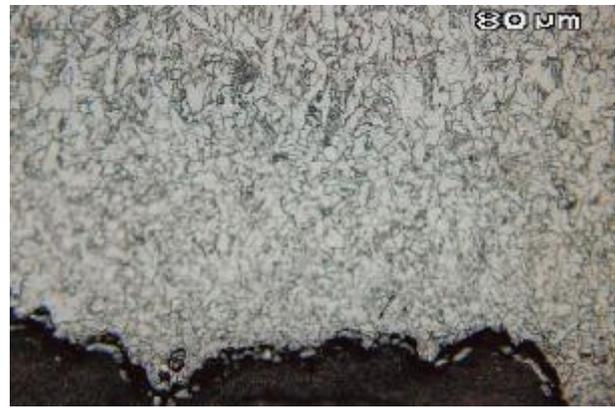
The results of this analysis indicated that the cause of the defects was pointing towards the welding preparation and final capping weld, a single pass 20mm wide fillet weld. It was also believed that there was very little post weld heat treatment thus causing large residual stresses within the HAZ.

Photo 3 The heat affected zone next to defect3
(Photo extracted from MPT report 11541.01)

The results of the analysis indicated that the material was a low carbon steel (<0.18% carbon) with no ‘normal’ pearlitic structures, thus it is impossible to determine if the arm had been heat treated. There was no evidence of hardening having occurred in the HAZ due to abnormal cooling rates. The overall material was deemed satisfactory.

It was also noted in MPT’s report that careful consideration should be given to any repair methodology of the defects in the vertical weld between the keyway plate and the central web.

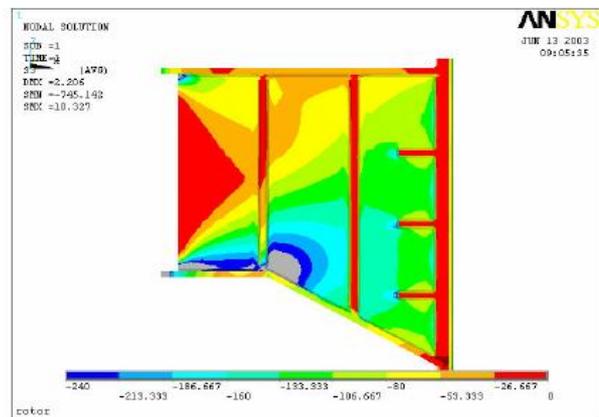
The results of the FEA indicated that the whole arm was in compression due to the large ‘heat shrink’ force from the rotor rim. The loading effect from the generator’s torque had very little effect on the overall loading of the arm.

The basic FEA results indicated that the arm design was good and should not allow the arm to fail in fatigue as the predominant loading was compression. However, fatigue cracking requires the crack to be in tension if it is to propagate.

Figure 4 FEA stress distribution of 3rd principal stresses with no rotation²

In the case of the rotor arm the only way that the defects can be in tension is if there are ‘tensile residual stresses’ due to a lack of post weld heat treatment (PWHT). The residual stresses are normally taken as the material yield stress (i.e. 265 MPa). Thus if residual stresses are present due to a lack of PWHT then there will be an oscillating tension force in the areas of all defects. In the case of defect 1 the oscillating force is between 17 and 143 MPa in tension.

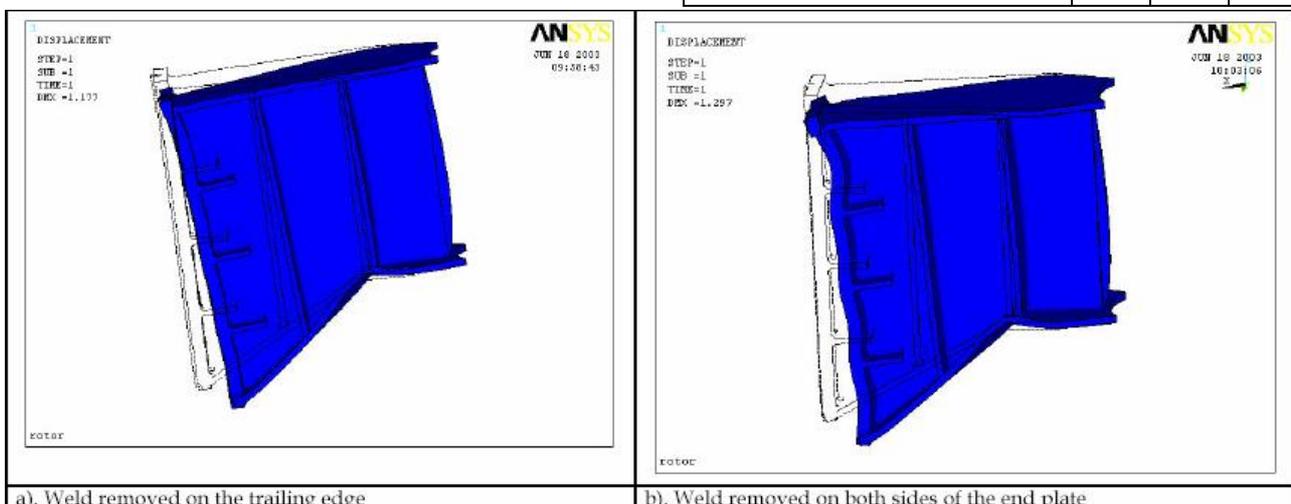
The further FEA analysis involved removing the vertical keyway welds completely to simulate complete failure of the welds. The first step involved removing the TE weld and observing the distortion in the key way plate. The results indicated that a distortion of up to 0.07 mm in the keyway slot could be expected. The second step involved removing both vertical welds from the

keyway place. The results were not so favourable with a maximum distortion of up to 0.42 mm. Almost half of the heat shrink (designed to be 1.1mm at 0% speed and 0.9 mm at 100% speed). The removal of the welds allowed the rotor arm to distort as shown (in distorted form) fig 5. The distortion is predominantly due to the 3mm gap.

The distortion of the keyway plate places additional loading on the 6 stiffeners located between the keyway plate and the central web. Stress calculations were carried out on the stiffeners and the surrounding plate material. The results indicate that with both welds removed a maximum shear stress of 129.3 MPa can be expected. This shear stress is just below the maximum permissible shear stress of 132 MPa.

Fig 5. Showing the displaced shape of the rotor arm during over-speed conditions, for two different

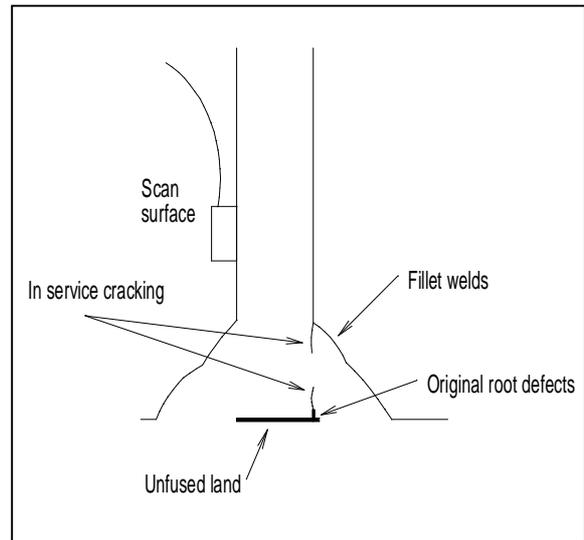
During the repair of defect 1 in September 2003 it was noted that the defect profile did not fit with that determined by the UT. The defect was longer and deeper than initially expected. Difficulties experienced in defect sizing were:

- The presence of significant original welding defects in the root of the fillet welds, which had propagated during the service life of the rotor
- The orientation of the defect
- The presence of both root and toe defects in the same area.

Fig 6 Detail of defect location and orientation

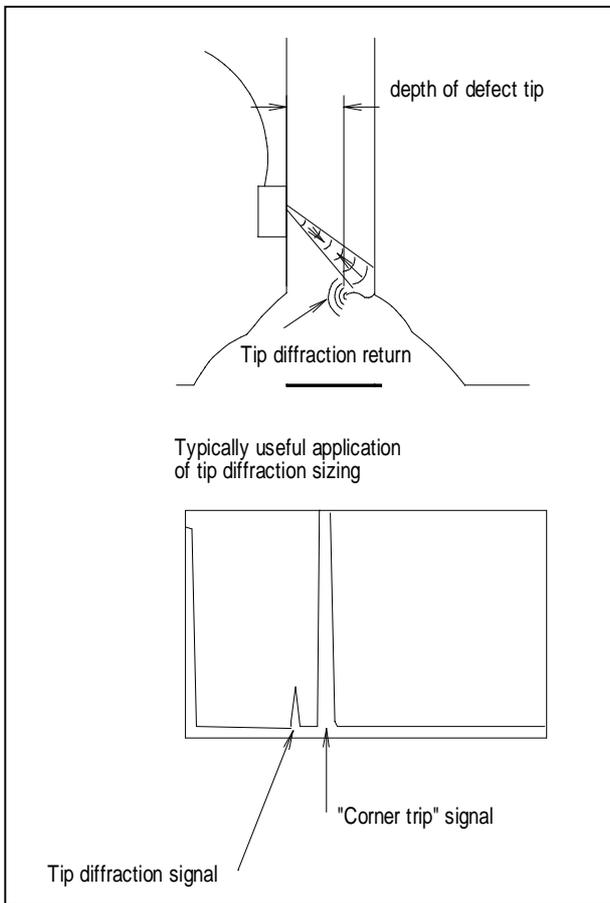
Tip diffraction methods for defect tip sizing work well when the defect lies in a plane perpendicular to the scan surface. The application of tip diffraction to size the defects in the rotor welds was attempted, but only limited success achieved.

These limitations of the UT method used for detecting and sizing of the defects in the fillet welds, underestimated the defect size. This may have had serious consequences resulting in premature failure of the rotor.

Figure 7 Tip diffraction signal

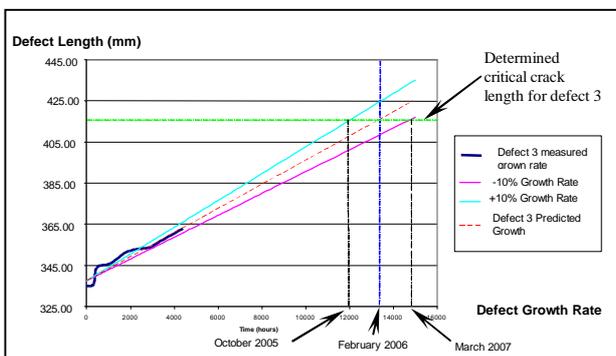
After the repair of defect 1 the continued growth rate of defect 3 was still of concern. It was predicted that the crack would reach a critical length by November 2005. This prediction was based on the applied loads, measured crack growth rate and the current operating conditions of the unit.

Figure 8 Trending of the defect 3 growth rate to critical crack length

The call was made to carry out a full arm replacement in October 2005.

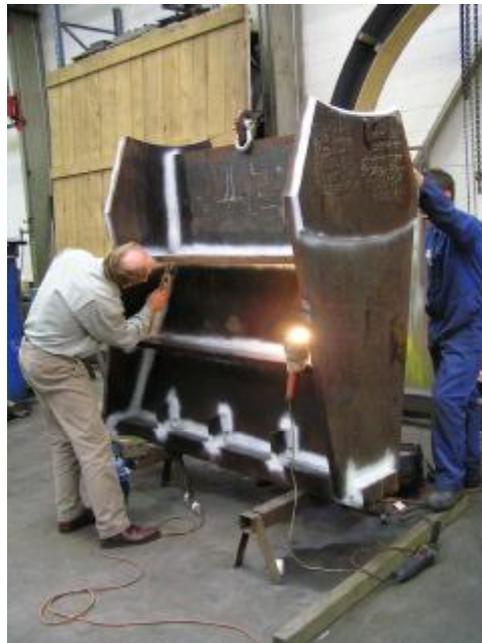
As part of the acceptance process for the arm, a detailed NDT inspection was carried out. The initial result indicated that the weld profiles did not comply with the required profiles as specified in AS/NZS 1554 part 5 and thus it was rejected even though there were no detectable defects.

Photo 3 The new arm under construction.

All the welds were dressed back to remove stress concentrations, weld undercut and other defects that may lead to fatigue in service.

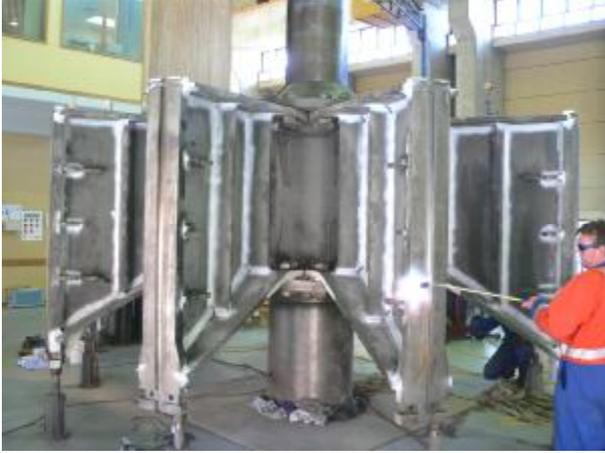
After the original arm was removed the eight remaining arms were tested by SQA (predominantly MPI). A number of significant defects were identified in three additional arms.

Photo 4 NDT and weld repairs of the rotor

With the use of UT it was identified that the critical gap behind the weld see figure 3 was not present¹ and the number of defects were manageable, so it was decided to carry out a weld repair of these defects.

To reduce the likelihood of residual stresses and potential fatigue issues, the bead tempered weld repair was used (as per the repair of the original defect 1 [1], [8]).
