# **RESTORATION AND CONSERVATION OF OUTDOOR BRONZE MONUMENTS: DIAGNOSIS AND NON-DESTRUCTIVE INVESTIGATIONS**

*A monument has been studied, celebrating Garibaldi and his soldiers leaving from Quarto-Genoa to Sicily: the bronze group, of the artist Eugenio Baroni, inaugurated in May 1915 and never restored, is positioned by the sea and has been heavily damaged, in some exposed porous areas, by marine particles rich of chlorides.*

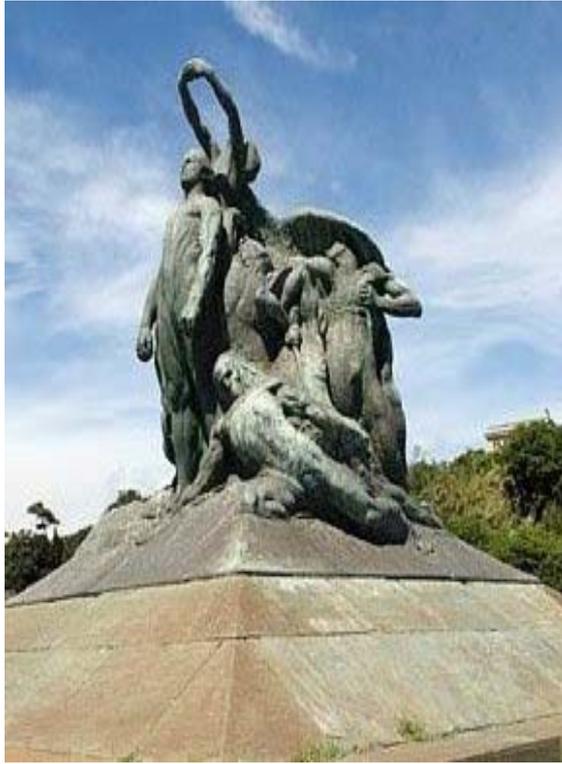
Fig.1. The bronze monument.

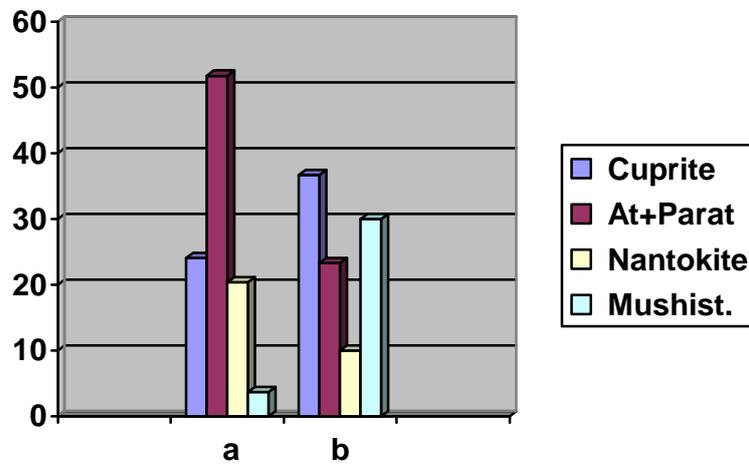
The main components identified in patinas placed in sheltered position and also in dark green and black patinas and drippings (named a) are:

- In depth cuprite, frequently nantokite
- In the outer layer atacamite, or atacamite + some mushistonite.

The components of green patinas exposed to heavy rain water, mainly green (named b) are:

- In depth cuprite, frequently nantokite
- In the outer layer mainly mushistonite and then atacamite.

Fig.2. % of copper and tin crystalline compounds in black and sheltered patinas (type a) and in heavily rain washed ones (type b).

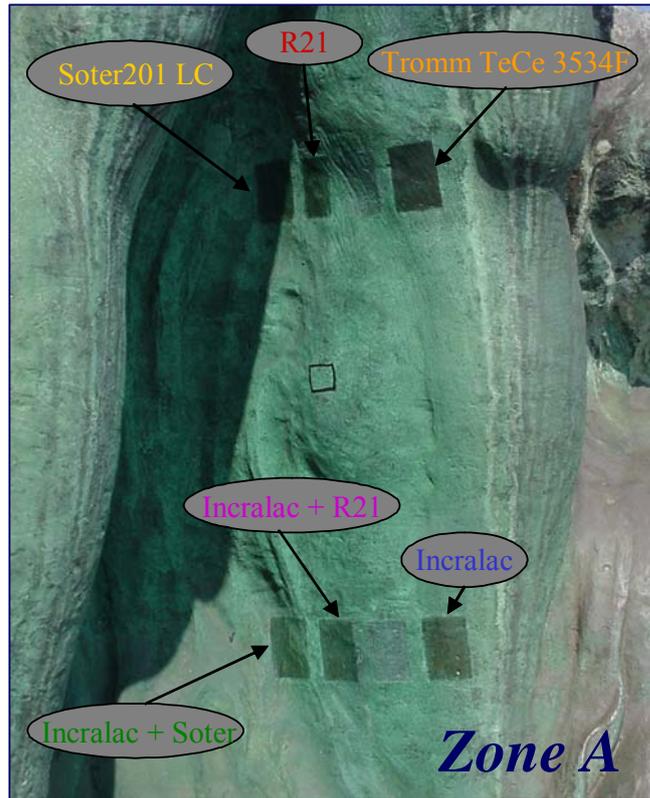
Fig.3. Areas of zone A.

- In the sheltered non porous areas of the zone A corrosion rate is very low for all coatings; the lowest values are exhibited by Inralac + Soter. Also corrosion rate of not coated areas is very low.
- For the exposed and porous zone BB, Soter (blend of microcrystalline waxes + an inhibitor, fluid and easy to apply, with a melting point lower than the other microcrystalline wax R 21), Inralac and Inralac + Soter result after 6 years to be very efficient, with  $I_d$  lower than 1 for Soter.  
The BB surfaces not treated have a very high corrosion rate (from 200 to 700 times greater than the c.r. of the coated areas).
- As far as it concerns all results of the six zones (only partially listed here), the double layers and also Soter and Inralac exhibit a good performance.

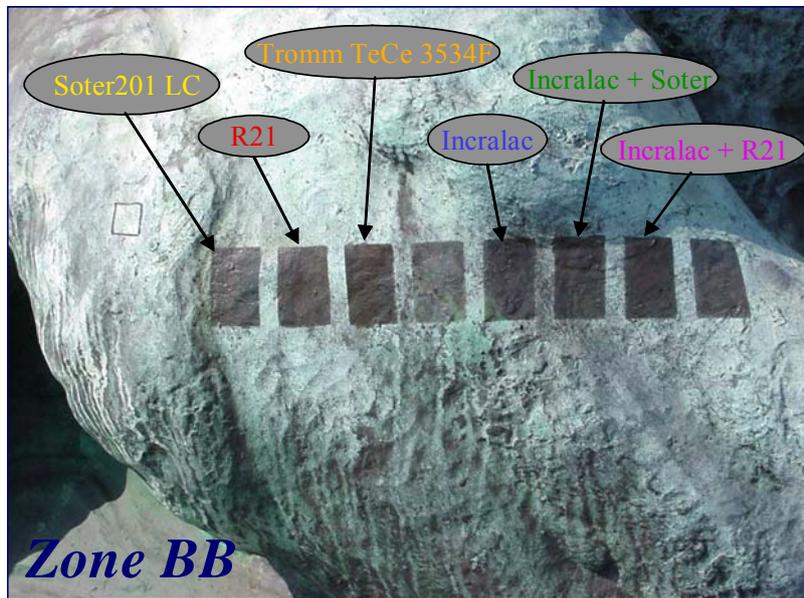
Fig.4. Areas of zone BB.

3. The adopted Rp methodology has allowed to measure the wet corrosion rate in areas representative of the monument. In general not only the sheltered and the treated areas but also the exposed ones – without coatings, cleaned and not cleaned - reveal no very remarkable corrosion rate but the BB not coated ones, exhibiting a porous superficial structure.
