UNDERSTANDING THE DECAY OF 14TH CENTURY MAGNESIAN LIMESTONE CARVINGS IN YORKSHIRE, UK

Sarah Eleni Pinchin¹, Tobit Curteis², Eric Doehne³, David Odgers⁴

ABSTRACT

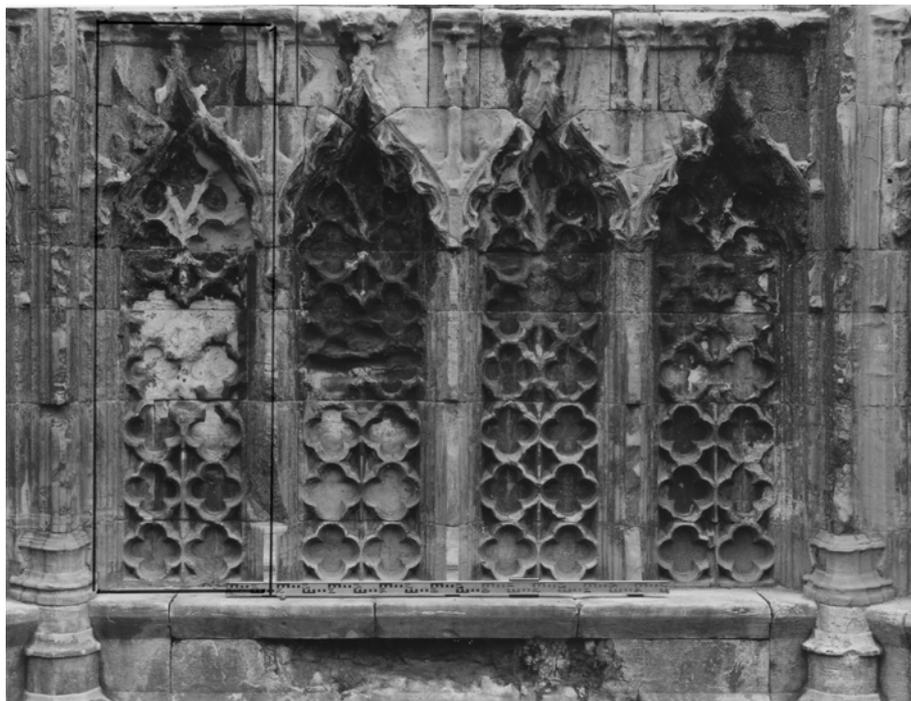
Photographs, prior to the reroofing in 1984, show that extensive damage to the surface topography has occurred in the last twenty-four years. Photographs from 1980 reveal that the surface has undergone significant damage following this intervention. (See Figs. 2-3.)

Fig. 2 Photograph of the Chapter House Northwest wall taken in June 1980.

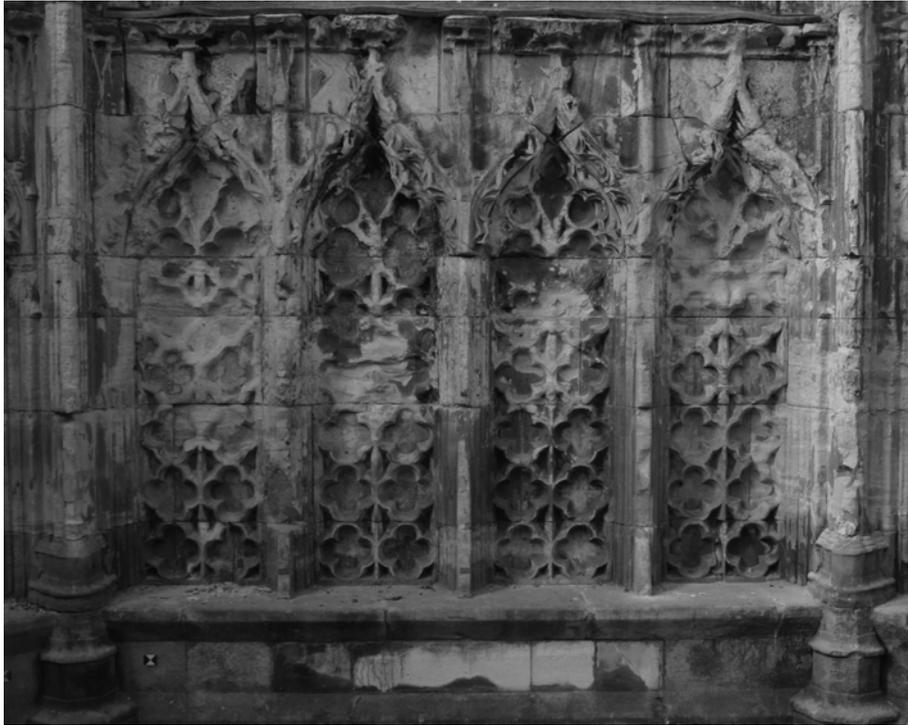
Fig. 3 Photograph of the Chapter House Northwest wall, taken in June 2007, revealing significant recent damage to the stone.

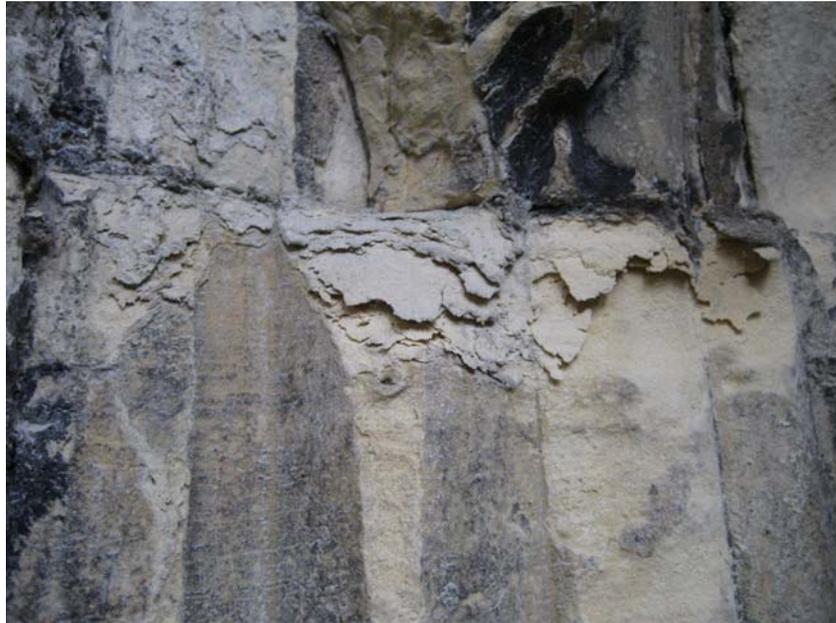
The stone displays different patterns of degradation. Deep sections of stone have been cut back from the surface plane and extensive interlocking cracks are noticeable on some stones. Other stone blocks exhibit spalling and flaking released in layers from the surface (See Fig. 4). Other surfaces lack cohesion and are powdering and features of the decoration have been softly eroded. A thick black crust, which clearly covered much of the surface at one time, now

Fig. 4 Detail of the flaking on the Northwest wall.

Magnesium sulfate salts are prevalent in the stone at Howden Minster and appear to be largely responsible for the damage observed there. The source of the magnesium ions in the magnesium sulfate likely comes from the magnesian limestone itself (dolomite), whereas sulfate ions come from deposits formed by sulphur dioxide of historic air pollution. Magnesium sulfate is a very soluble salt, frequently able to convert the ambient moisture into liquid water (3). It is about 300 times more soluble than calcium sulfate, which makes it more mobile and capable of penetrating deeper into the stone leading to more aggressive damage (4).
