Defects Detection in Electrical Insulators and Breaker for High Voltage by Low Cost Computed Radiography Systems

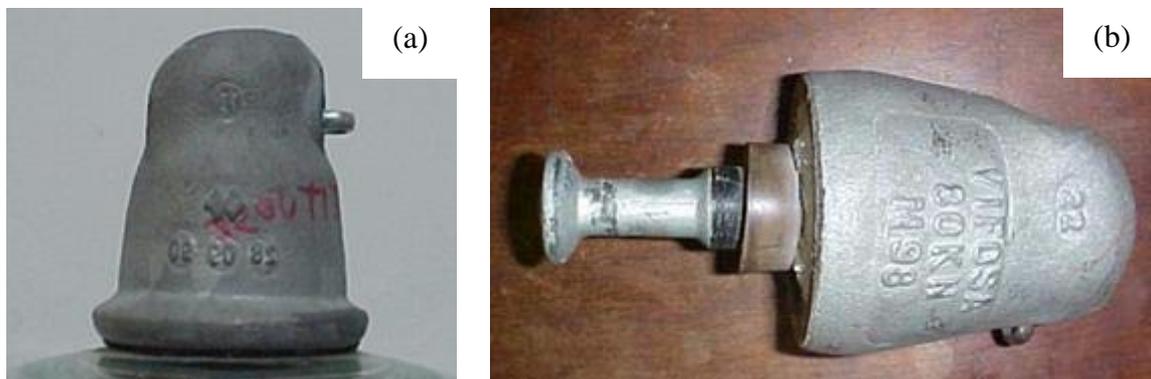
Figure 1 shows photos of parts of glass insulator of good glass insulator and broken one. A glass insulator works as a electrical capacitor so as tempered glass is between two metallic parts made of steel, which are cemented by a special cement.

Figure 1. Photos of glass insulator employed in a high voltage transmission line: (a) upper part of a glass insulator of 10 inch in diameter and 80 kN; and (b) glass insulator with glass part broken.

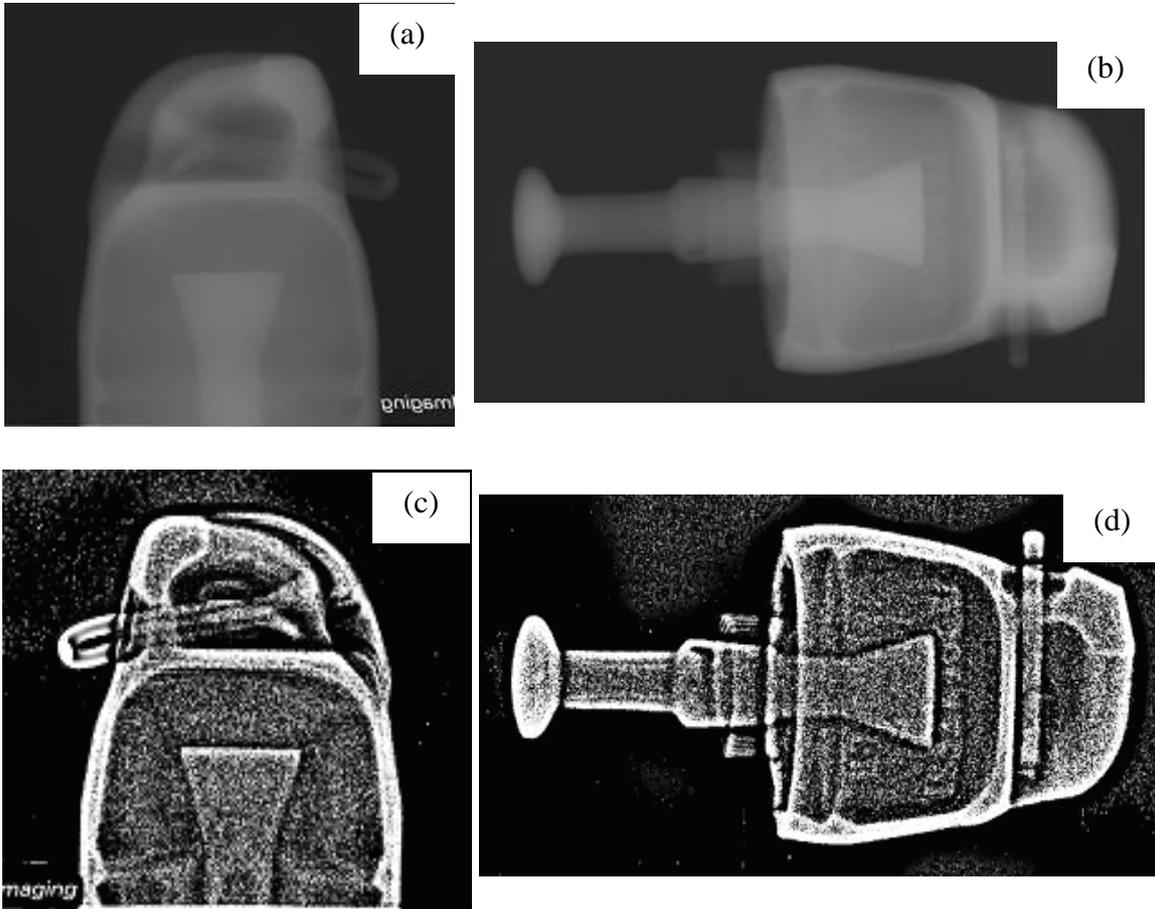
Figure 2 shows as obtained digital radiography and processed radiographies by Matlab using IPT and LOG filter. In principle, even though the quality of radiography are considered good and a texture can be observed only in figure 2(b), which it was attributed to glass cracks texture on digital radiography, however, it can be easily observed after LOG filter application as shown in figure 2(d).

Figures 2(a) and 2(b) are as-obtained digital radiographies. 2(c) and 2(d) show processed digital radiographies of radiographies shown on 2(a) and 2(b) by LOG filter.

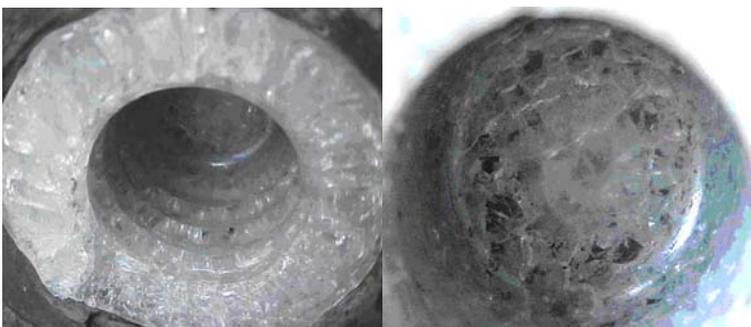
In order to assign that texture observed on digital radiography using Ir-192 gamm-ray source with 1,5 Ci activity coupled with IP reader Denoptix, one of metallic part cemented to glass part was carefully extrated from the broken glass insulator. Figure 3 shows clearly that tempered glass broke also in the interior region.

Figures 3 shows the interior part of tempered glass in two magnifications after the the extractetion of one of metallic part. It is clearly observed that whole glass part is cracked.

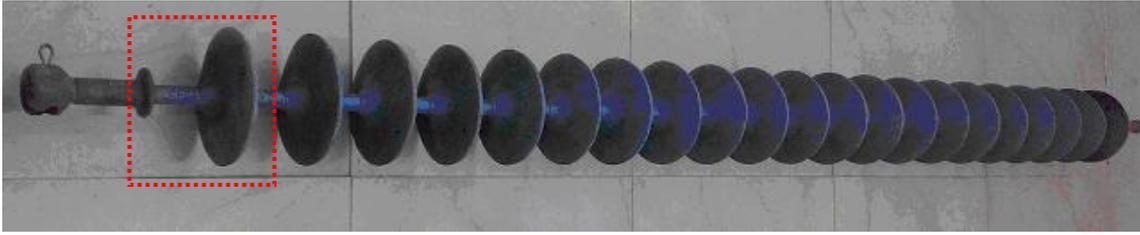
Figure 4 shows a photo of composite insulator employed in high voltage transmission line of 230 kV showing part that was imaged by the computed radiography.

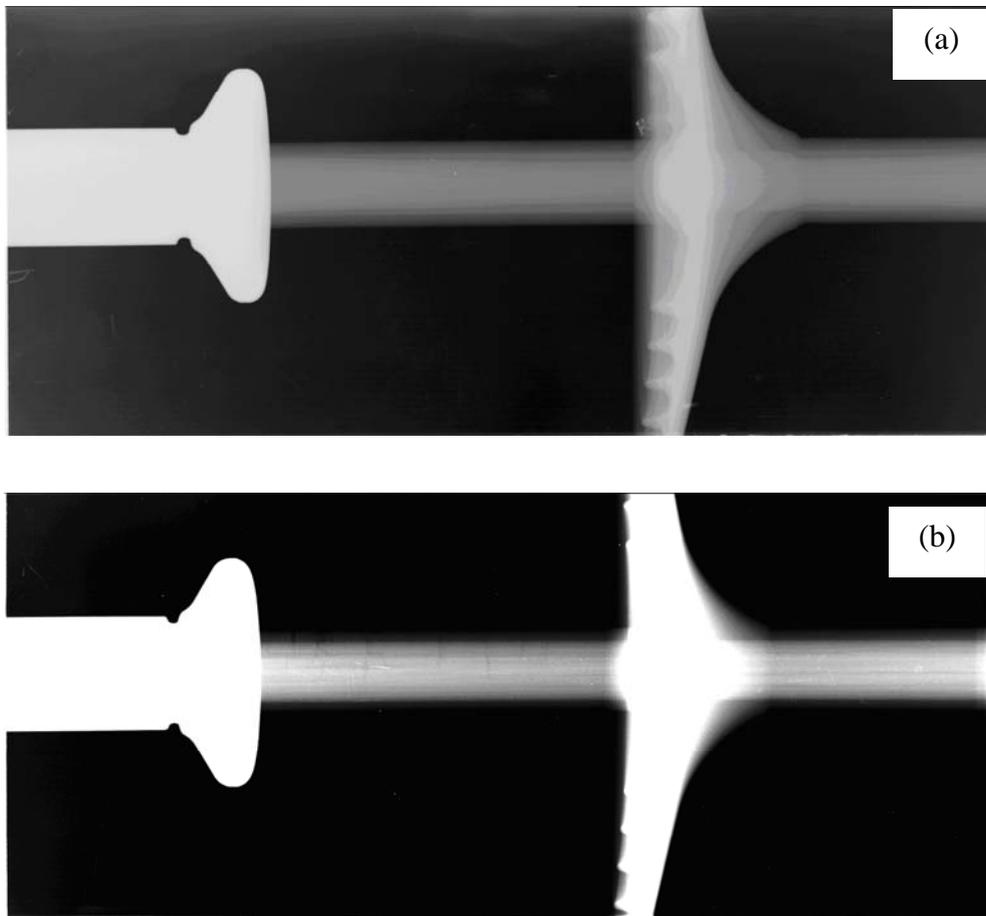
Figure 5 shows as-obtained digital radiography of good composite insulator and one with cracks on polymeric part. Visualization of those cracks by the naked eyes are most of time difficult because the surface usually is coated with dust. Therefore, computed radiography can easily detect such cracks.

Figure 5 shows as-obtained digital radiography of composite insulator classified as good (a) and with cracks on external polymeric materials

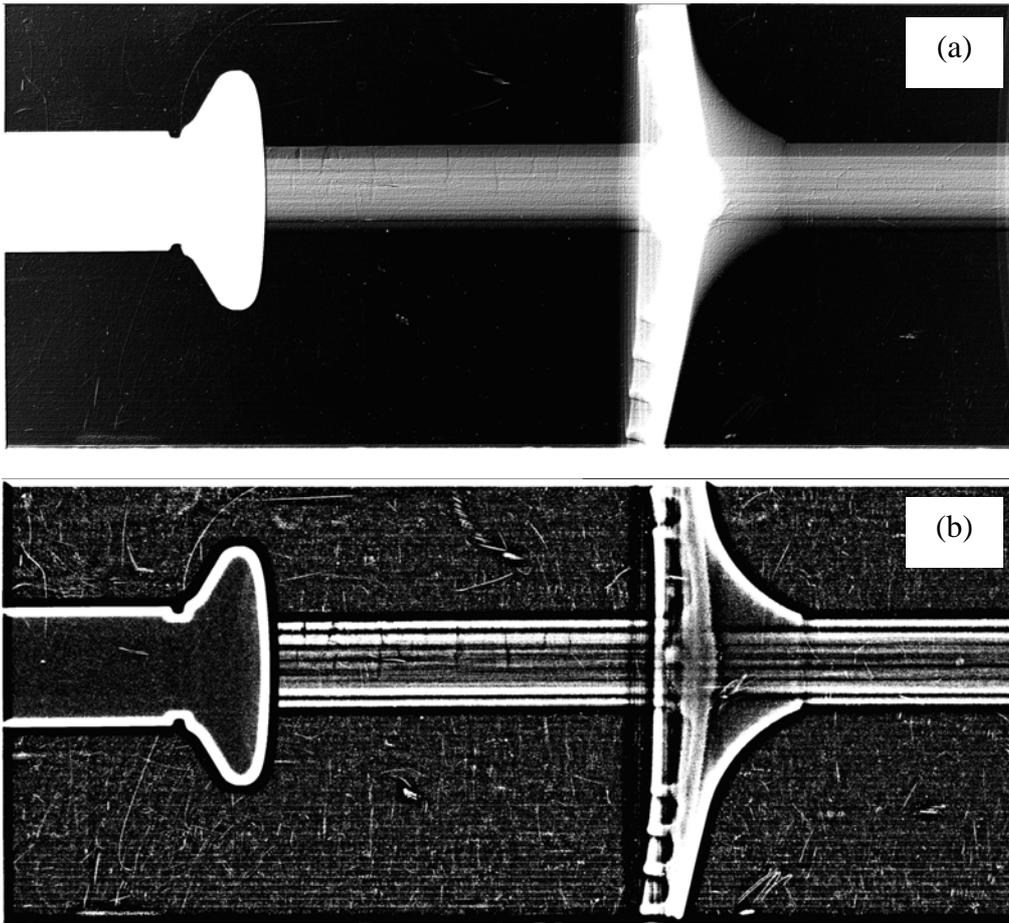
In order to enhance those cracks that are visible on as-obtained digital radiography, figure 6 shows two digital radiographies processed by embossy and LOG – Laplacian and Gaussina filters. The cracks appear perpendicular to composite axis. When the LOG filter is applied, scratches on the imaging plate also evidenced, but beyond cracks, the fiber texture is also enhanced.

Figure 6 (a) Digital radiography processed by emboss filter, and (b) processed by LOG filter.

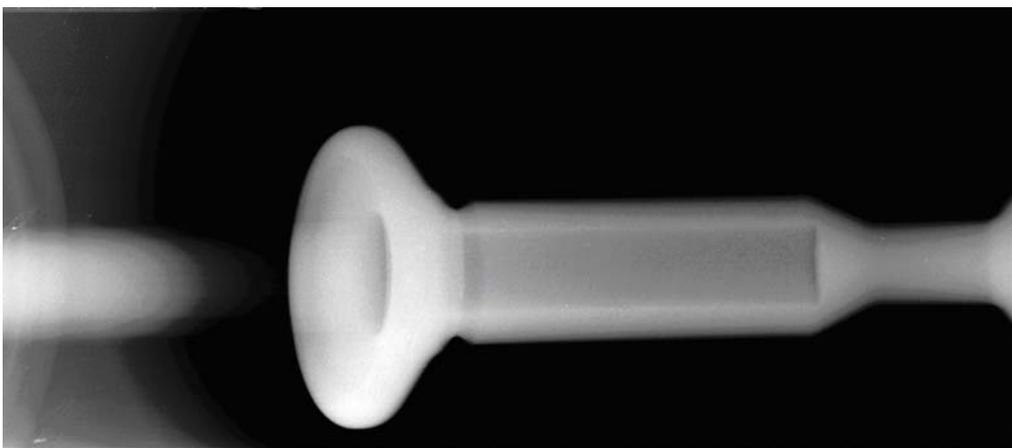
Another interesting result was the possibility to observe the composite material in the interior of metallic end, as shown in figure 7. Radiographic image was obtained reducing the distance between IP and the X-ray source to about 250 mm.

Figure 7 –Composite part in the interior of steel glove.

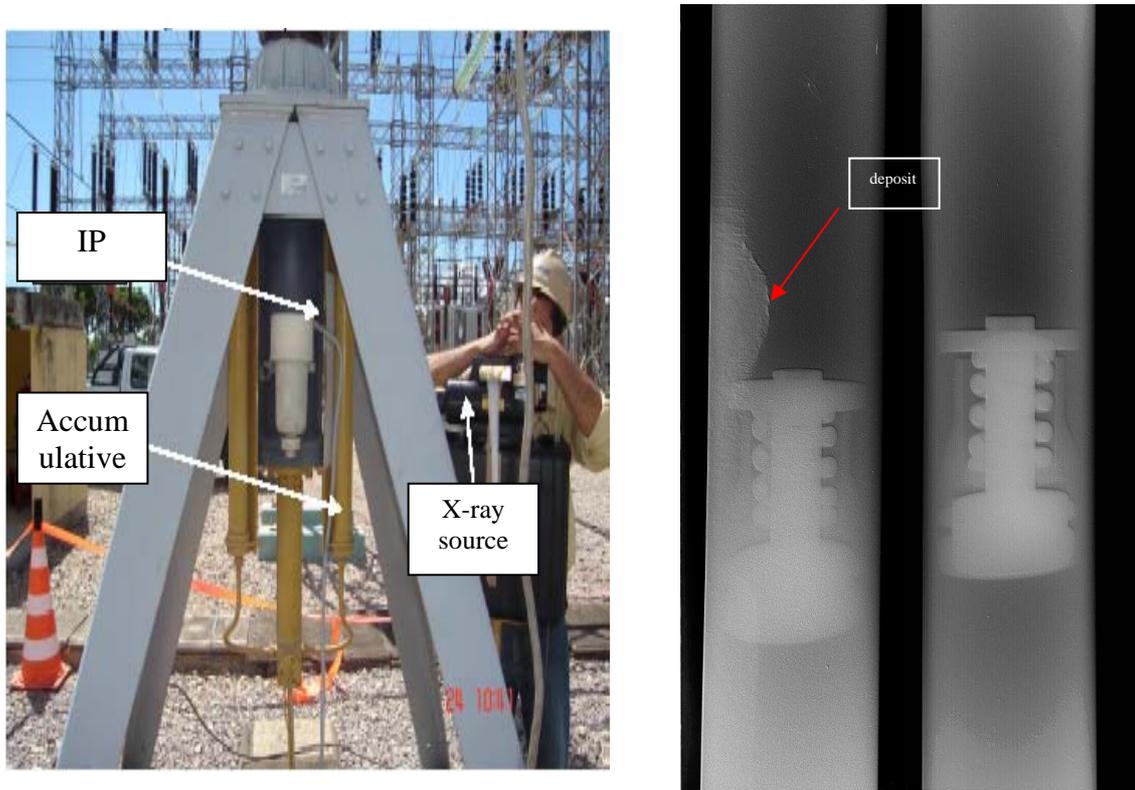
Figure 8 shows a photo a breaker at substation and digital radiography with emboss filter applied. In normal operation, the both valves should be at the same level,

however, the radiography revealed easily that some kind of material deposited on inner wall of cylinder making difficult one of valve move along it.

Figure 9 –Photo of break system at a substation and digital radiography with emboss filter showing deposition of materials on inner wall of cylinder making difficult the movement of one of valves.
