Feeler Pig – A New Tool for Multi-Size Pipeline Inspection

Claudio CAMERINI, Carla MARINHO, Aldo FRANZOI, Sergio IBAJÉ, Petrobras, Rio de Janeiro, Brazil

Abstract. The PPG-1/PGP-1 crude pipeline connects platforms Pargo and Garoupa in the Campos Basin. Crude is processed at Garoupa by removing water and transferring it to the coast. For 10 years this pipeline had operated with more than 20% of water. In 2001, the pipeline was surveyed with a Magnetic Flux Leakage (MFL) pig. The results showed internal corrosion in almost the entire 22 inch-pipeline concentrated on its bottom part (channeling corrosion). This type of indication is very difficult to size using MFL tools. The logistic arrangements were made to replace the damaged pipeline, but before the beginning of the work the pipeline was surveyed again using an Ultrasonic (US) pig this time, in order to enhance the sizing of all defects. The results of the US pig confirmed the MFL pig report, so all previous arrangements were maintained with the purpose of replacing the corroded segment.

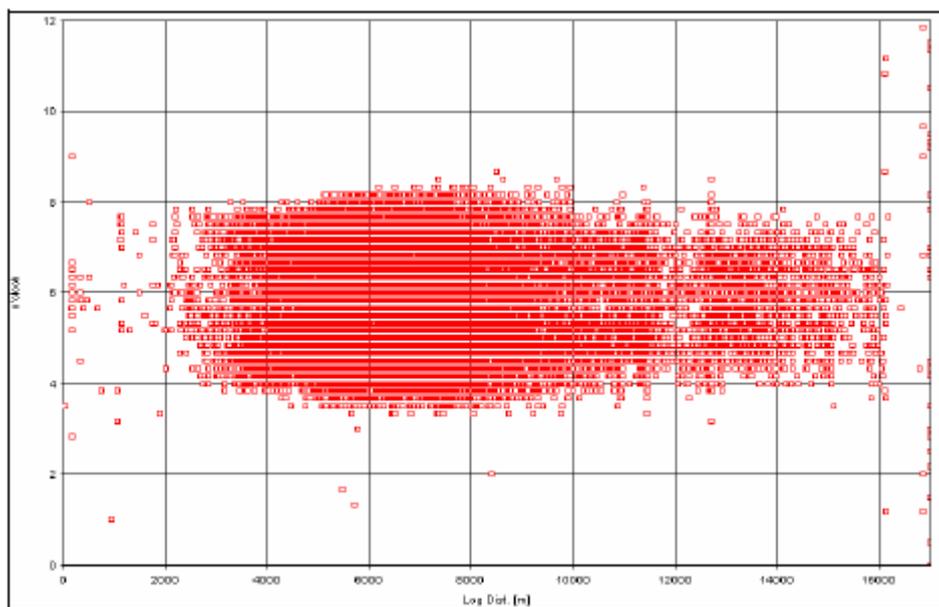
The results of the MFL pig inspection indicated extensive corrosion at the lower generatrix, with a large accumulation of defects. The company in charge of the inspection reported difficulty to size discontinuities due to the large number of defects clustered at the lower generatrix and the presence of metal debris inside the pipe is suspected.

The global results of MFL Pig and US Pig inspections are shown on figures 2 and 3, where the similarity of longitudinal and circumferential distribution of discontinuities can be seen. Both of them are concentrated between the 4 o'clock and the 8 o'clock positions and approximately between kilometers 2 and 16.

Figure 2 – Distribution of all discontinuities recorded by MFL pigs (planned pipelined). The hourly position of the occurrences is on the vertical axis. The position along the pipeline in meters is represented on the horizontal axis.

After the initial discussion, a preliminary list of the more significant metal losses was delivered. There were severe defects along the whole pipe, mainly concentrated at the lower generatrix. Although the pipe was operating under low pressures and made of API 5L X60 steel, a technical analysis performed considering the high corrosion rates as well as the remaining strength of the tubes recommended that 16 km of the pipe were replaced.

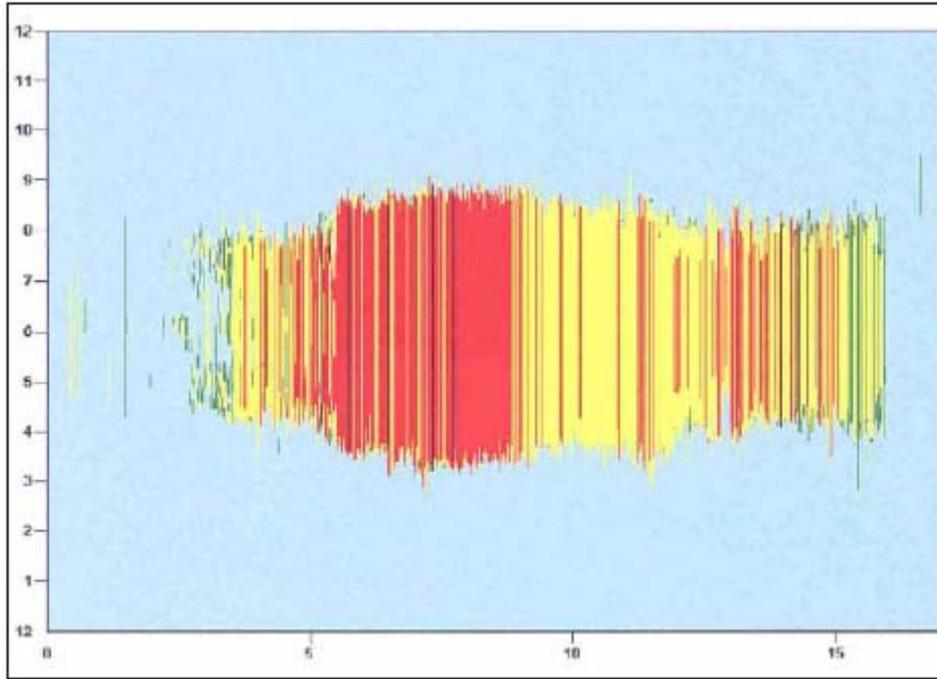
The report presented general internal discontinuities such as mass losses located at the lower generatrix, between 4 o'clock and 8 o'clock positions. Corrosion was not severe in

the initial segment of the pipeline and it got worse as the distance from point zero of the pipeline [2] increased.

In general the results were qualitatively similar to those provided by the MFL Pig, yet less defects were mapped and they were not so deep. An analysis of the remaining useful life of the pipe – which took into account the parameters that rule the corrosive process as well as the remaining pipe strength – pointed out that the damaged segment could still operate for a few years. Considering that pipeline replacement always requires a significant amount of time, the initial recommendation to replace 16 km of the pipeline was followed at an approximate cost of US\$ 15 million.

Figure 3 – Distribution of all discontinuities recorded by the US pig (planned pipelined). The hourly position of the occurrences is on the vertical axis. The position along the pipeline in kilometers is represented on the horizontal axis.

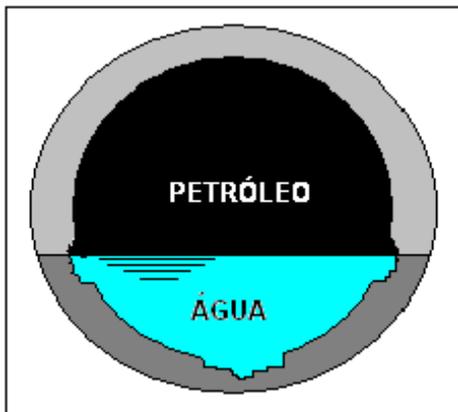
The pipeline corrosive process was caused by a combination of mechanisms associated to marine growth deposition and separation of the water phase produced. The first process can be confirmed by the large amount of Barium sulfate debris removed during the pipeline cleaning operation. The second process becomes evident by the number of years that the pipeline has operated producing large amounts of water at low flow rate speeds of about 0.5 m/s. Figure 4 shows a schematic drawing of the preferential location of the defects between 4 o'clock and 8 o'clock positions.

Figure 4 – Water-oil interface and corrosion-prone areas in laminar flow with emulsion break.

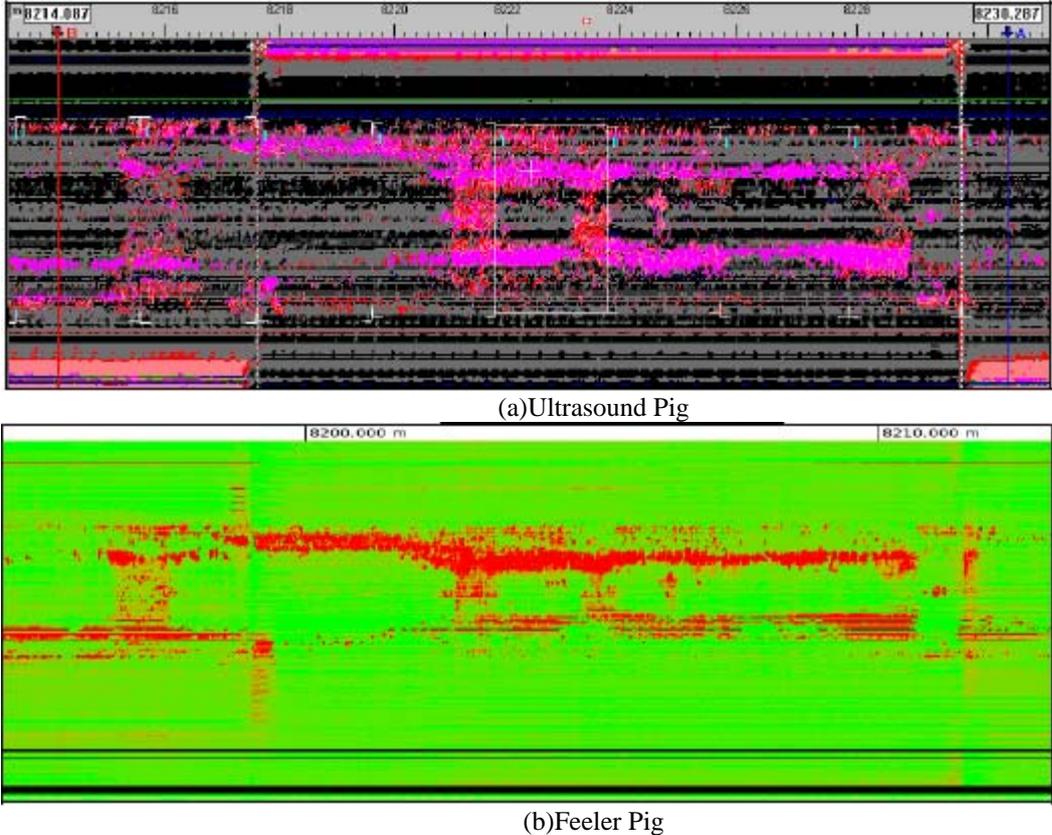
In general terms, the global analysis of the run revealed that both corrosion surface mappings were similar, which means that the cross-sectional and the longitudinal sizings provided by both tools was the same and that the resolution characteristics of each one of the techniques were equivalent.

Figure 6 shows a typical result of this comparison where the geometrical similarity of corrosion provided by both techniques can be clearly observed.

Figure 6 – Images obtained by both pigs in the same defective area. There is “visual” similarity between the two images.

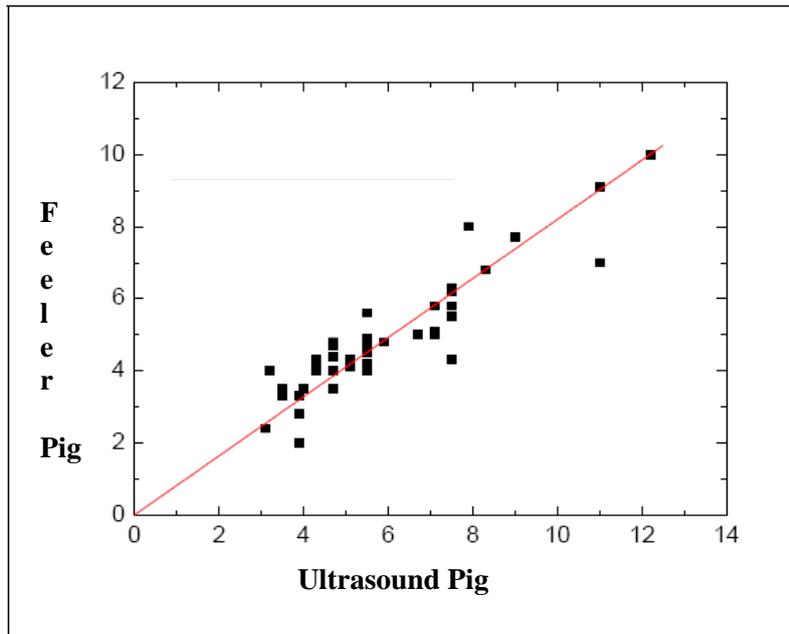
Figure 7 shows the depths correlation measured by both techniques for a given set of corrosion defects. An excellent correlation is observed, in spite of noise interference. The correlation factor measured in this graph is 0.82, which indicates that the geometrical technology – Feeler Pig – tended to provide lower values than the ultrasound technique.
