Non-Destructive Evaluation of Low-frequency Electric Resistance Welded (ERW) Pipe Utilizing Ultrasonic In-Line Inspection Technology

Rick MEADE, Tuboscope Pipeline Services, Houston, Texas

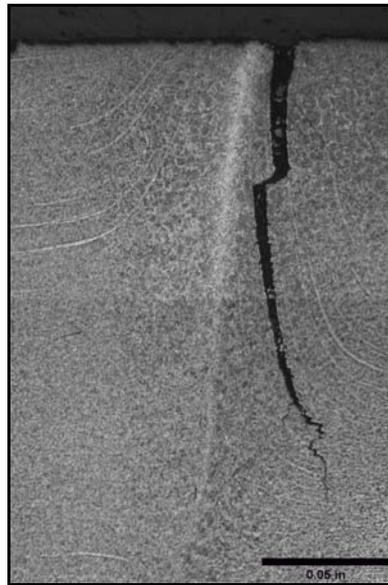
Figure 1 - Hook Crack

Figure 1 is a photomicrograph of a hook crack. It measures 0.186 inches (4.7 mm) deep with a part of that measurement being associated as a possible fatigue crack.

This is an excellent example of the formation of hook cracks and the reasons for concern. The ERW fusion bond is visible as a whitish line running from top to bottom. The white lines that appear to swirl upwards to the top or outside surface of the pipe are the original laminations in the plate. These would have been parallel to the plate surface until the edges of the plate were upset during the welding process thus reorienting the lamination to the shape shown. The hook crack formed as a result of the original lamination.

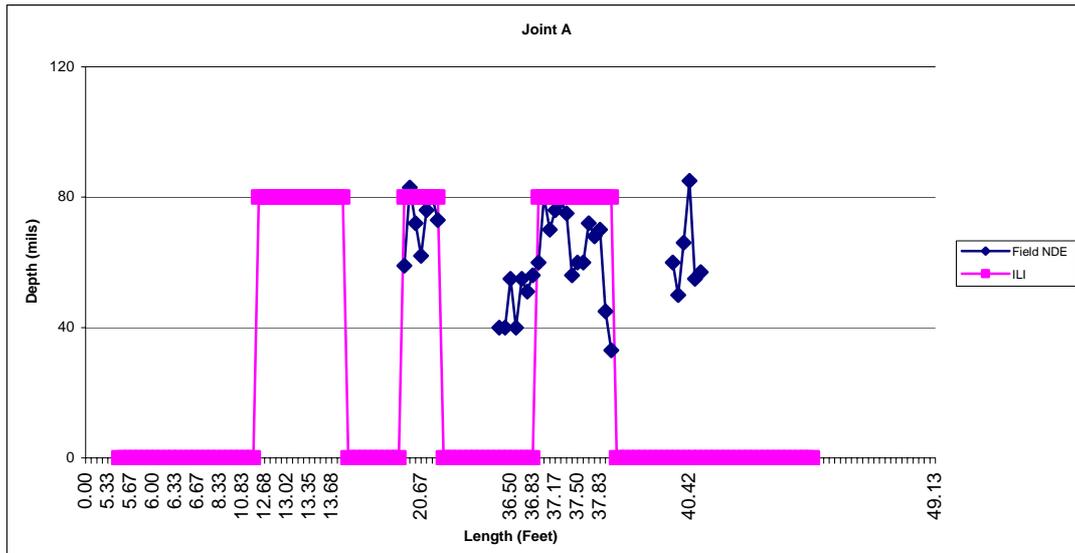
Figure 5 - UTCD Tool Results / Field NDE Results (Joint A)

It should be noted that only three of the features detected exceed the 0.040 inch (1 mm) reporting threshold. The three reported features and the field NDE results are shown in Figure 5.

The NDE field technicians confirmed two of the reported features but at the same time failed to confirm one UTCD prediction and reported one feature that was not reported by the UTCD tool. This unreported feature was actually detected by the tool but the depth estimate was below the reporting threshold. (See Table 1.)

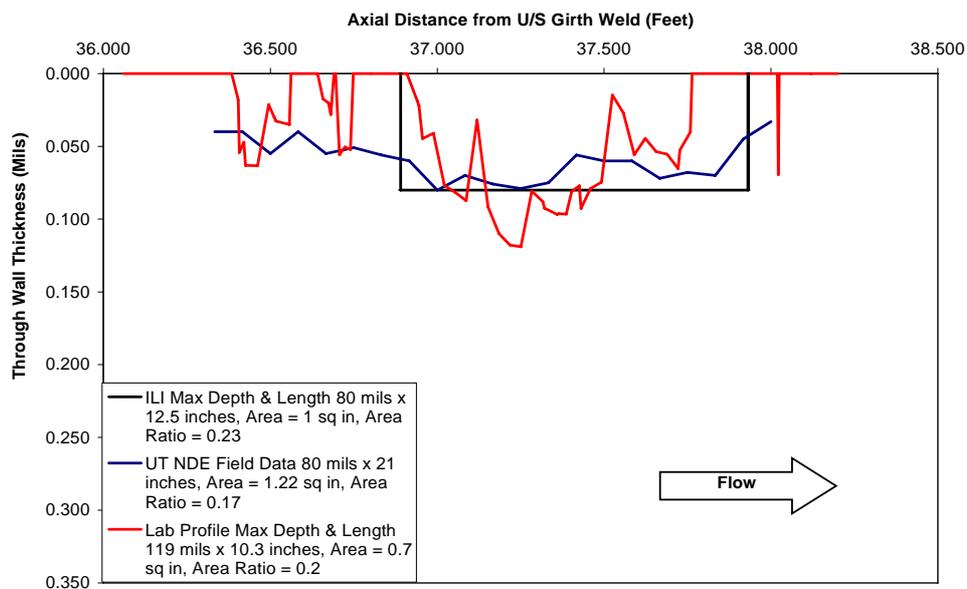
Figure 6 - UTCD, Field Data and Feature Measurements (Joint A)

Figure 6 shows a comparison of the UTCD tool prediction, the field measurements and the measurements obtained from destructive testing of this feature.

There are several points of interest when reviewing Figure 6:

- The ILI depth prediction was under called when compared to the actual maximum crack penetration. Also, the actual maximum penetration is in the 2-3 mm grade band.

- Actual crack profiles will prove beneficial for establishing more accurate depth prediction algorithms, establishing future models that build a crack profile from ILI data, and aiding in the discrimination of the origin of a reflection. In this example hook cracks were identified.

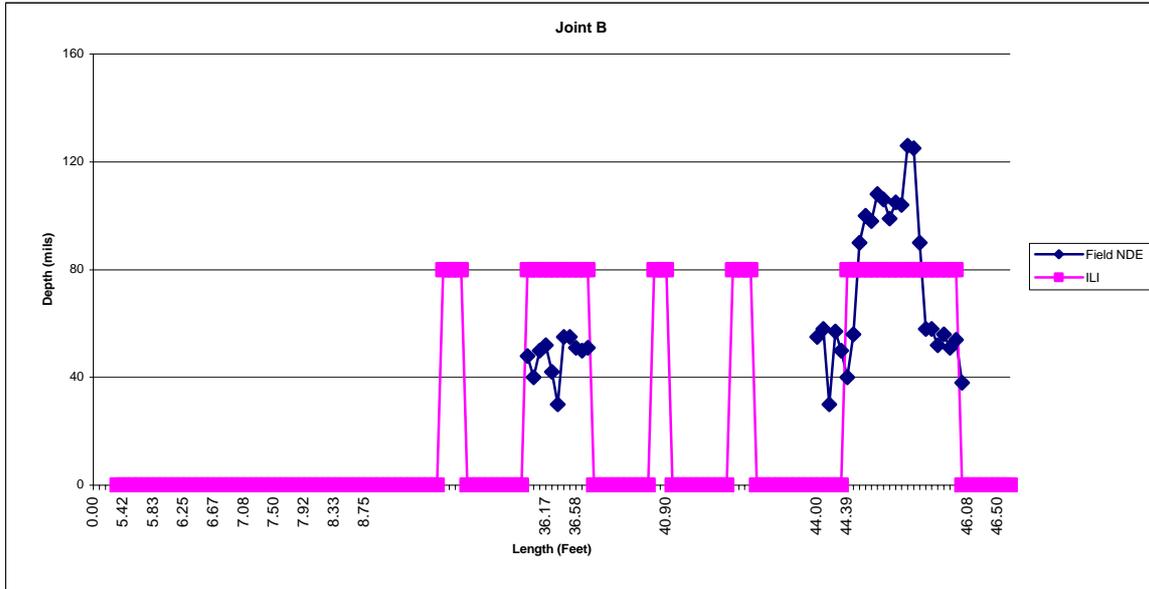
Figure 7 - UTCD Tool Results / Field NDE Results (Joint B)

The UTCD tool identified 5 crack-like features in this joint, Figure 7. The field evaluation confirmed two of the features but could not locate the other three.

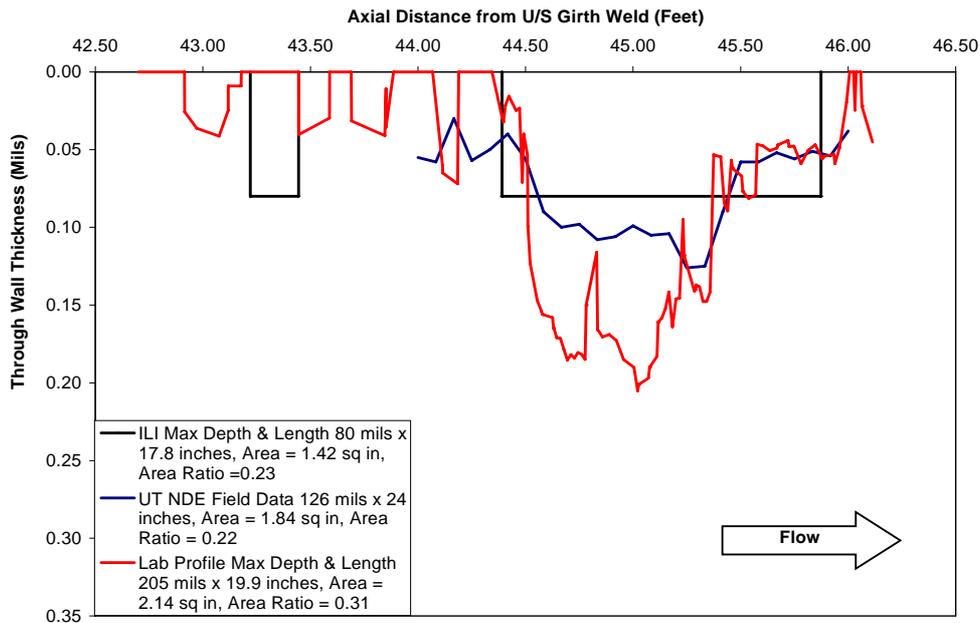
Figure 8 - UTCD, Field Data and Feature Measurements (Joint B)

Figure 8 shows a comparison of the UTCD tool prediction, the field measurements and the measurements obtained from destructive testing of the feature at 43 feet.

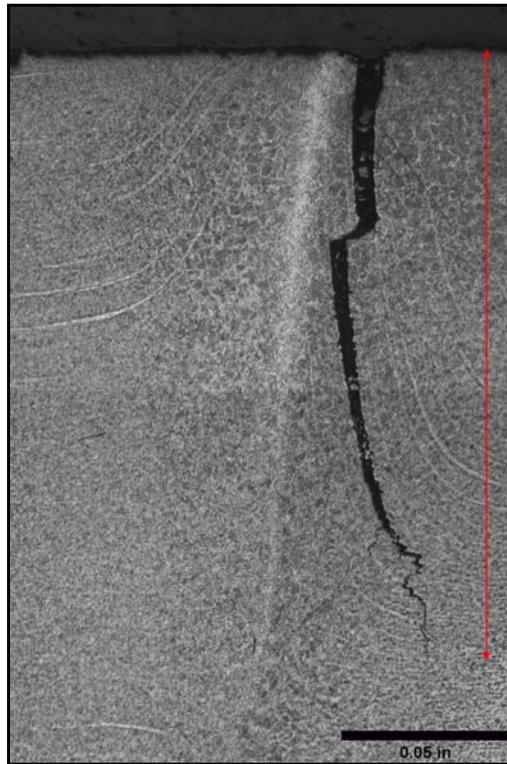
Figure 9 - Hook Crack

This joint was analyzed using conventional destructive testing techniques. At this time it was determined that the ERW weld contained hook cracks. Although hook cracks are mill anomalies, they are potential initiators of fatigue cracks. Figure 9 is a photomicrograph of a hook crack found in this joint. It measures 0.186 inches (4.6 mm) in depth with a part of that measurement being associated with a possible fatigue crack. The UTCD tool estimated the depth of this crack as 0.040 – 0.080 inches (1 – 2 mm). It is likely that the sloping orientation toward the bottom of the crack did not allow for more accurate sizing.

After discovering this crack the operator asked Tuboscope to review the data and determine if any other features exhibited similar characteristics. A review resulted in several locations being identified for field investigations. This is an important outcome of the integrity process. Cooperation between the Service Provider and the Operator is essential. Feedback from the Operator is the tool by which improvements can be made and ILI analysis algorithms advanced.

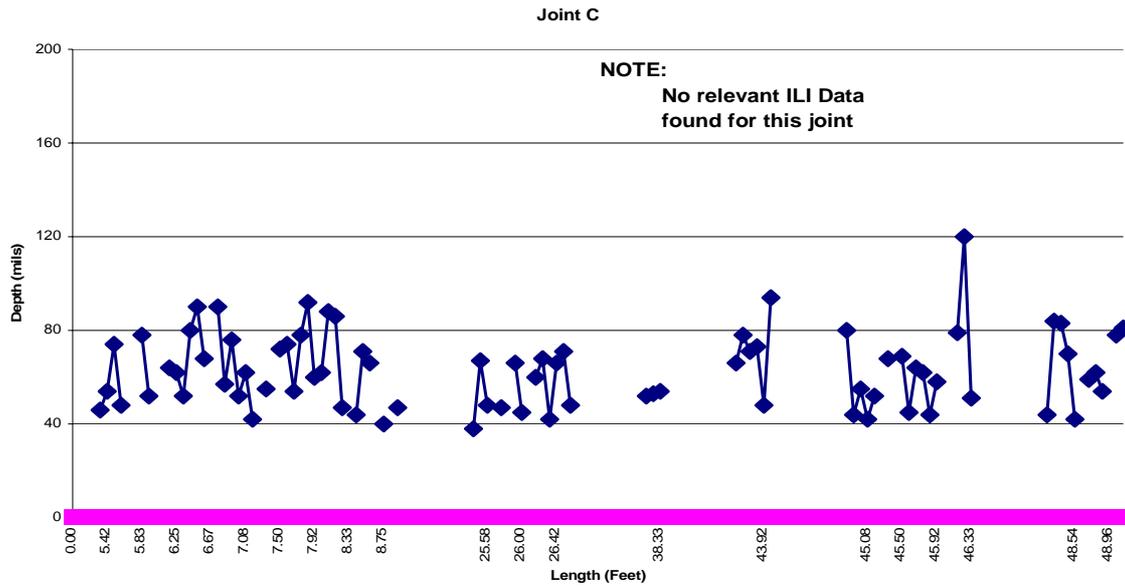
Figure 10 - UTCD Tool Results / Field NDE Results (Joint C)

The UTCD tool did not report any features in this pipe joint yet field evaluation indicated several crack-like features.

The initial assessment by field NDT is that the UTCD tool did not detect these features. In fact, the tool detected 7 such features but estimated the depth below the reporting threshold.

This joint was specifically chosen for destructive examination due to the apparent discrepancy between field measurements and the UTCD tool predictions.

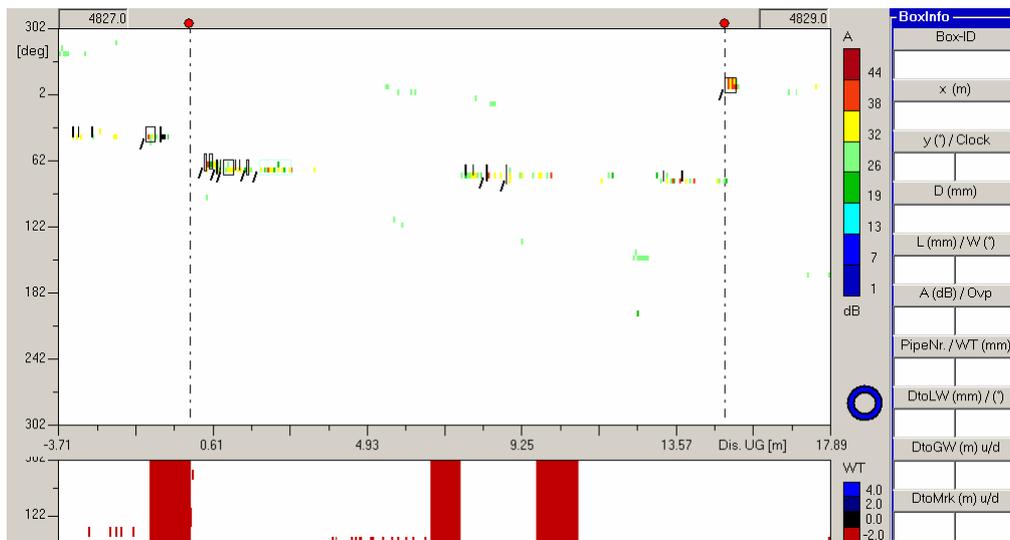
Figure 11 - Screen Shot of Joint C

Figure 11 is a screen shot of the C Scan UTCD data [4] with the actual analysis results tabulated in Table 2.

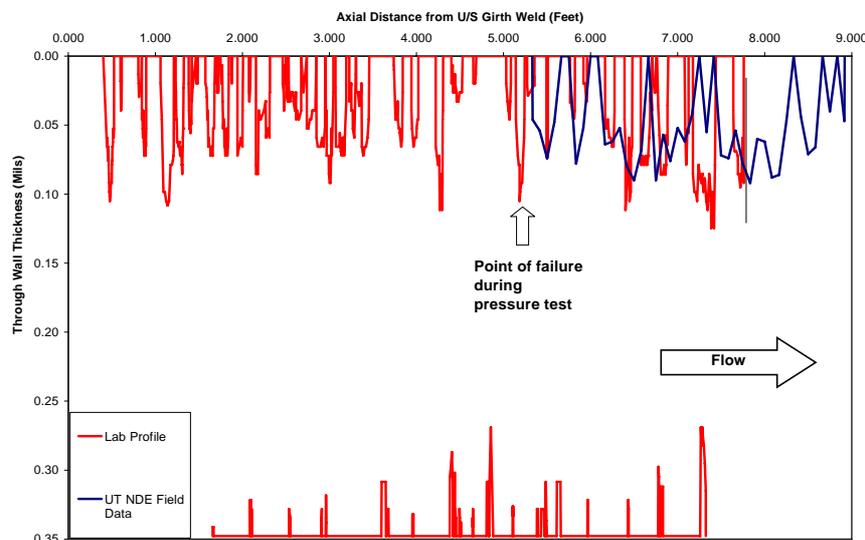
Figure 12 - Field Data and Feature Measurements (Joint C)

This joint failed at 3964 psi (270 bar). This was a much higher failure pressure than expected when using the feature profiles from the field NDE in the failure prediction model. A review shows the failure initiation point is between 4.5 feet (1.35 m) and 5.5 feet (1.68 m) from the upstream girth weld and can be correlated to one of the UTCD feature locations (26931).

Figure 12 shows a comparison of the field measurements and the measurements obtained from destructive testing of the first 9 feet (3 m) of the pipe joint.

It appears that the UTCD depth predictions are under called. In particular, at 5.4 feet there is an approximate 0.100 inch (2.5 mm) external crack. The ILI results identify this crack as < 0.040 inches (1 mm).

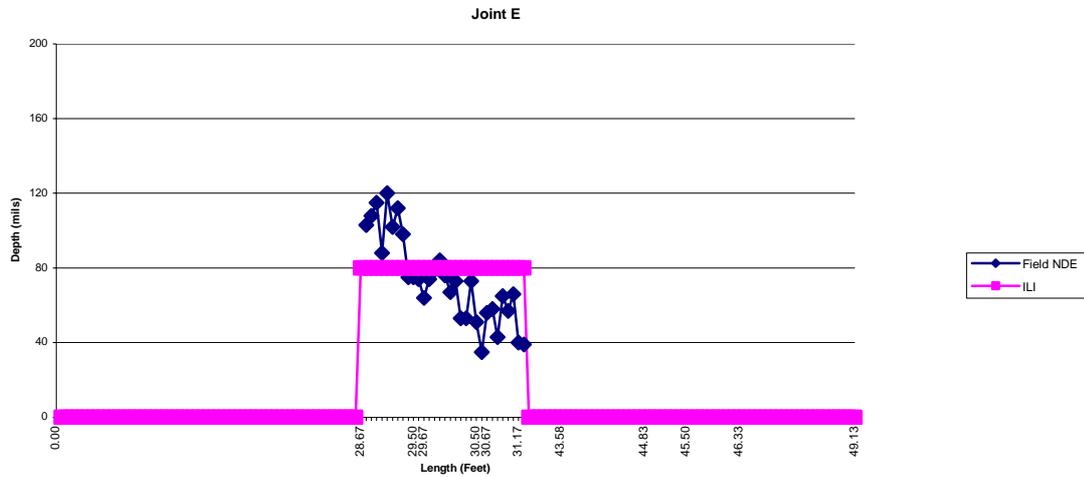
Figure 13 - UTCD Tool Results / Field NDE Results (Joint E)

Figure 13 is a graphical output of field NDE and UTCD results. This joint of pipe was selected for burst testing due to the correlation between the UTCD predictions and the field measurements. The features found in this joint of pipe are also hook cracks.

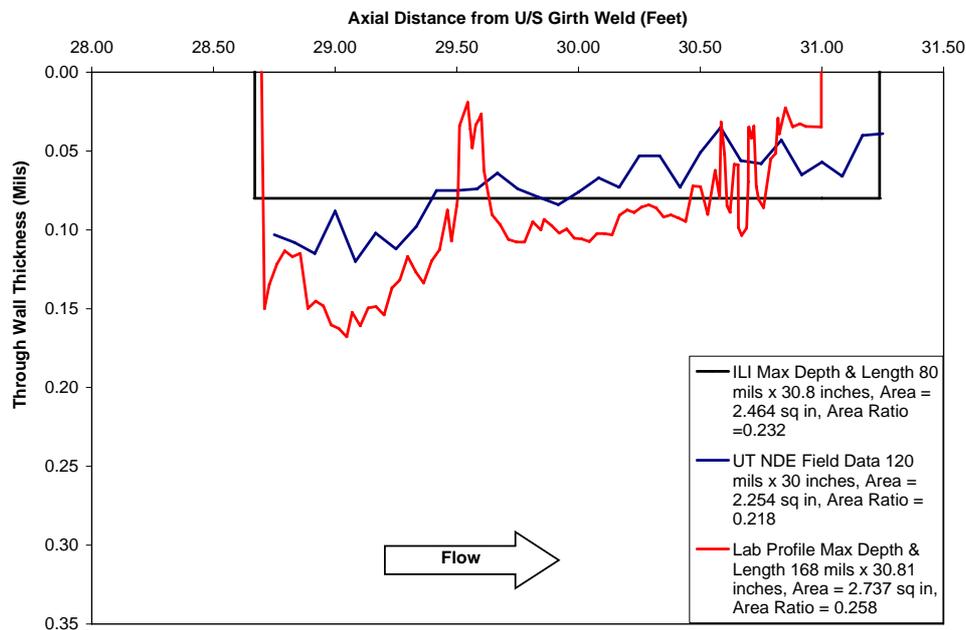
Figure 14 - Field Data and Feature Measurements (Joint D)

Figure 14 shows a comparison of the UTCD tool prediction, the field measurements and the measurements obtained from destructive testing of this feature.

This joint failed at 2900 psi (197 bar). This was a higher failure pressure than expected. The initiation of the rupture correlated with both field NDE and the ILI results.
