# In-Service Flaw Detection and Quantification on the MiG-29 Composite Vertical Tail Skin

Krzysztof DRAGAN, Sławomir KLIMASZEWSKI  
Air Force Institute of Technology, Warsaw, Poland

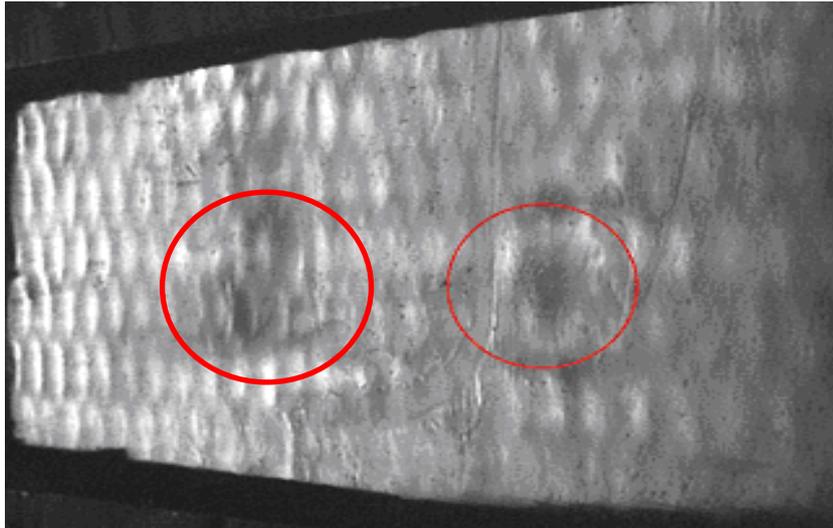
Pic.2 Key feature of DSight™ images – surface with disbands

As we can notice the surface without distortions (Pic.1) gives smooth light distribution. Whereas damages caused by low energy impacts show areas with different gray scale value (Pic.2). The most important feature of data assessing using DAIS® system is the fact that detectable damages have got surface distortions. The main purpose of applying enhanced visual test with the use of DSight™ for composite skin of vertical tail, was to assess number of low energy impact damages. The next step in that approach was to deliver ultrasound test.

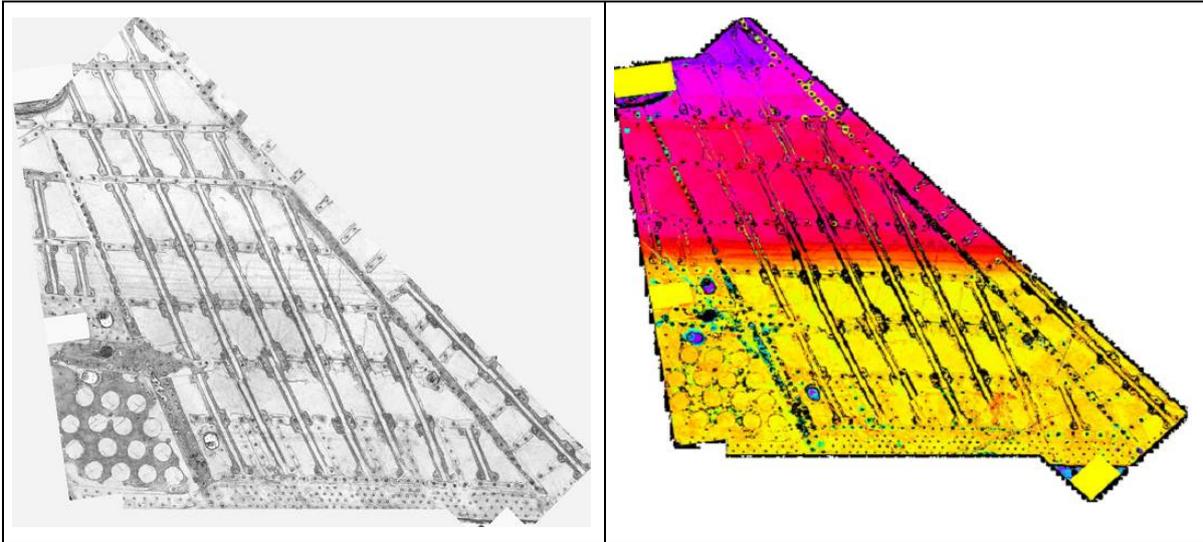
Pic.4 Collected C-Scan data Amplitude (left) and TOF (right) of MiG-29 vertical tail.

All areas of composite skin were inspected. On the amplitude data different colors are connected with different signal attenuation. Color range in the TOF data gives information about different composite skin thickness as well as damage depth. That system of data presentation is very helpful for damage description as well as for finding damage location. Single sensor Pulse-Echo technique was used with the one side access. Below, on the picture (Pic.5), some results of inspection are presented.

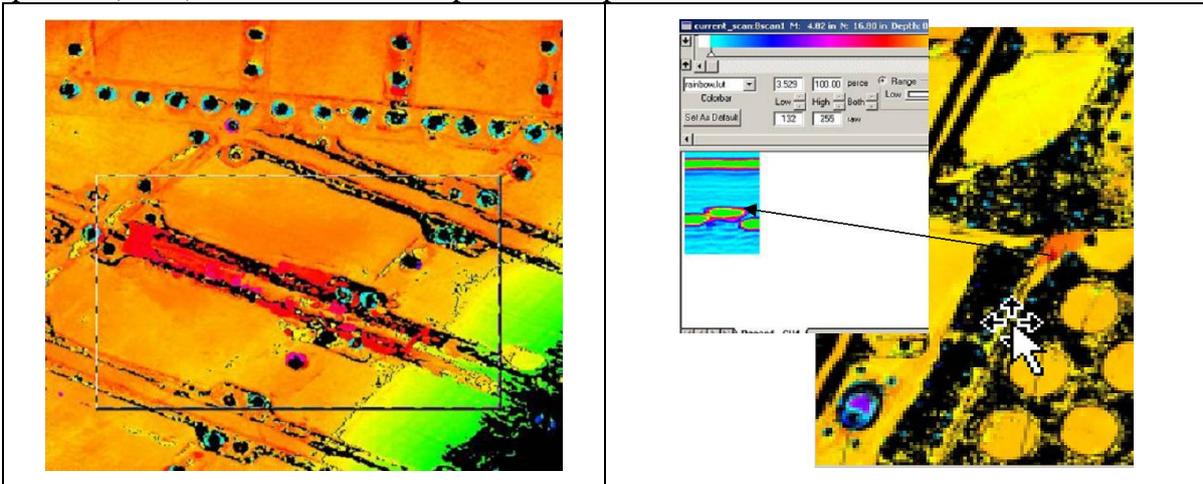
Pic.5 Damages in the composite skin of vertical tail.

As we can notice on the left picture delamination area is presented over the longeron structure. That signal is very distinguished with higher reflection amplitude and depth of damage lower than thickness of composite skin. On the right picture foreign object inclusion with C-scan and B-Scan data is presented. That results are only some selected areas of the vertical tail. During the inspection the most often damages such as disbonds and delamination (especially around fasteners) were found. Also, both foreign object inclusion as well as porosity happened.

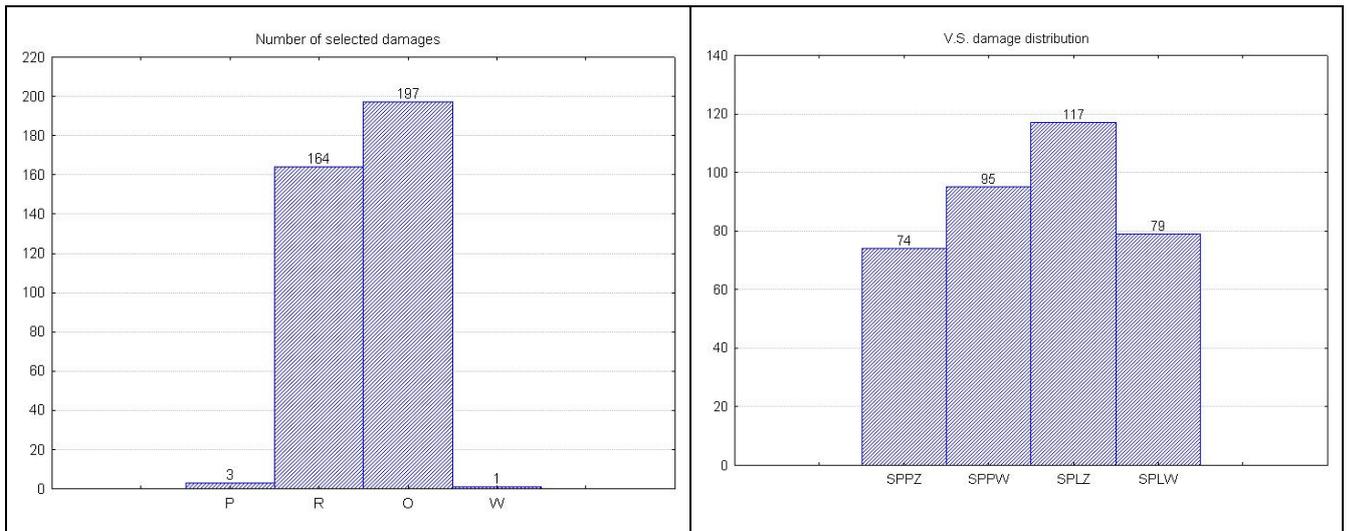
The total number of damages was found and equaled 366. The distribution of the damages placement regarding to the side of the vertical tail (internal and external) as well as left or right tail have approximately normal distribution. The total number of damages is following:

- SPLZ - external side of left tail – 117;
- SPLW - internal side of left tail – 79;
- SPPZ - internal side of right tail – 95;
- SPPZ - external side of right tail – 74.

Pic.6 Number of selected damages and damage distribution placement of vertical tail.

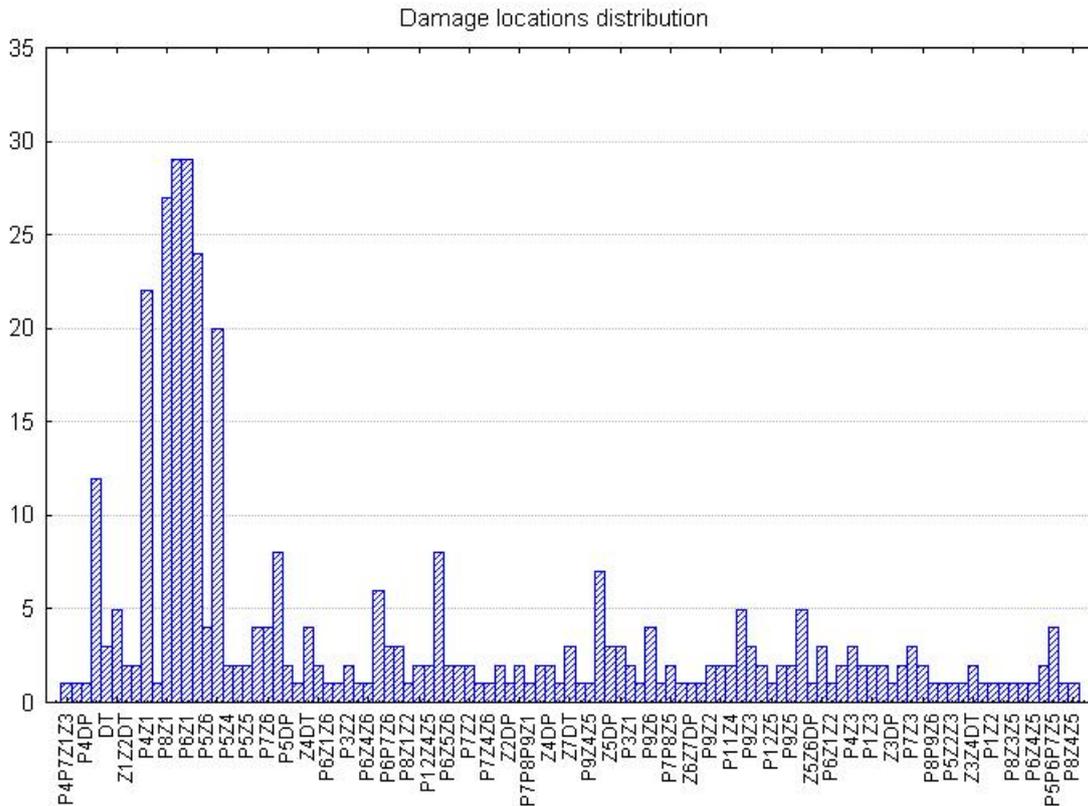
The observed damage distribution in the structure of composite skin of vertical tail does not show repeatable character of locations (except disbonds). The areas of damage occurrence are more random as we can notice on the chart (Pic.7).

Pic.7 Damage distribution in the vertical tail structure.

Only few more locations repeat for disbond. Only for disbonds we can describe placement more necessary for inspection. For other damages distribution of their location is random. Therefore it is crucial to inspect the whole area of vertical tail composite skin.
