The Detection and Assessment of Carburisation Damage in Visbreaker Heater Tubes

John LILLEY, Veritec Sonomatic Ltd, Warrington, U.K.
Hermenegildo RUIZ CAMARENA, CEPSA, Sanroque, Spain.

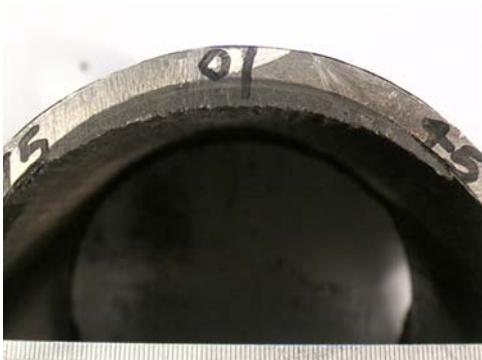
During shutdowns, mechanical cleaning devices are used to remove as much of the coke deposits as possible, but in practice residues are left behind at the internal upper surfaces of the horizontal tubes. See Figure2. The coke deposits provide a rich source of carbon which diffuses into the material over time and leads to chromium carbide formation. Unsurprisingly, this adversely affects the material properties to the point where fracture could occur under certain thermal transients caused by temperature excursions or start-up/shut-down events. Needless to say, tube failure under the operating environment is undesirable.

Figure 2. Coke deposit remaining inside a furnace tube after mechanical cleaning.

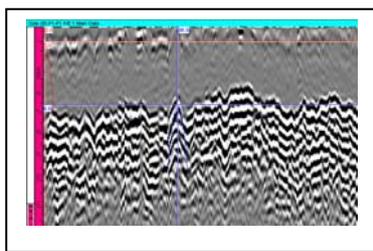
Figure 7. Tube 2

Figures 7 through 12 show examples of damaged tube collected on site. Figure 13 shows a tube which is clear of carburisation, but contains minor inclusions only. This was not realised at the time of inspection and the tube was replaced.

Refer to figures 7 through 9. In all of these images the carburisation interface is obscured by the lateral wave. Figure 7 has a through-wall crack which was detected using a 45°shear wave probe. This technique was initially deemed to be important, but it was soon realised that only excessively carburised material would be cracked, and such material would be rejected as a matter of course. Therefore the detection of individual cracks was deemed unnecessary and this technique was later abandoned.

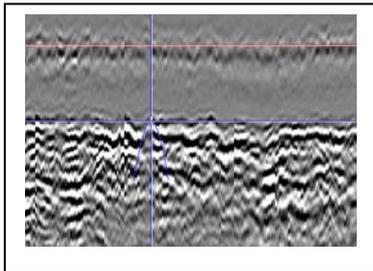
Figure 9. Tube 6

Figures 9 and 10 show a weak oxidation layer close to the internal surface. Figures 10 and 11 show a distinct carburisation interface and figure 12 is clear of any flaws.

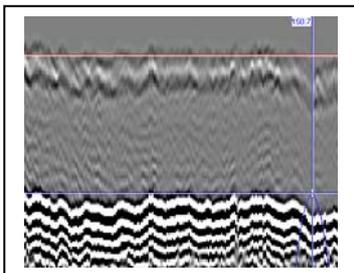
Figure 13. Tube 15. This tube has minor inclusions only. Gain settings and image interpretation are very important to avoid false calls.

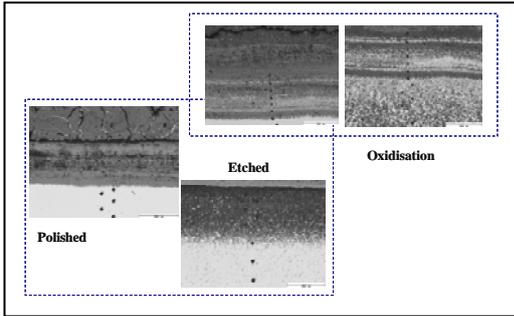
Figure 17. Polished and etched mounted samples

Material close to the internal surface was found to be oxidised and above this a distinct carburised layer was identified (Figure 17). The boundary between carburised and un-carburised material was found to be surprisingly pronounced. Microhardness values also showed a rapid transition between affected and unaffected material (Figure 18). Ultrasonic measurements were able to delineate the carburisation layer from oxidised material and also detect the presence of coke on the internal surface (Figure 19).

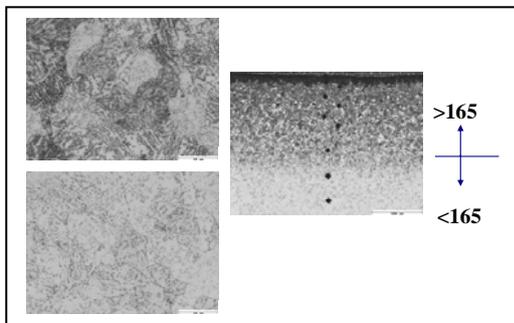
Figure 18. The transition between carburised and un-carburised material. The microhardness indents are 0.1mm apart.

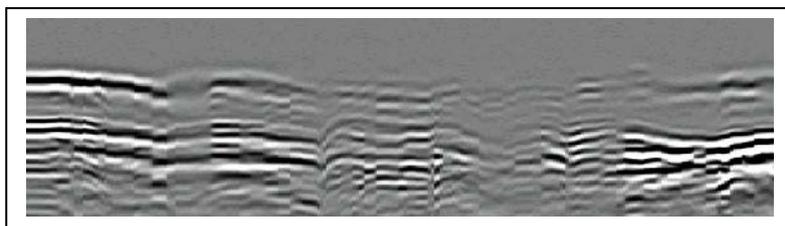
Figure 20. Heavily damaged tube (90° section).

It was found that although the carburisation interface was detectable using TOFD, carburised material was readily penetrated with ultrasound. Through-wall measurements with TOFD are not linear, and although it does not appear to be the case from the images, the lateral wave actually occupies almost 50% of the wall thickness. The lateral wave is exaggerated through the material curvature and surface texture effects. Once the carburisation layer extends into the lateral wave region it becomes undetectable. Therefore, the inspection needs to be conducted with great caution. A heavily damaged section of tube is shown in Figure 20.

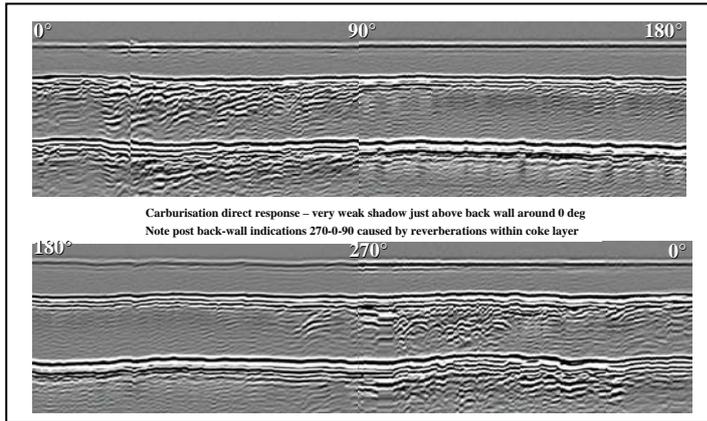
Figure 21. A fully circumferential scan of a slightly damaged tube.

Figure 21 shows a full circumferential scan of a slightly damaged tube. The carburisation damage is evident as a feint white half cycle preceding the back wall echo around the 0° position. This signal has been observed several times and correlates to 0.5mm penetration of carburisation. Note the post back-wall reverberations in this data which are caused by interference from the coke deposit.
