## **LONG RANGE ULTRASONIC INSPECTION (GUIDED WAVE UT) “AN END-USER’S VIEW”**

**Mohammad Ismail Al-Ammandi, BAPCO**

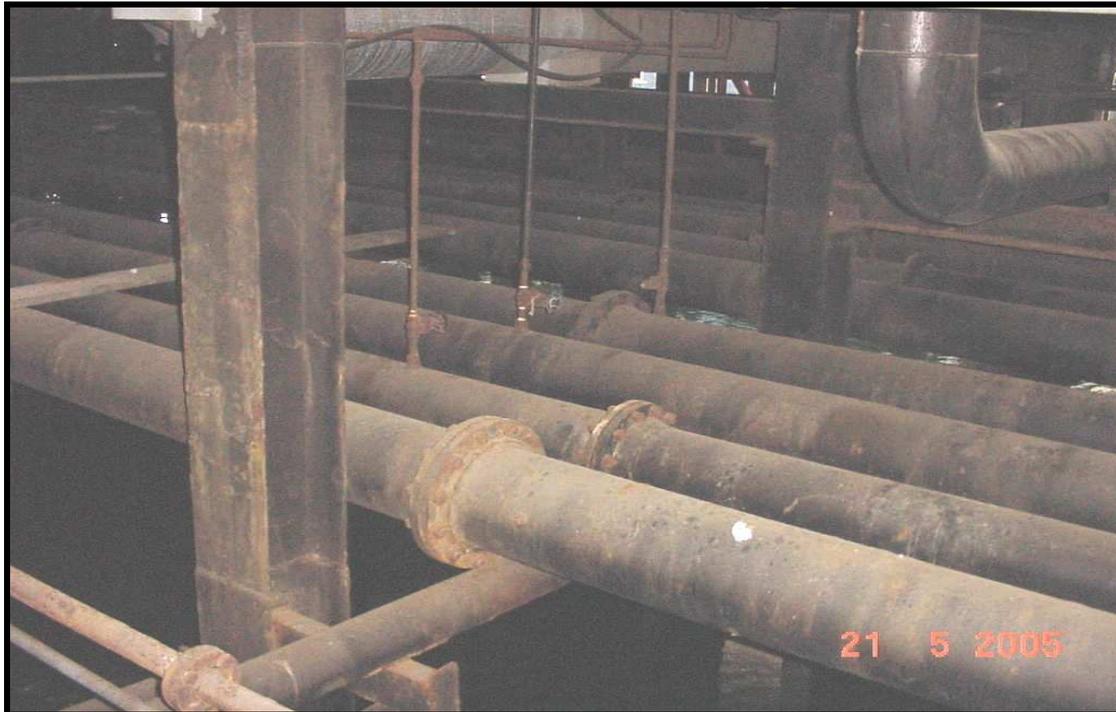
Of particular concern are the contact points where the lines sit on their tubular steel supports, as well as other locations where the close proximity of structural steelwork has reduced the effective application of protective paint systems (*photo 2*). Although the presence of varying degrees of internal corrosion losses is a distinct possibility, and this must be reported on, the main focus of the exercise of applying Long Range UT is to detect external corrosion at supports and obstructions.

**Photo 2:** Sample of tubular steel support and the close proximity of lines under T-Head.

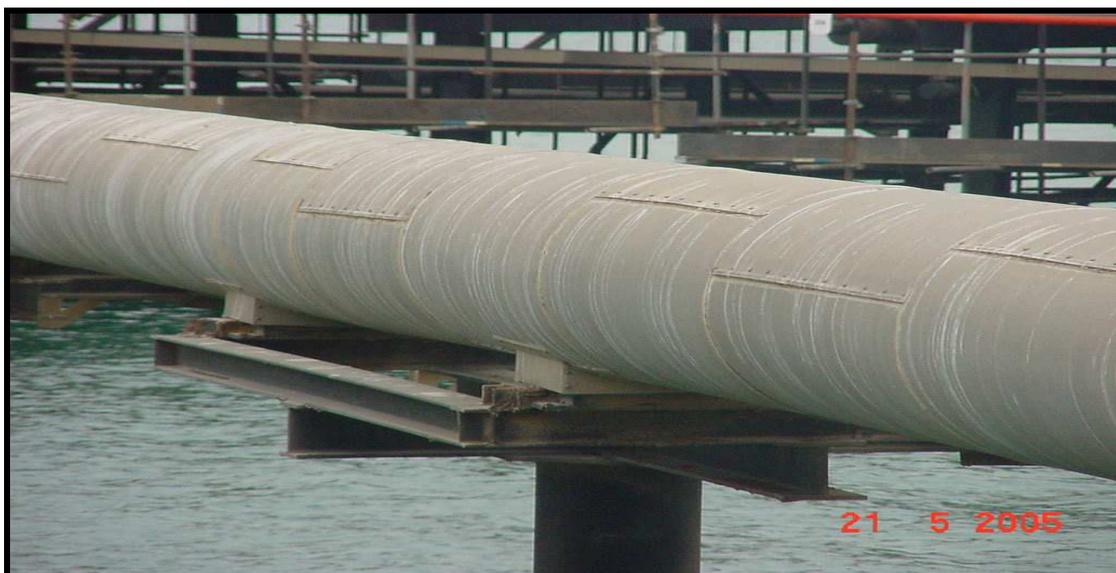
In order to position the probe ring, the insulation and paint coating had to be removed from the line at approximately 250 feet intervals. It was found that during the trial, the Guided Wave signal could only be reliably interpreted for distances of up to 50 feet upstream and downstream of the transducer position. This also depended upon the proximity of the probe ring position to the line supports. The ideal location for the probe ring would be centrally between sets of supports. The conclusion is that access and insulation/ paint removal would have to be provided at 100 feet intervals at best, with shorter distances where the measured position is too close to the supports (*photo 8*).

*Photo 8: Type of supports for the RLPG line.*

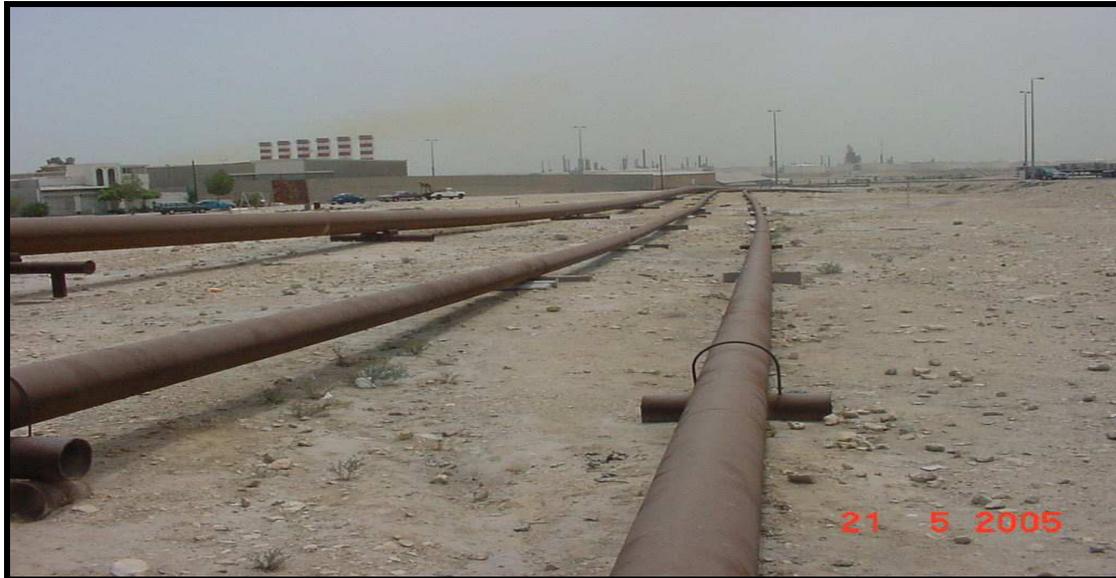
they come ashore at Jasra to the Refinery (approximately 25 km). AB 1 was constructed in 1945 and AB 2 in 1947. Since then, only minor maintenance works were required. However, the land section of AB3 was constructed in the early 70's and recently, some leaks have developed at a low point of the pipeline at the 6 o'clock position. This is considered to be due to water drop-out.

*Photo 9: View of the AB Pipeline.*
