" THERMOGRAPHIC APPLICATION FOR THE CONDITION ASSESMENT OF BUILDINGS - AN EXPERIENCE"

Santanu Saha;

INTERNATIONAL INSPECTION SERVICES; SHARJAH; UAE

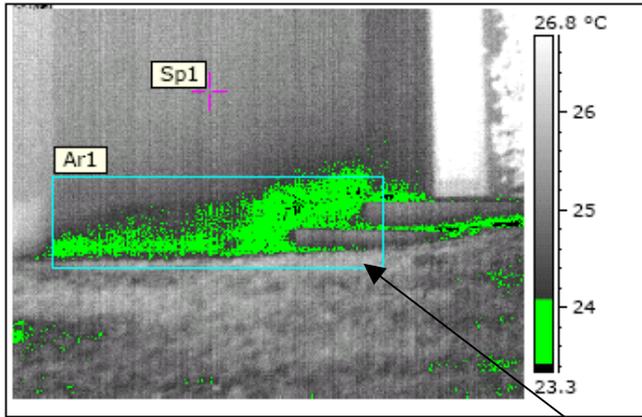
Thermograph - 1

Evidence of water ingress due to capillary rising.

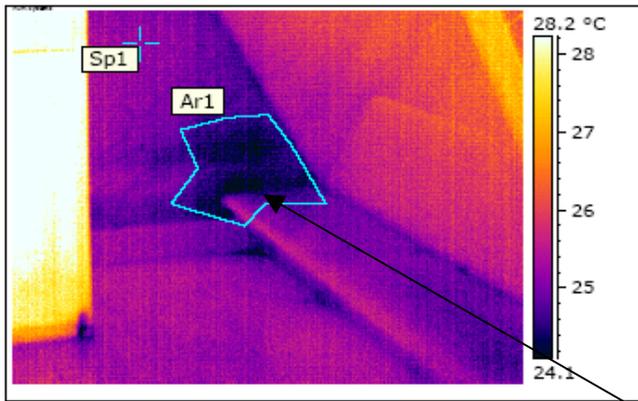
Thermograph - 2

Evidence of water ingress due to capillary rising or possible water leakage.

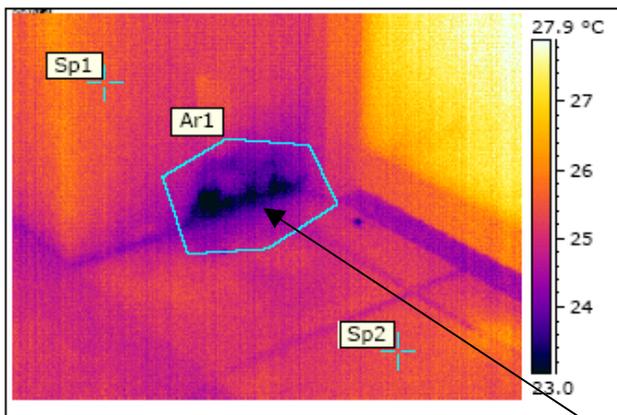
Thermograph - 3

Evidence of water ingress due to capillary rising or possible water leakage.

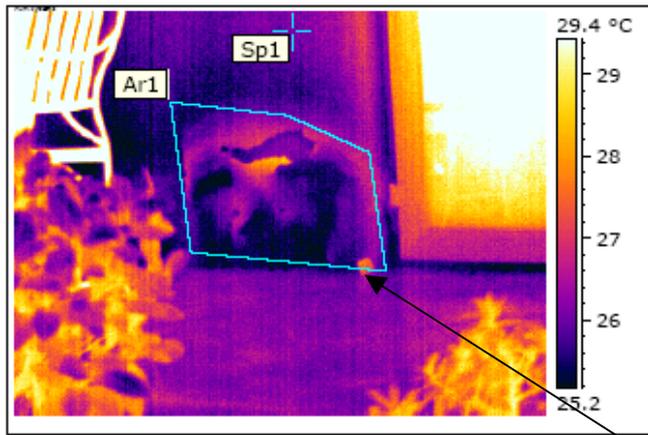
Thermograph – 4

Evidence of water ingress due to capillary rising or possible water leakage.

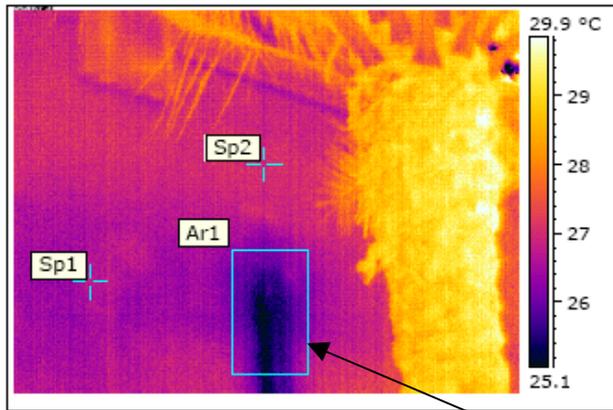
Thermograph - 5

Evidence of water infiltration due to possible leakage of adjacent concealed piping. No visual staining could be noticed.

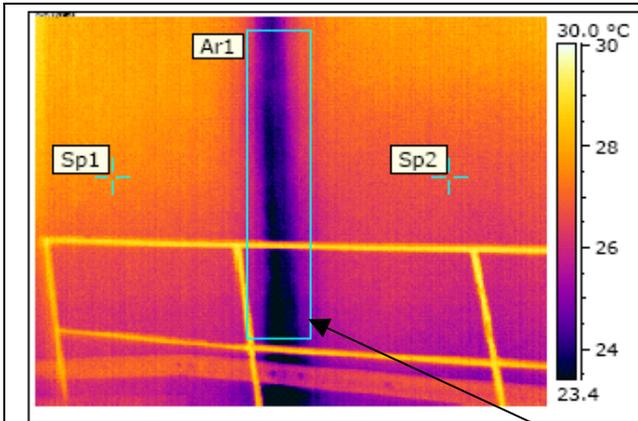
Thermograph - 6

Evidence of water infiltration due to possible leakage of adjacent concealed piping. A faint visual staining could be noticed.

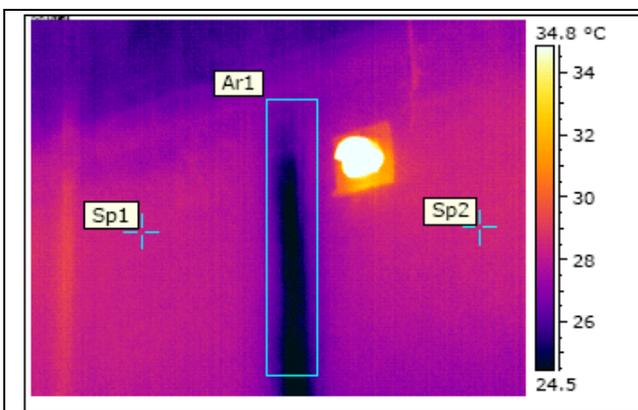
Thermograph - 7

Evidence of water infiltration due to possible leakage of adjacent concealed piping. No visual staining could be noticed.

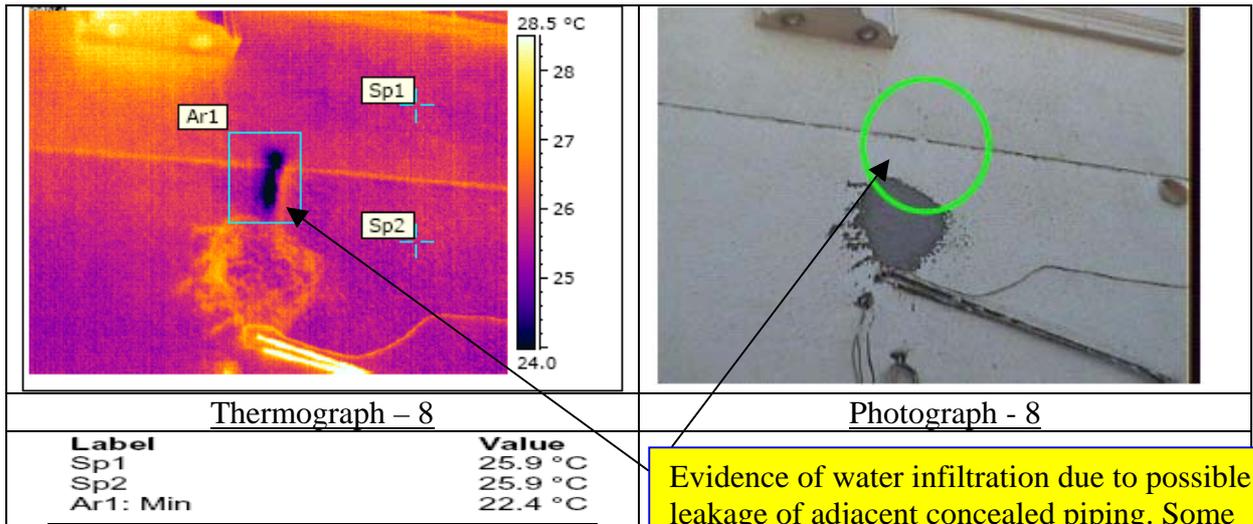
Evidence of water infiltration due to possible leakage of adjacent concealed piping. Some repair work could be noticed, possibly due to water spillage.

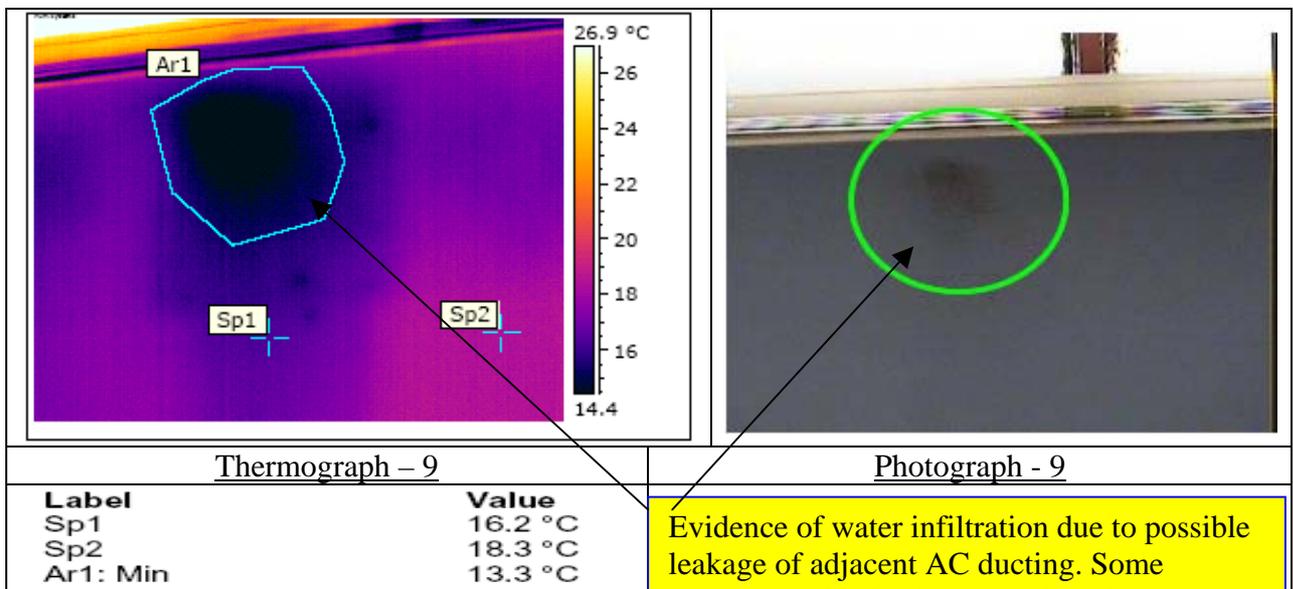
Evidence of water infiltration due to possible leakage of adjacent AC ducting. Some staining could also be noticed on the paints.
