APPLICATION OF NON-DESTRUCTIVE TESTING METHODS TO DIAGNOSTICS AND REPAIR OF ELEMENTS OF THERMO-ENERGY SYSTEMS

On the occasion of a preventive inspection of a steam line some critical flaws were detected. They could easily result in a failure of an element of the device if the system continued to operate.

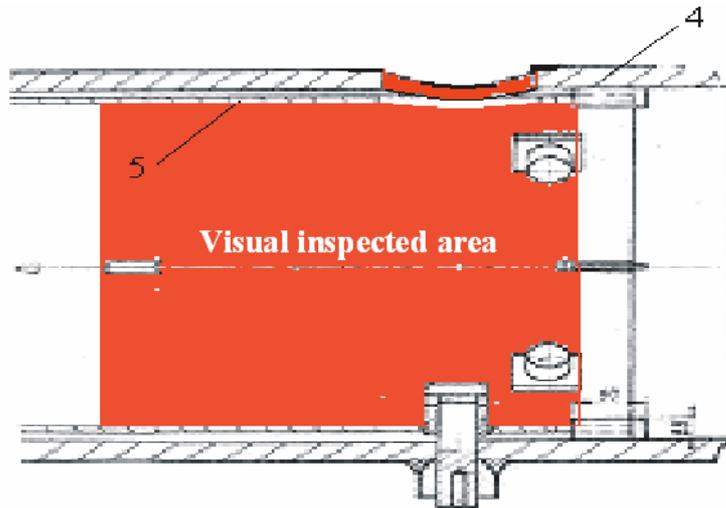
examination, measurement of lengths, areas of certain locations, and depth of damages. A special stereo probe was used for the purpose. The videoscope was used to examine the steam-line area hatched in Fig. 3. The steam line is a critical location. All the damages and cracks found at the steam-line surface and cracks at the sheath pipe (Fig. 4) were detected. In the examination the cracks due to thermal fatigue of the sheath pipe were not detected, although they were initially expected. Several cracks were found at the steam line where the tube attachment was welded to the steam line and some cracks at the drillhole of the sheath pipe.

Fig. 3: Visually examined locations of steam-cooler inside.

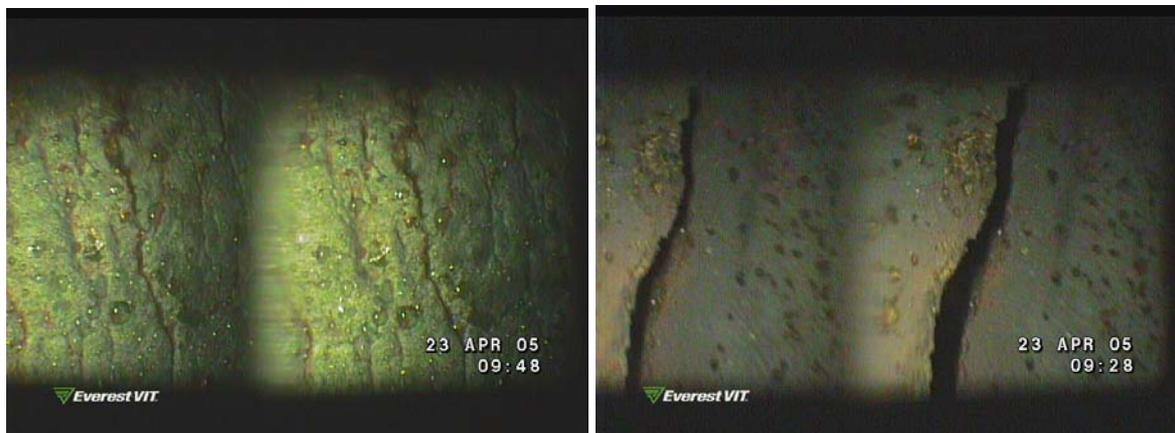
Fig. 4: Appearance of cracks inside of tube attachment; 5 x [3].

The depth of the crack located at the built-in tube attachment (Fig. 2, Pos. 3) could not be measured due to its inaccessibility. The occurrence of cracks at the steam line is not admissible; therefore, a decision was taken, to separate the tube attachment by grinding the fillet weld connecting the tube attachment to the steam line. The liquid penetrant examination was then employed to determine the number and size of cracks.

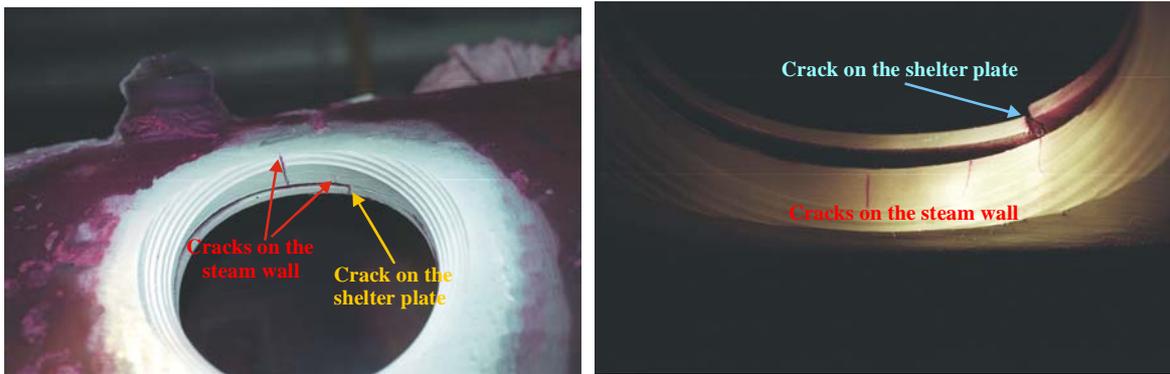
The crack lengths were measured up to 8 mm in the radial direction of the drillhole (Fig. 5). In Fig. 5, left, the entrance of the cooling pipe to the steam line, including the cracks in the steam-line wall and the protective plate, is shown. In Fig. 5, right, the same location is shown from

another viewing angle and magnified so that the crack size and the deformation at the protecting plate could be assessed.

Fig. 5: Cracks made visible in liquid penetrant examination.

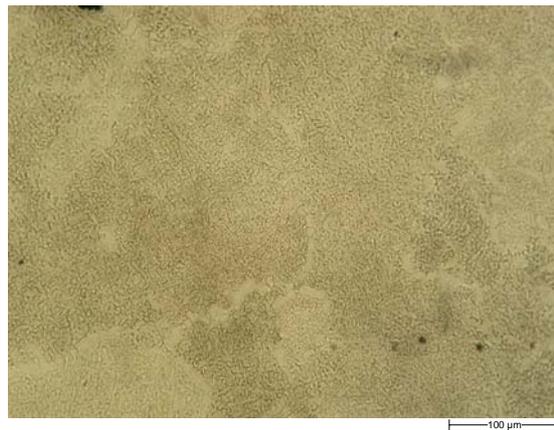
Fig. 6: Microstructure of replica taken from undamaged pipe section; 150 x.

Figures 6 and 7 show the microstructure of the metallographic replica taken at the location 15 mm off the drillhole. The image clearly shows very fine, single gas pores. In accordance with the guidelines of the German association of operators of large power stations (VGB) the microstructure was grouped in class 2a, in the early stage of the creep process. These guidelines are very helpful in the assessment of the material microstructure subjected to thermomechanical loads. They also suggest, with reference to the class, further measures to be taken in terms of scheduled inspections and repair measures.

The final decision regarding the mode of repair was made after taking and assessing metallographic replicas. The replicas showed no changes in the material microstructure close to the drillhole that would require a replacement of the entire pipe segment of the steam line. A local repair was decided upon.

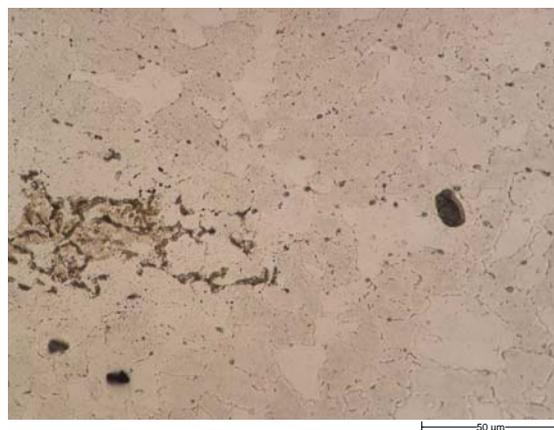
Fig. 7: Microstructure of replica showing a crack and single gas pores; 300 x.

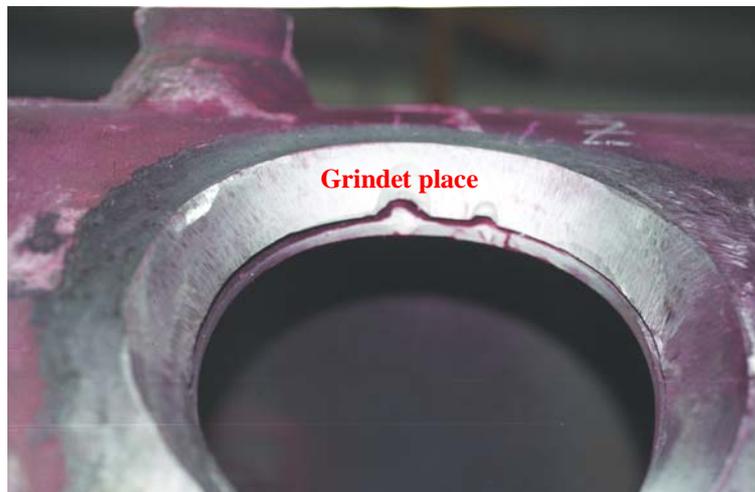
It was decided to increase the drillhole in the steam-line wall by groove preparation. The entire cracked area at the steam-line was eliminated. After preparing the groove by grinding a liquid penetrant examination was repeated. Cracks were detected at two locations shown below. The cracks ran in the tangential direction of the pipe and in the surroundings of the opening. The cracks were hidden and appeared only after grinding the weld groove, i.e. the crack was detected only thanks to the groove preparation. It was decided to eliminate cracks at these locations by local grinding of the steam line (Fig. 8).

Fig. 8: Weld preparation by grinding close to cracks.

The next step was surfacing at two locations to obtain the geometry desired. For the repair of the steam line made of common CrMo steel, i.e. 13CrMo44, a special thermal regime of preheating was chosen. The second important technological phase was monitoring of the temperature cycle during and after welding in order to prevent the occurrence of too high internal stresses that could produce deformation of the attachment area that could reduce operating efficiency of this part of the steam line. In accordance with the welding technology the surroundings of the welded joint shall be thermally isolated and preheated at a temperature from 200 °C to 250°C. This temperature shall be maintained during the welding process itself as well. Immediately upon welding completion the temperature at the bell-shaped measuring point shall be raised to 675 °C and be kept constant for a minimum of 20 minutes, a cooling rate 250 °C/h during heating being

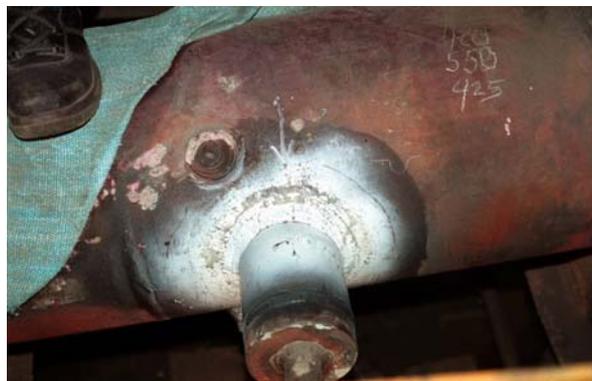
The final testing of the weld made was performed after repair welding and heat treatment. After repair welding visual examination of the weld and its surroundings was performed. It was followed by the magnetic particle examination to confirm the quality of the material condition and of the steam line after welding. The material condition after surfacing and heat treatment can be efficiently assessed by measuring hardness of the weld and its surroundings. The measuring points for hardness were prepared with surface grinding. The measurements were made employing a portable hardness tester EQOTIP. Both examinations showed that repair welding and heat treatment were efficient. The hardness measured being appropriate, repair was completed and the steam line put back to operation. If inadmissible hardness values were found, additional inspection of the microstructure with the replicas from the repaired area would be performed to confirm whether undisturbed operation with respect to the inspection schedule would be possible.

Fig. 9: Appearance of steam line with welded area and completed magnetic particle examination supplemented by hardness measurement.
