Condition Assessment of a 45-year old prestressed concrete bridge using NDT and verification of the results

1 CONDITION ASSESSMENT OF THE BRIDGE DECK

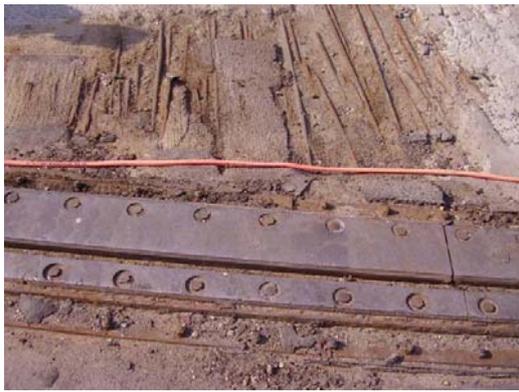
Figure 2: Large areas of visible corrosion damages after cutting the concrete near to the surface: (a) Close to joints and (b) road curbs. Details of (c) corroded reinforcement with pitting-corrosion and (d) prestressed steel with great loss of section.

Fig. 2 reveals the condition of parts of the excavated reinforcement. Damages occurred concentrated close to joints (Fig. 2a) and road curbs (Fig. 2b). The reinforcement showed pitting corrosion due to de-icing salts. This indicates the construction had preexisting damages from the 13-year period without sealing layer in combination with some leakages that occurred in the later period (Fig. 2c). Even the prestressed steel showed severe corrosion with great loss of section (Fig. 2d). It can be assumed that tendon ducts in that shape might have been fractured even before removing the concrete. This assumption is in accordance with the results of the investigation with Magnetic Flux Leakage (MFL) presented in chapter 2.

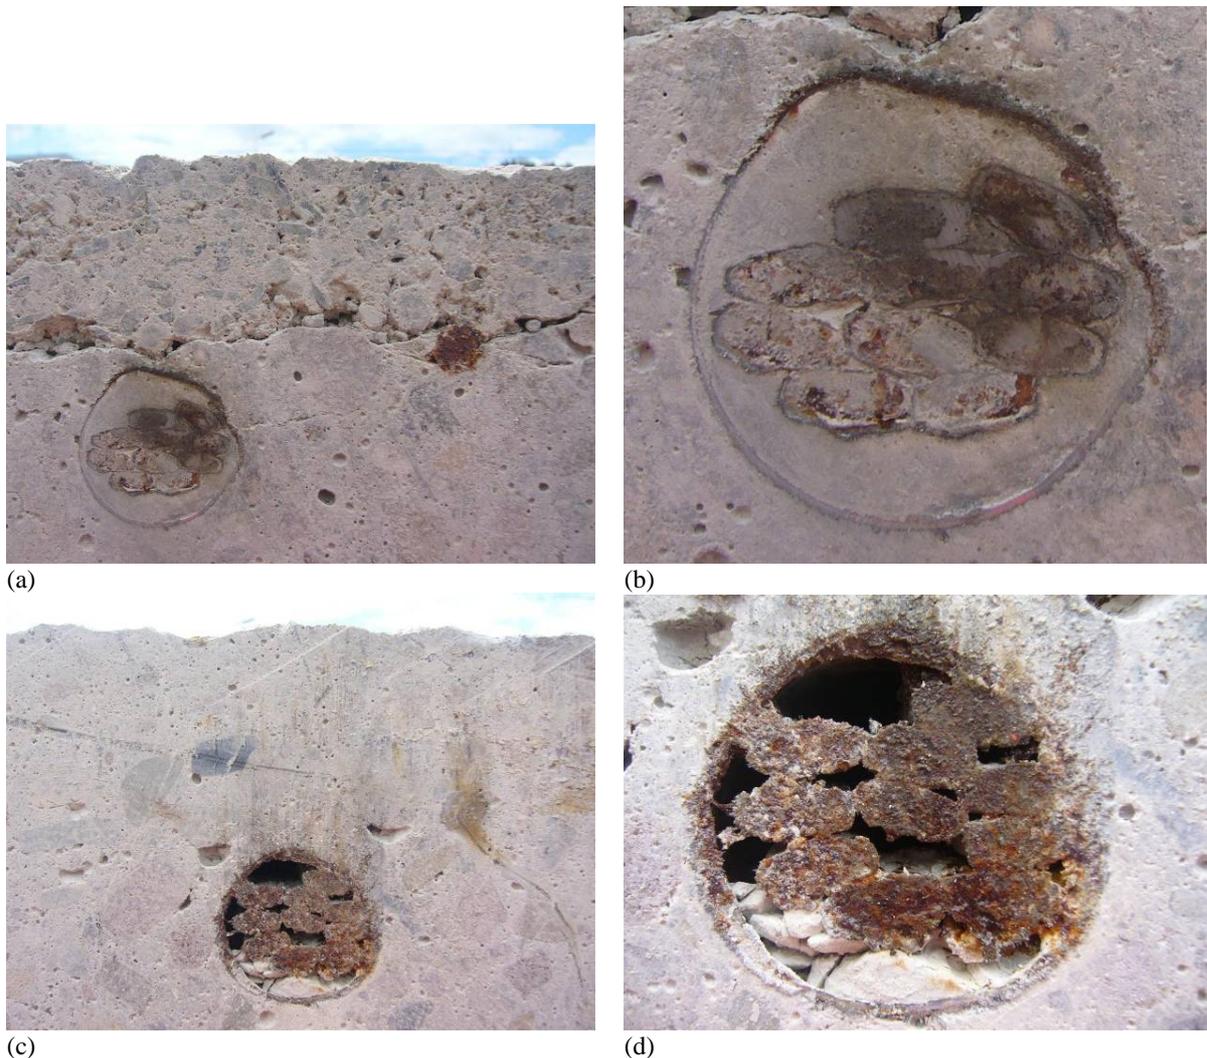
Figure 3: (a) Poor concrete quality and corroded rebar near to the surface. (b) Detail of (a) with corrosion of the tendon duct but no corrosion of the prestressed steel. (c) Good concrete quality with partly ungrouted tendon duct and (d) severe corrosion of the prestressed steel.

Large areas showed a poor concrete quality of the concrete near to the surface. Reasons for that might be the combination of insufficient curing of the concrete surface after casting together with dynamic (traffic), chemical (de-icing salts) and climate (frost-thawing) stress. Fig. 3 shows two typical patterns. Fig. 3a and b show that poor concrete quality of the concrete cover even with corrosion of the reinforcement and the tendon ducts does not necessarily mean corrosion of the prestressed steel. But injection faults as shown in Fig. 3c and d have lead to severe corrosion of the prestressed steel even with a concrete cover of good quality. That means in consequence that injection faults affected in this case already the stability of the bridge deck. Normally injections faults are only estimated to be spots of high risk of further damages.

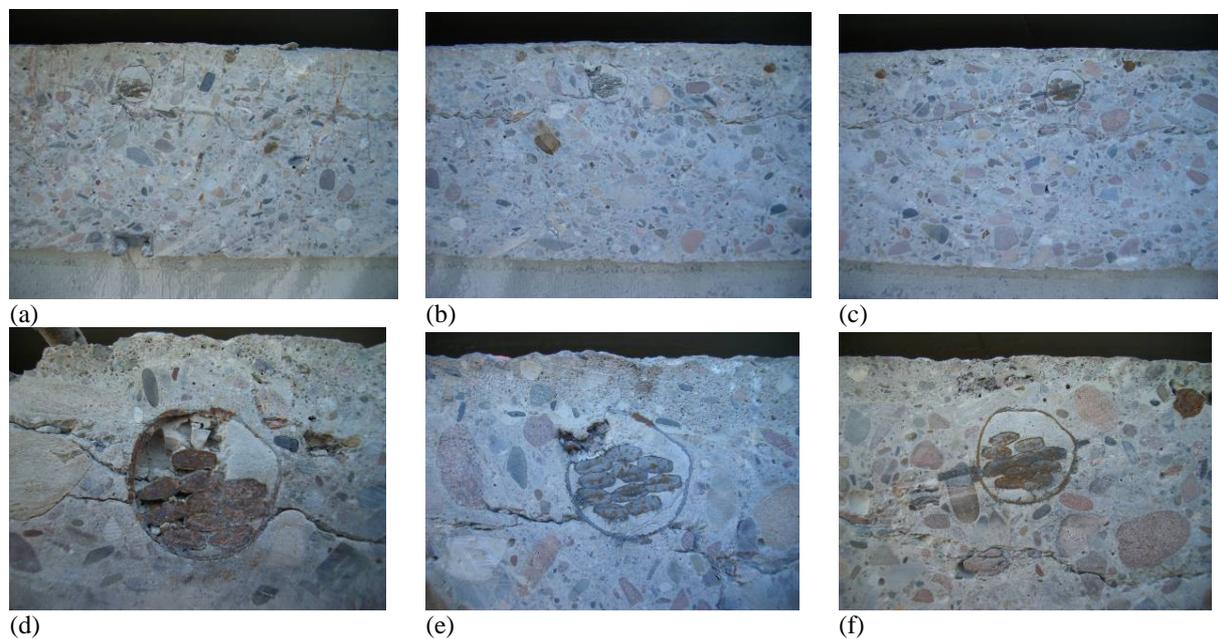
Figure 4: (a)-(c) Delamination in the concrete near to the surface with details in (d)-(f). The depth of the delamination is varying: (d) in depth of tendon duct, (e) at the lower edge of the tendon duct or (f) beneath the tendon duct.

Fig. 4a-c shows a delamination along one part of the bridge within a distance of 10m. The details of the photos shown in Fig. 4d-f reveal that the depth of the delamination layer is varying. The delamination either crosses the tendon duct (Fig. 4d, as expected), runs at the bottom of the tendon duct (Fig. 4e) and even beneath (Fig. 4f). Unlikely to the case of poor concrete quality shown in Fig. 3a typical delaminations occur normally not in combination with corrosion. This leads to the conclusion that the location of areas with active corrosion (e.g. with potential mapping) does not necessarily identify areas of delamination.

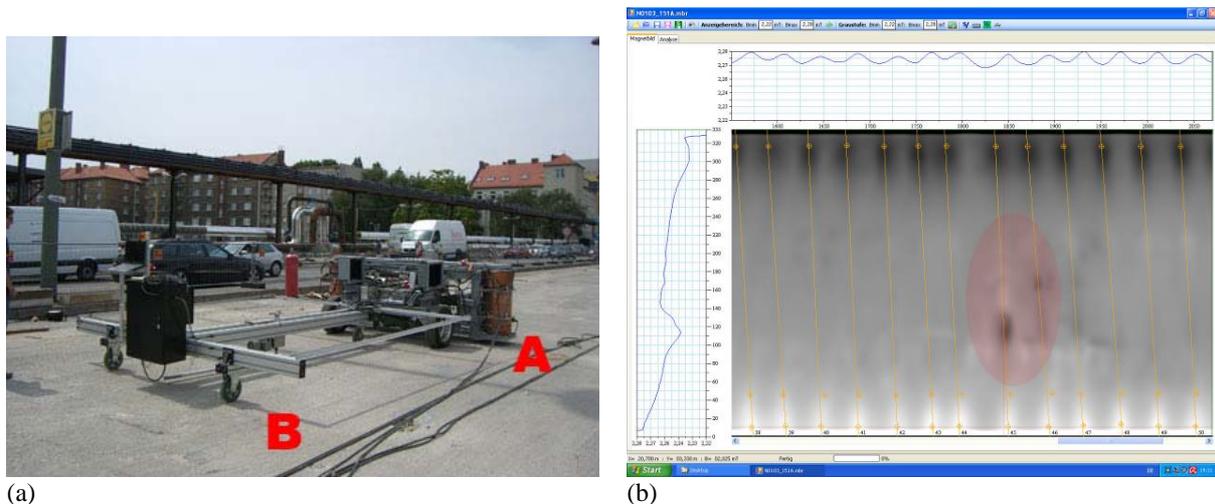
Figure 5: (a) Combined magnetization (A) and rotating sensor unit (B) in a tractor appliance developed from TU Berlin ready for testing up to 4000m² in one night shift. (b) Results of investigated tendon ducts with two typical fracture signals marked (white to grey).

For the investigation of the Spandauer-Damm-Brücke described in chapter 1 a total bridge deck area of more than 600m² with later verification of the results was investigated with the tractor appliance shown in Fig. 5a. At the northern part of the bridge (2008) eleven signals with suspect of a fracture have been detected. Five of them could be verified as true fractures. At the southern part of the bridge (2009) six signals with suspect of a fracture have been detected. Two of them proved to be true fractures. The so called “Positive predictive value” of this method (relation TP/(TP+FP) with True Positive and False Positive, [5] in German: “Relevanz”) can be quantified with approx. 30 to 50%. It is the probability that an estimated fracture is a true fracture. Considering the fact that these seven fractures have been identified out of a total area of more than 600m² allows very precise, fast and reliable detection.

Special attention was given to the False Alarms (estimated fracture but no true fracture; FP: False Positive). As one reason two rebars along the tendon duct that were not built in accordance with standards lead to this false suspect. A detailed radar investigation in such an area would help to reduce the rate of false alarm. In addition to that the question about the risk to miss fractures (FN: False Negative) has to be answered. Therefore systematical tests representing the investigated structures (e.g. reinforcement ratio, depth of tendon ducts, amounts fractured strings to sound strings) have to be carried out. In case of this bridge with tendon ducts in a depth of approx. 10cm plus asphalt layer fractures with more than 50% of the total steel amount will be detected. In case of the removed asphalt layer fractures with more than 30% will be detected. To come to reliable conclusions concerning the stability questions about True Positive (hit), False Positive (false alarm) and False Negative (miss) have to be answered.

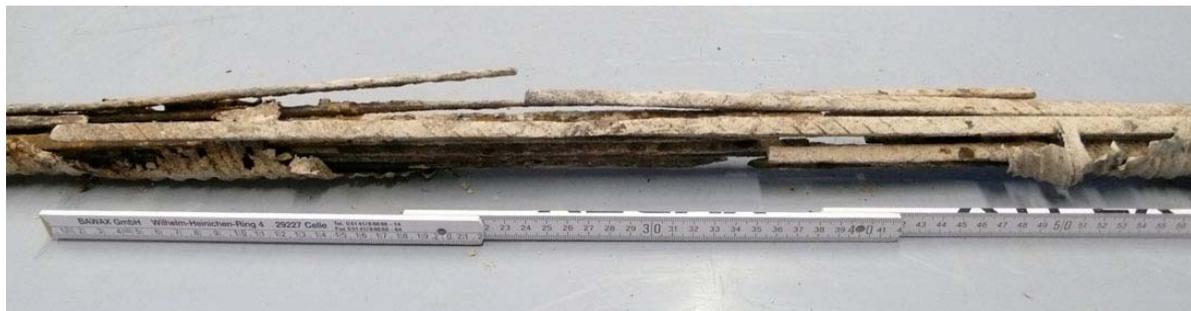
Figure 6: Excavated tendon duct of an area with typical fracture signal; all strings have been fractured.

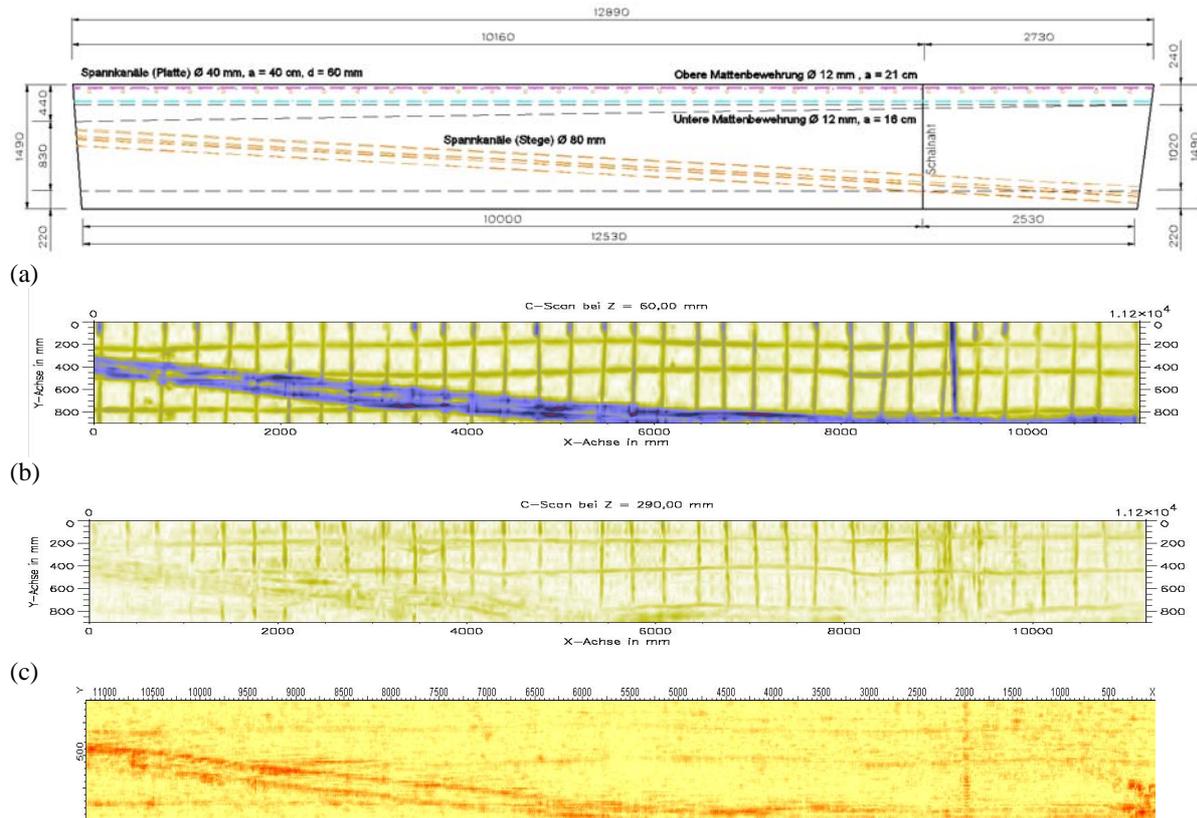
Fig. 8a is a drawing of one of the box-girders from Spandauer-Damm-Brücke stored at the TTS of BAM. It shows the estimated location of the tendon ducts drawn from the knowledge of the location of the ducts at the edges. The results of radar and ultrasonic reveal, that the true location is different. It can be easily read out with an accuracy of

1 to 2cm. Radar provides very detailed information about the reinforcement near the surface (Fig. 8b) and even at the back wall of depth of 29cm (Fig. 8c). Ultrasonic produces a very clear image of the two tendon ducts that run in very close distance. Processing cross-sections out of these 3-D data cubes containing the results will allow in the future reconstructing lost as-built drawings. It will also be possible to verify the “true” construction in critical parts after static calculation. For the future it is planned to add to each reflector its depth and location together with the expected uncertainty of measurement. Also the detection of injection faults is possible, but a reliable detection requires further research in combination with modeling [8].

Figure 8: (a) Drawing of one box-girder from Spandauer-Damm-Brücke with estimated location of the tendon ducts. The imaging of results from radar and ultrasonic testing reveals the true location of reinforcement and tendon ducts. (b) Radar: Section of depth of 50 mm with reinforcement and tendon ducts. (c) Radar: Section of depth of 290 mm with reinforcement of the backwall of the box-girder web. (d) Ultrasonic: Projection of depth between 25 and 55 mm with reinforcement and tendon ducts
