## NDE for Type 304L Stainless Steel Material Characterization

Kenji Krzywosz  
EPRI NDE Center  
1300 West WT Harris Blvd.  
Charlotte, NC 28262  
USA

### Abstract

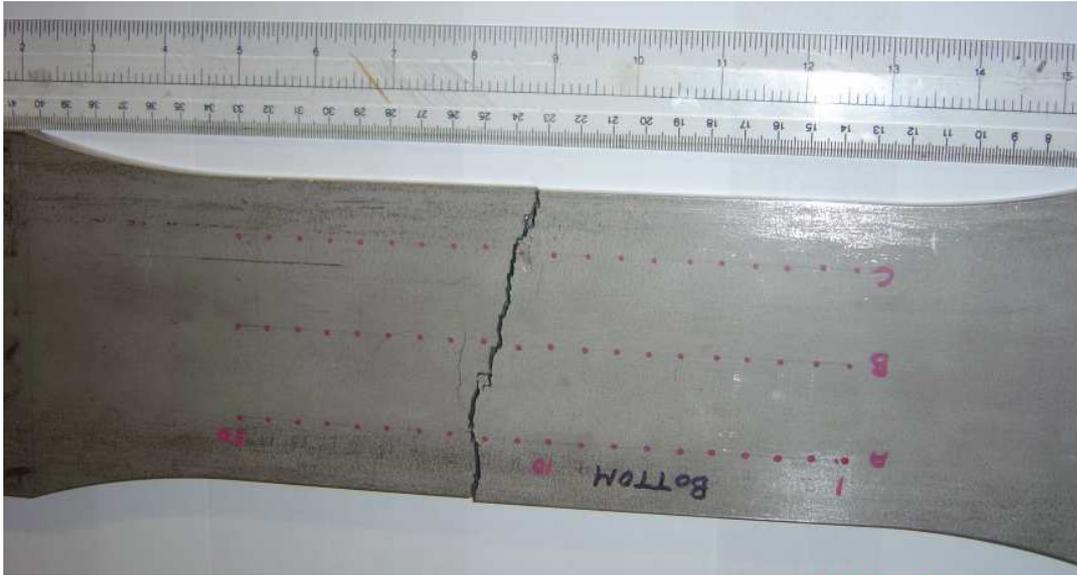
**Figure 1**

At 10K fatigue cycles, the normalized impedance values decreased on both the top surface (2.3-3.0) and bottom surface (2.7-3.2). This decrease in the normalized impedance values was attributed to emergence of incipient cracks. At 16,870 cycles, the plate sample #626 broke in half as shown in Figure 1.

**Cracked Type 304 L specimen at 16,870 fatigue cycles**

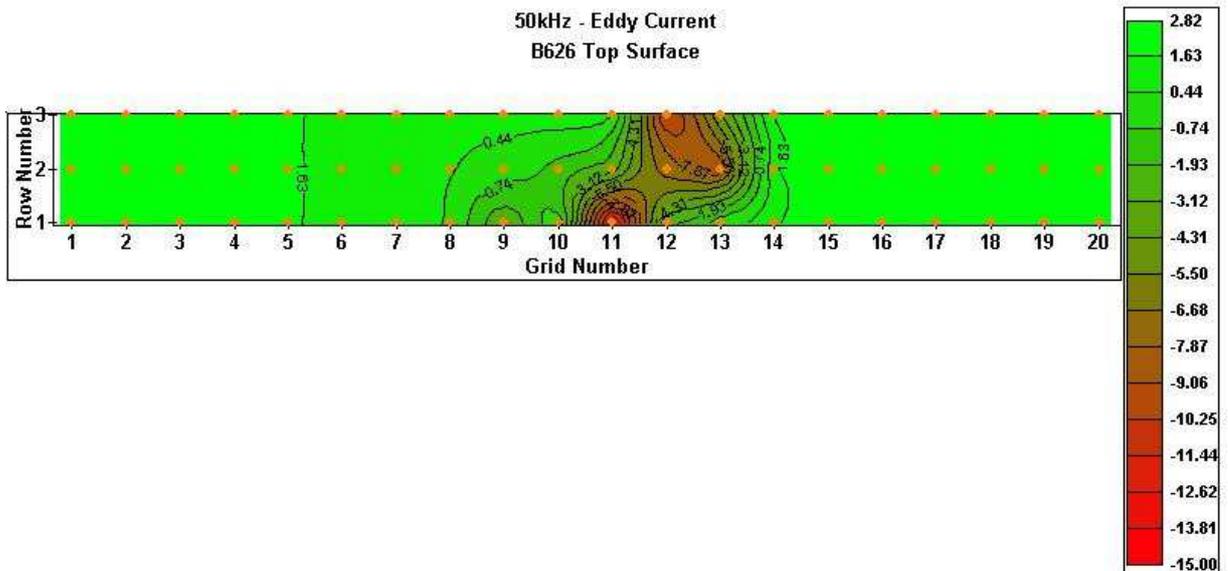
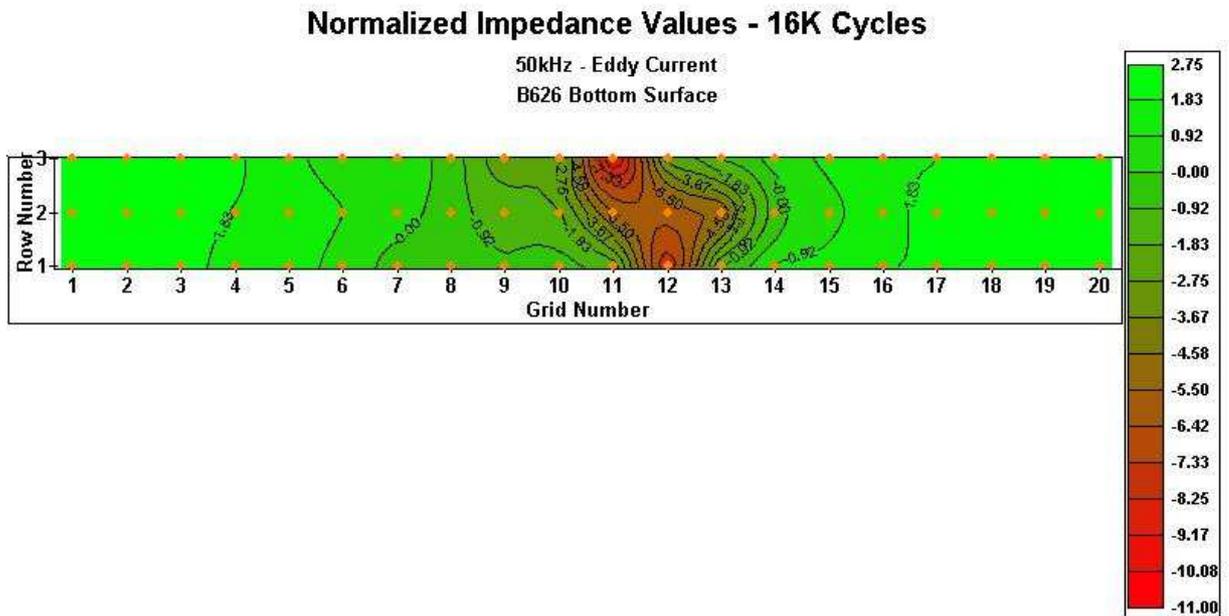
**Figure 2**

The normalized impedance plots of the cracked specimens are shown as Figure 2. As expected, the overall reduction in the normalized impedance values was noted due mainly to the presence of multiple fatigue cracks. Negative impedance values were the results of the eddy current sensor placed in the immediate proximity to the opened crack. The overall reductions in the normalized coil impedance values were more in line or along the developed crack line shown in Figure 1.

**Normalized impedance values at 16,870 fatigue cycles**

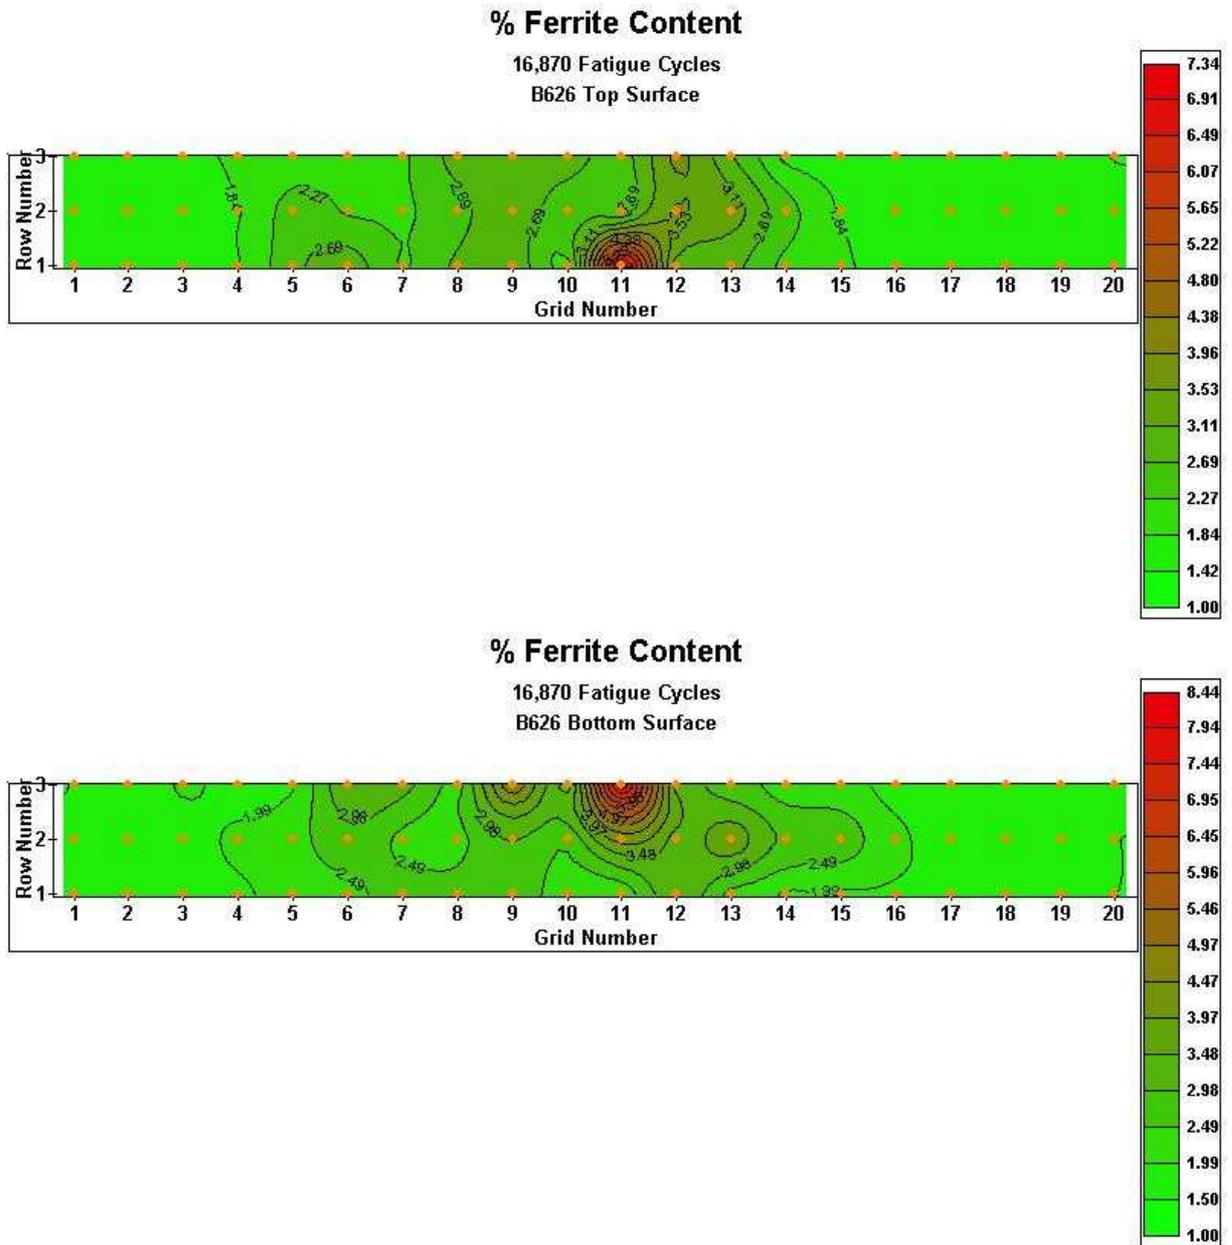
**Figure 3**

Similarly, the percent ferrite content ranged from 1.3-1.6 on top surface and from 1.2-1.7 on bottom surface at the beginning. By the time the specimen broke at 16,870 fatigue cycles, more pronounced ferrite content increase was noted, especially on one side of the cracked interface as shown in Figure 3. It should be noted that Row 1 Grid 11 of the top surface is same as Row 3 Grid 11 of the bottom surface.

**Percent ferrite content by DC field measurements after 16,870 fatigue cycles**

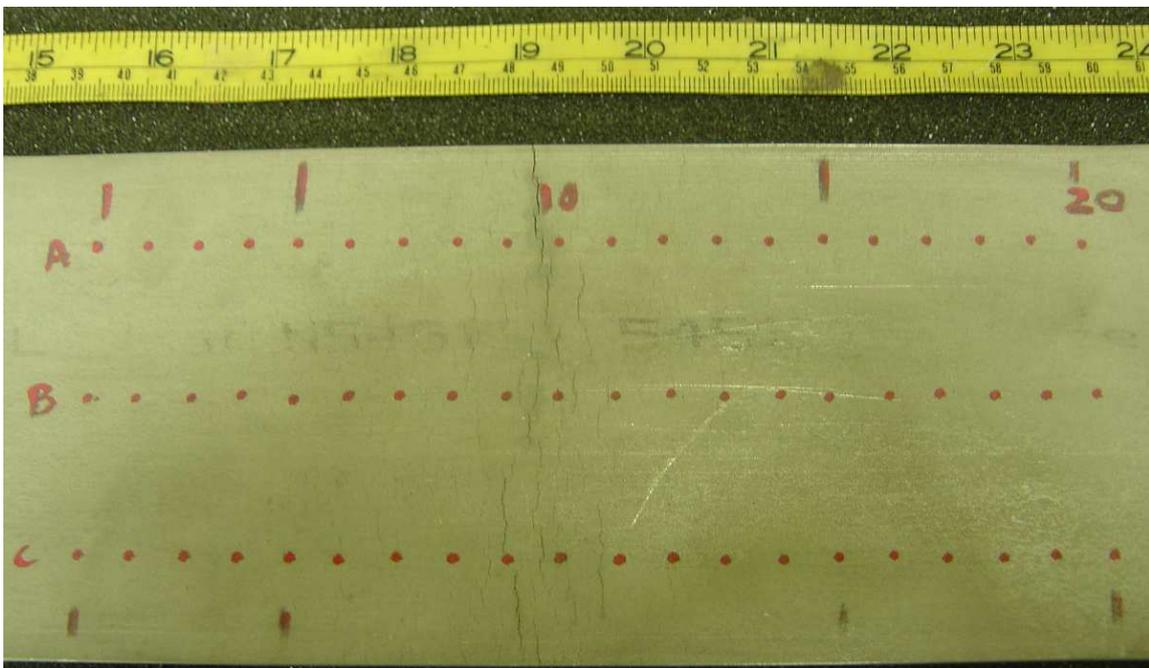
**Figure 4**

Figure 4 shows the area of interest containing multiple surface cracks from the top side of the sample. The fatigue process was stopped before the specimen cracked completely in half as was the case for specimen #626. The sample was cracked partially through wall at top mid-point of the inspected area. The sample cracked partially closer to Row 1 Grid 7 of the top surface – this crack location on the bottom side was associated to Row 3 and fell between Grids 6 and 7. The above locations applied to detail scan regions of the normalized impedance plots. For the percent ferrite content plots, the crack location was identified as Row 1 Grid 10 of the top surface. The similar crack location on the bottom side was at Row 3 and fell between Grids 9 and 10.

#### **Partially cracked specimen #627 as viewed from the top side**

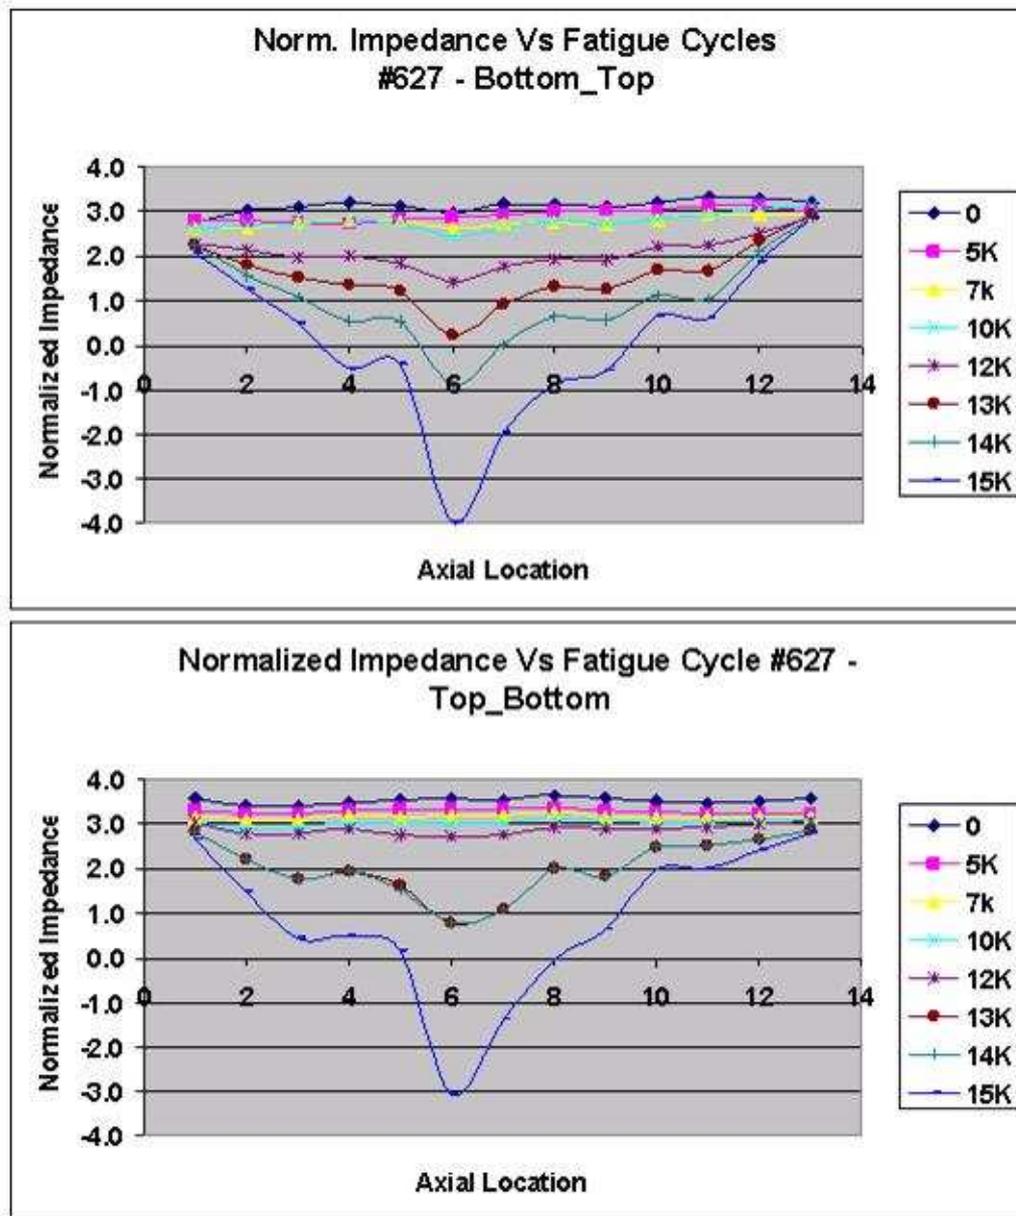
Figure 5 shows normalized impedance plots of the bottom line from top and bottom sides of specimen #627. They all indicate gradual progression of normalized impedance reduction with increasing fatigue cycles, especially after 10,000 cycles.

The major crack location is indicated by the lowest normalized impedance value. For this specimen, the crack was located at the axial location of 6 as shown in the figure. This point is equivalent to axial location 9 of Figure 4 starting from the left-hand side of the plate. The corresponding top and bottom surface profiles were very close even though they were separated by 10mm thick plate width.

**Corresponding top line scans of normalized impedance plots with fatigue cycles**

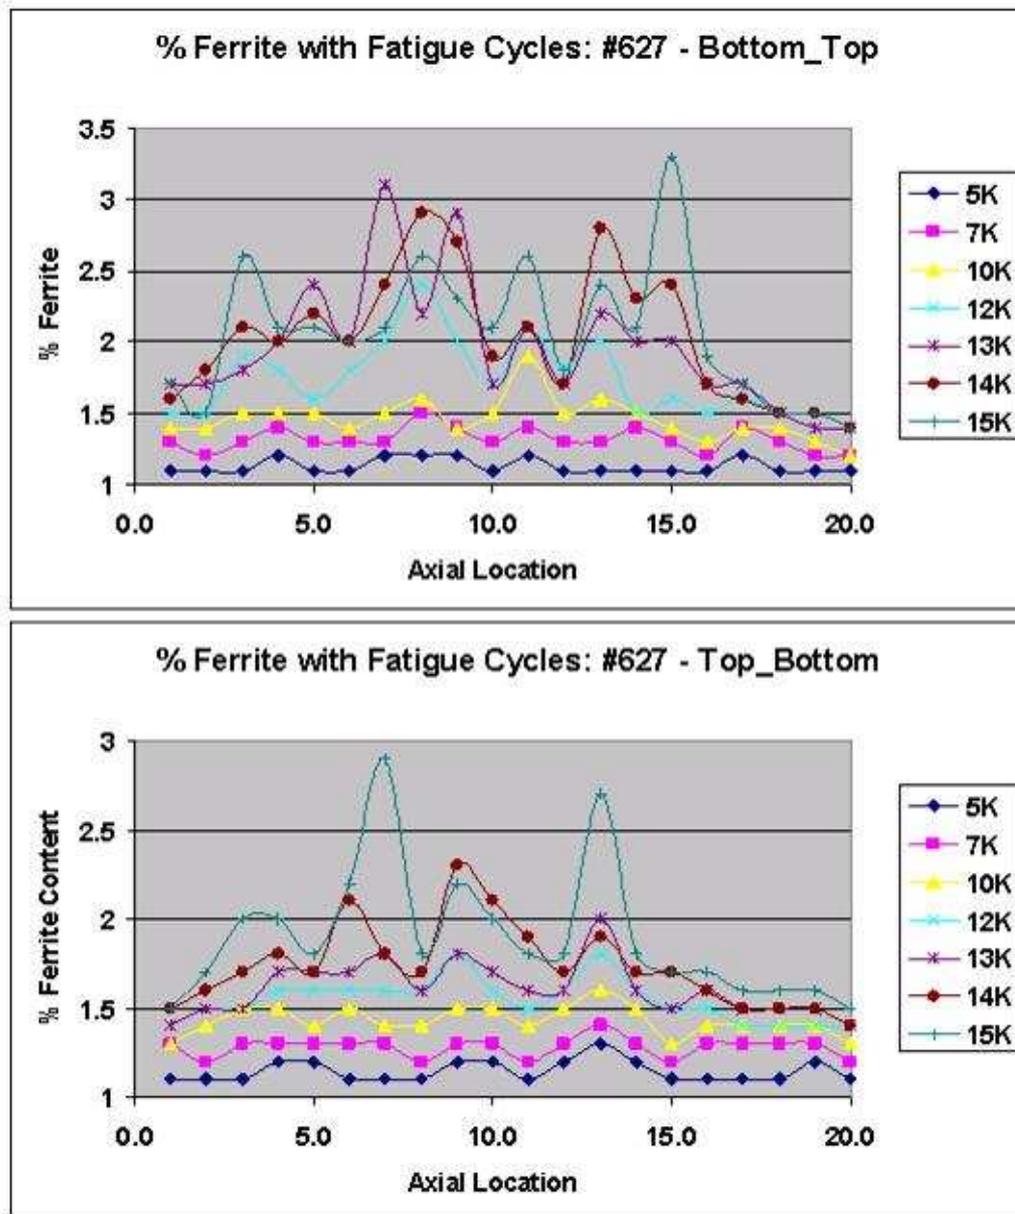
Unlike specimen #626, where the highest percent ferrite content was located at the crack initiation site, the higher percent ferrite contents for specimen #627 were found just outside of the crack initiation site. Figure 6 shows complex nature of the observed percent ferrite contents with increasing fatigue cycles. Higher fatigue cycles did result in higher percent ferrite contents but for this specimen, those higher values did not correspond with the major crack site. As shown in the figures, higher percent ferrite contents were noted adjacent to the observed crack locations.

Corresponding top line scans of percent ferrite plots with fatigue cycles
