Pressure tube flaws and artifacts observed in CANDU fuel channels; detection, sizing and characterization issues

Michael Trelinski
Senior Technical Expert
UT Fuel Channels
Inspection & Maintenance Services
Ontario Power Generation
230 Westney Rd. South
Ajax, Ontario
L1S7R3 Canada
E-mail: Mike.trelinski@opg.com
Phone : 905.428.4000 x 4052
Fax : 905.428.4199

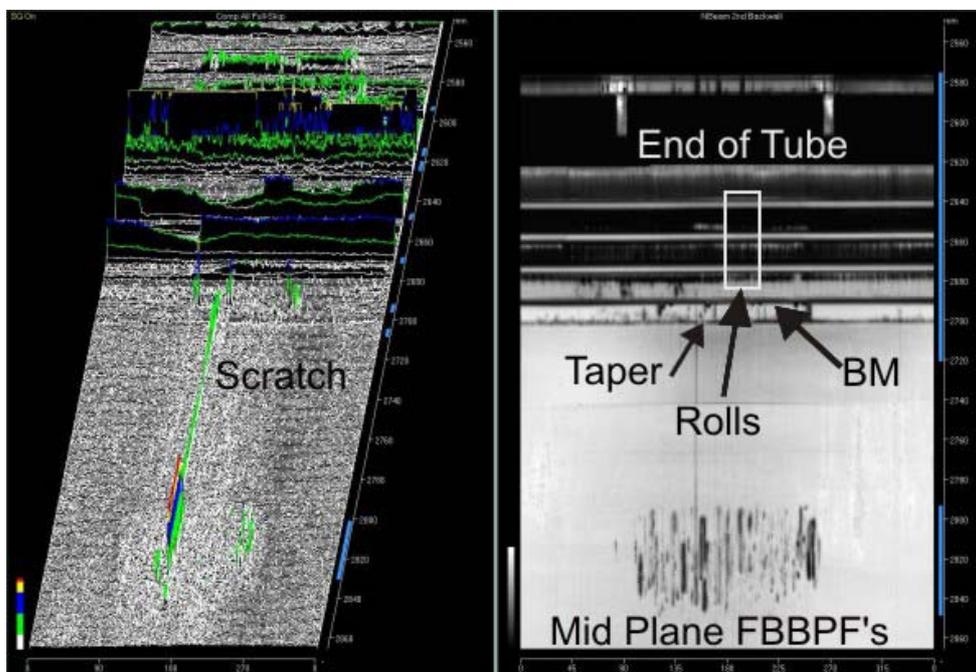
The FBBPF's result from fretting between fuel bundle support parts and PT material. Such fretting (due to bundle vibrations) is typically not significant with the exception of reactors in 13 bundle configurations. In such reactors, bundle #13, which resides in the Inlet Rolled Joint (IRJ), may vibrate more vigorously, causing accelerated fretting between bundle support pads and PT ID. In addition to this, a phenomenon called Abnormal Fuel Support (AFS) may cause deep and extensive fretting in the Burnish Mark (BM) and Mid Plane (MP) areas.

Indications in this category may or may not respond well to the amplitude based inspection whenever shear wave amplitude based or normal beam probe pulse echo approach is being used. Such indications are fairly sensitive though to the normal beam probe amplitude drop methods and are seen as having very distinct appearance. Sizing and characterization of such indications using normal beam probe B-scans normally do not present major problems. This is not necessarily true in the case of multiple, overlapping residencies and indications affected by the erosion process or uneven surface caused by the irregular shape of the support pads.

Figure 1 Bundle 13 Mid Plane fretting and Rolled Joint artifacts seen on UT data

Some of the PT artifacts can be seen in Figure 1.

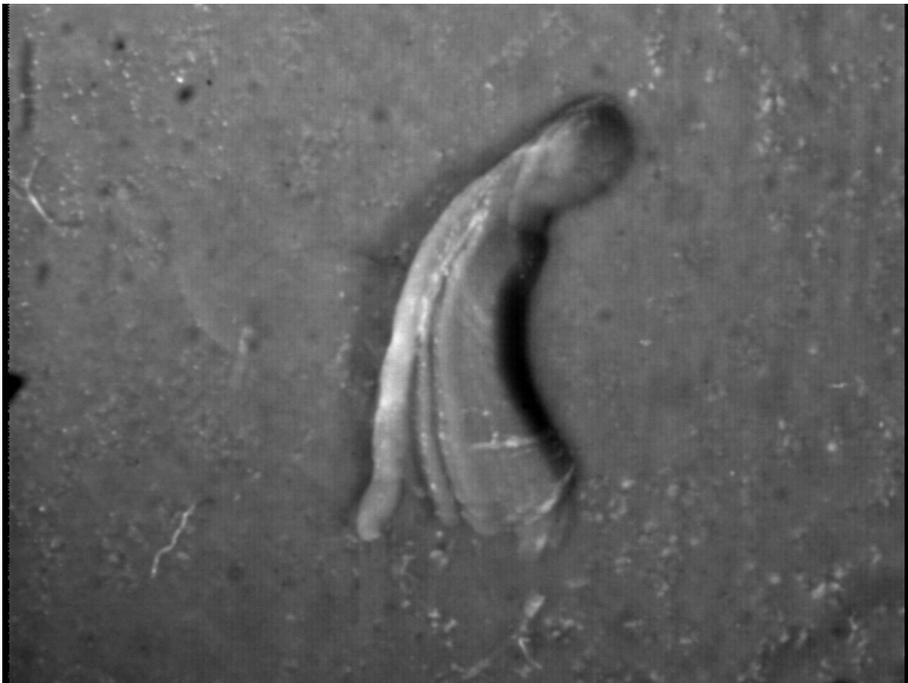
The primary sources of debris fretting are pieces of foreign material trapped between the bearing pad supports and PT ID. Fuel bundle vibrations and movement during refueling operations may cause the foreign material to fret into the PT surface. The debris frets are thought of as resulting from random process and are not expected to possess too many commonalities. Indeed, the experience indicates that there are very few similarities amongst debris frets. They vary greatly in sizes, shapes and types depending on the original source of fretting and the damage process.

Figure 2 Example of a debris fret (replica)

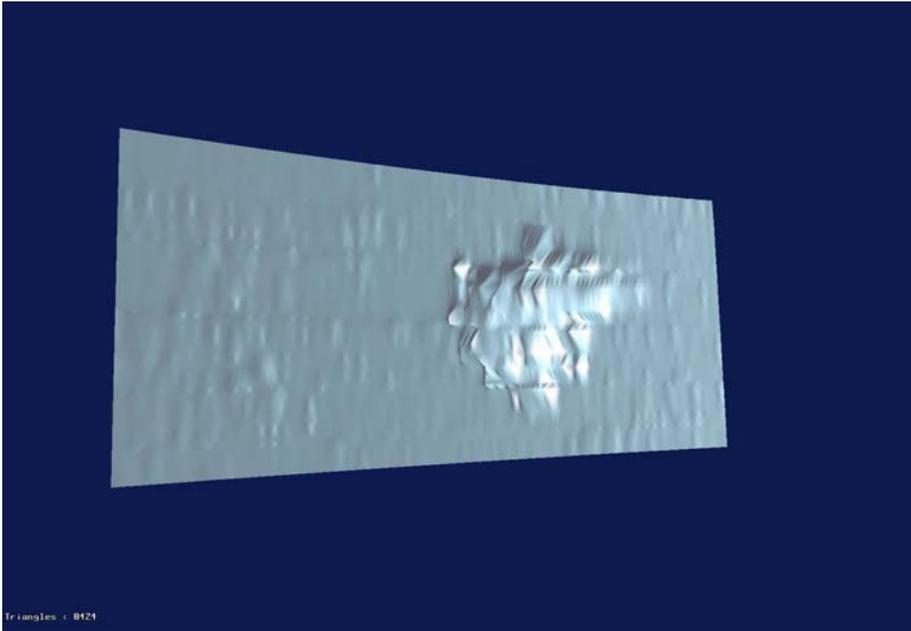
Ultrasonically, most of the debris frets respond well to the amplitude based inspection although significant non-uniformity of the response may result from raster scans selected for the detection scan. The tight and deep debris frets often present the challenge for accurate sizing. Use of multiple sizing methods is essential for proper sizing of such indications. Current IMS procedures require use of at least three separate sizing methods for sizing of PT indications. The examinations of debris frets replicated or contained in removed tubes fully justify such approach.

Figure 3 Example of a debris fret image obtained using ultrasonic data

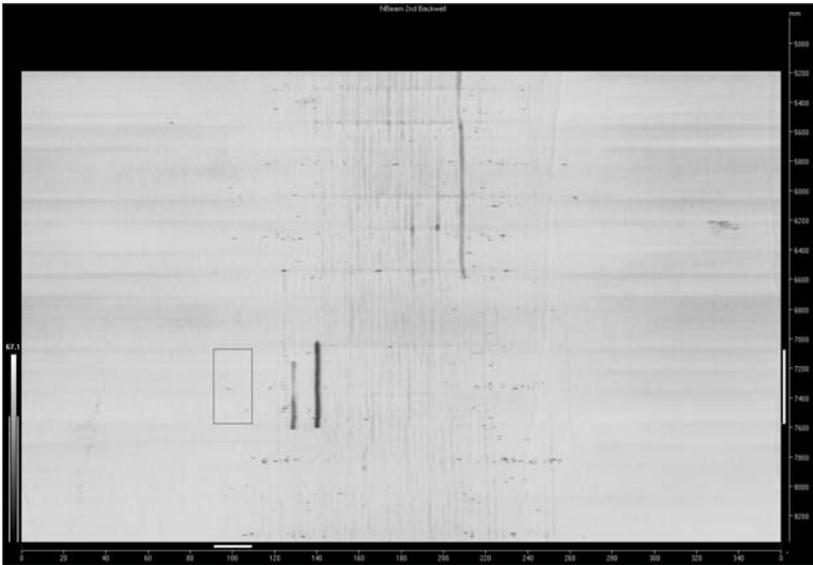
Mechanical damage flaws are caused by interaction between fuel bundles, foreign objects, Fuel handling (FH) tooling and maintenance tooling and PT surfaces. The mechanical damage flaws are typically axially oriented and uniform in depth. They tend to respond well to shear wave, angle beam amplitude based inspection and can also be easily seen on the C-scans obtained using normal beam probe amplitude drop methods. In some cases an accumulation of pushed up material can be seen at the end

of the indication. Typical mechanical damage indications are not difficult to detect and size using UT methods.

Figure 4 Mechanical damage indication seen on normal beam probe data

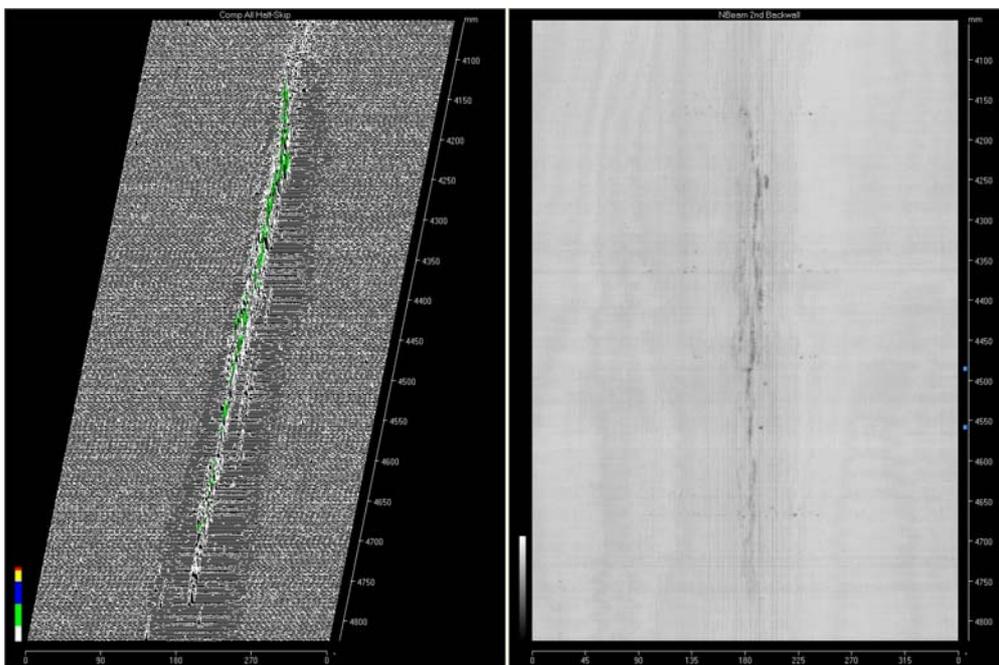
PT to CT contact causes small scratches to appear on the PT OD. Such scratches can usually be seen on both shear wave angle beam displays and normal beam amplitude drop based C-scan displays. They are however, low level indications and may be sometimes masked by system noise. Contact indications will stay in the same place even after the actual contact has been removed.

Figure 5 PT to CT contact seen on UT data
