## EXPERIMENTAL NON-DESTRUCTIVE TESTING OF FRP MATERIALS, INSTALLATION, AND PERFORMANCE, DALLAS COUNTY BRIDGE, MISSOURI, USA

N. Maerz<sup>1</sup>, G. Galecki<sup>1</sup>, and A. Nanni<sup>1</sup>

<sup>1</sup> University of Missouri-Rolla, Rolla, Missouri, USA

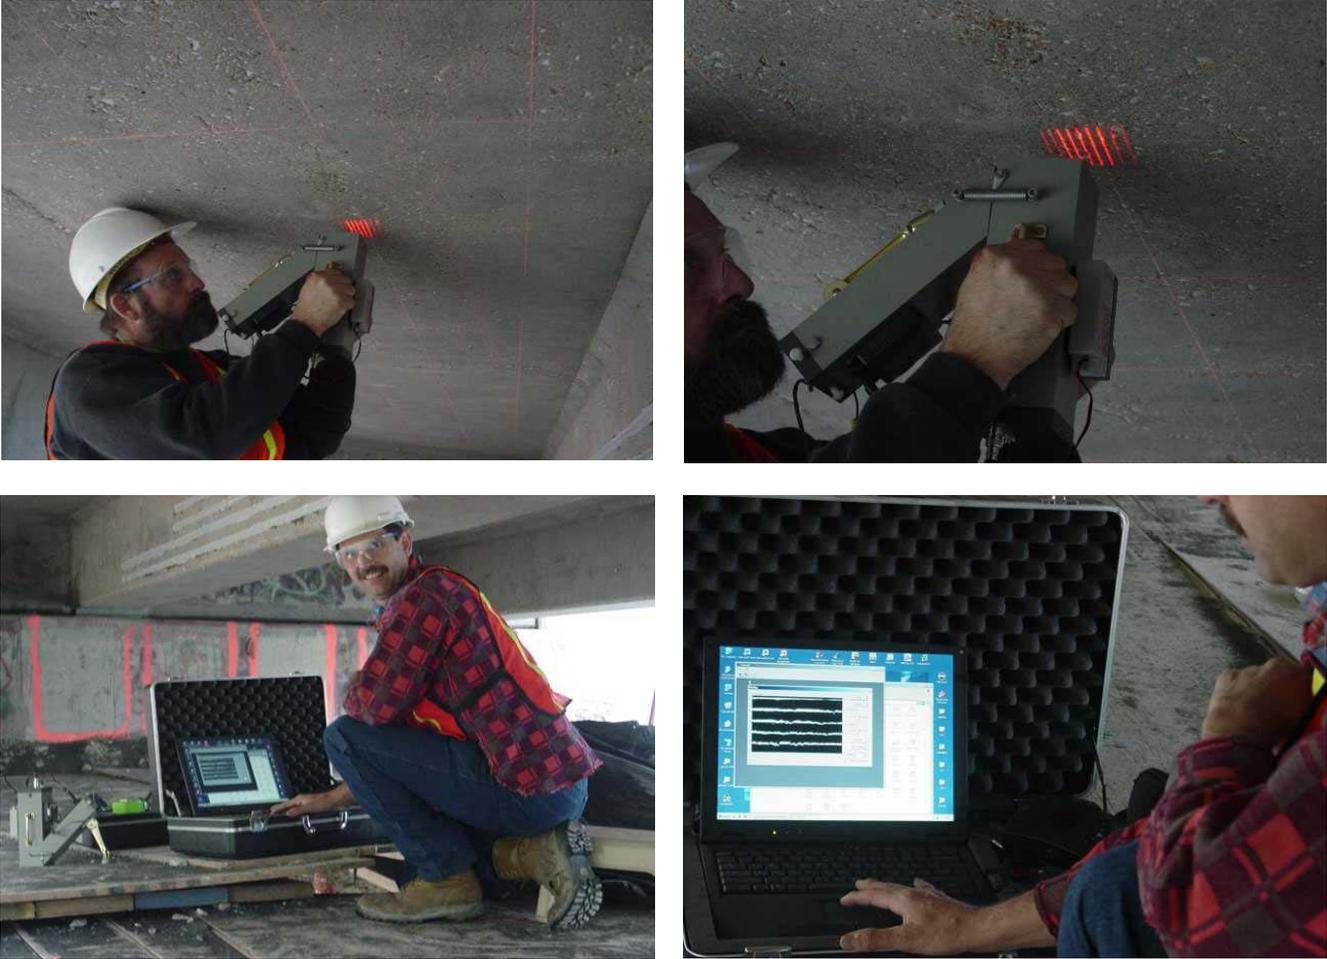
Figure 10: Roughness measurements on the bridge deck.

1. Concrete surface roughness measurements were made after sand blasting and prior to FRP sheet application on one section of the bridge deck using the laser profilometer (Figure 10). Measurements were made on a grid on 1 foot centers.

**Concrete Substrate Surface Roughness:** Roughness measurements were made on 4 sections of the bridge deck (Figure 10). Measurements were made on 12” centers, an example of a set of measurements is given in Table 1. Table 2 shows the mean and standard deviation of the measured roughness.

The mean values which are around  $8^\circ$  reveal that the roughening sandblasting done by the contractor was in general below the optimum value for bond performance ( $12^\circ$ ). The variability was very low, but is probably due to the fact that very little material was removed by the sandblasting, and that the final roughness was similar to the original cast roughness of the concrete.

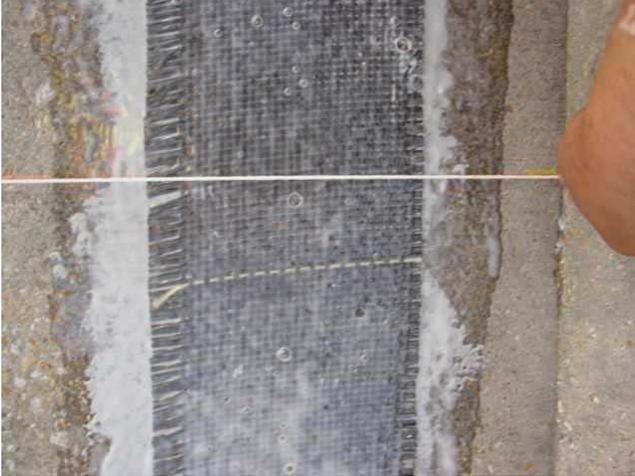
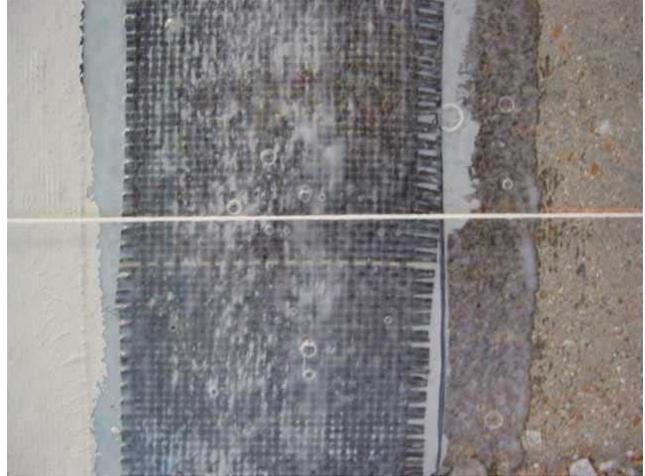
2. Fiber alignment measurements were made after FRP sheet application, and before painting. Transparent epoxy was used to make the tracers more visible (Figure 11).

Figure 11: Alignment errors of 7.2 and 0.9°, respectively.

**FRP Fiber Alignment:** Fiber alignment measurements (Figure 11) were taken on four sections of the bridge deck. In all 421 measurements were made. The mean alignment error was  $3.6^\circ$  with a maximum error of about  $11^\circ$ . Almost 25% of the measurements indicated alignment errors over  $5^\circ$ . In fairness to the contractor, these thin strips of bi-direction fabric are difficult to keep aligned. In tests with of a broad sheet applied to the center girder, the alignment error in 12 measurements was about  $1.2^\circ$ , with no measurements above  $5^\circ$ .

*FRP Fiber Alignment:* The fiber alignment measurements were also quick and easy. There is a special requirement for FRP sheets with highly visible tracer fibers, running in the load bearing direction. Also the use of transparent (clear) epoxy is recommended, so that the fibers are more visible. This creates a potential problem for the contractor, because without the dye in the epoxy, it is difficult to determine when complete mixing has been attained.

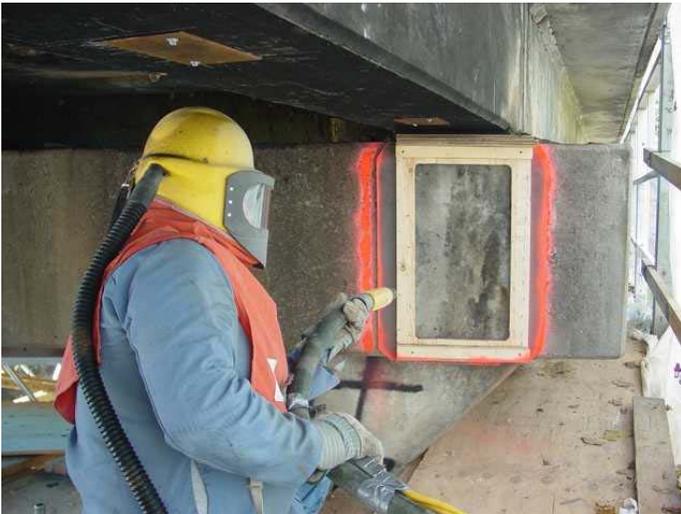
Figure 12: Surface preparation by sandblasting.

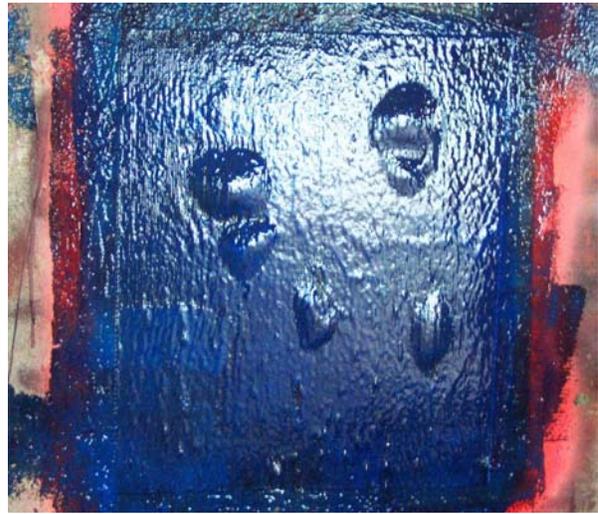
3. Test sections of FRP materials were applied on one abutment and one bent. These were sandblasted to specified differing roughnesses (Figure 12), and roughness was characterized prior to FRP sheet installation. Delaminations were forced under the sheets installed in these test sections by air injection (Figure 13). These delaminations were measured and will be re-measured every six months.

Figure 13: "Forced" delamination by air injection.

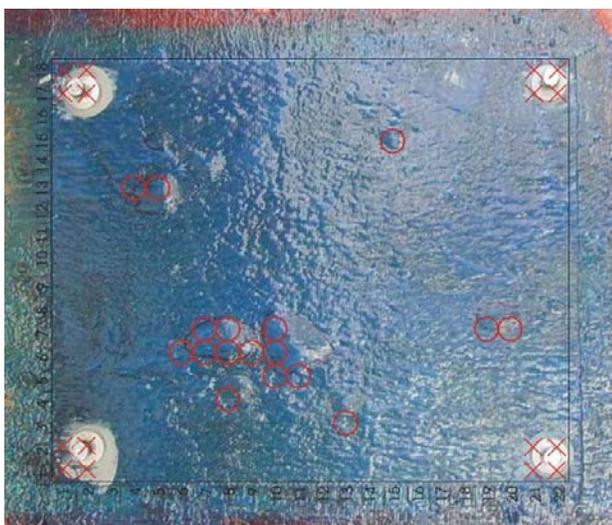
**FRP Delamination:** Impact echo delamination testing found all the major planned delaminations. An example is given in Figure 16. A few small delaminations (less than 1 square inch) were not identified because the sampling was on 1 in on centers. However, some small delaminations that were not intentionally installed, were identified using the impact echo testing.

Figure 16: Delamination Measurements overlain on image of test FRP strip #4.

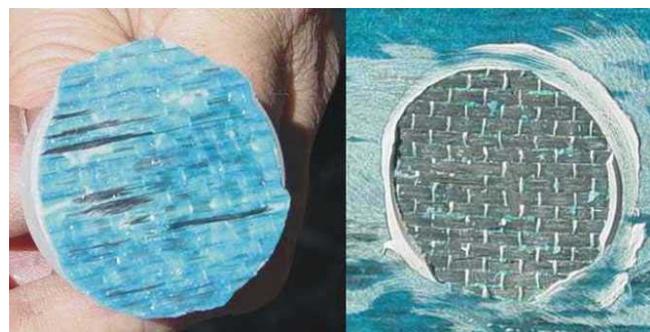
Figure 17: Pull-off plugs separating at the FRP/epoxy interface.

*FRP Bond Pull-off:* The FRP (destructive) Pull-off tests done to date, all failed at the interface between the FRP sheet and to covering epoxy (Figure 17). The average Pull-off load for 10 samples was found to be 9745 lbs. For future non-destructive testing, the plugs will be loaded to 6500 lbs (2/3 of the average strength), every 6 months.

*FRP Bond Pull-off:* The bond Pull-off tests to determine max loads have all failed above the FRP, between the FRP and the epoxy. Although it is expected poor quality epoxy/installation will result failure at lower loads, and perhaps at the FRP/concrete interface, this has not yet been verified.
