OPERATING EXPERIENCE WITH THERMALLY TREATED ALLOY 600 TUBES IN MODEL F STEAM GENERATORS: CRACKING

M. Kim, C. Yim, and J. Park
Kaitec, Daejeon, Korea

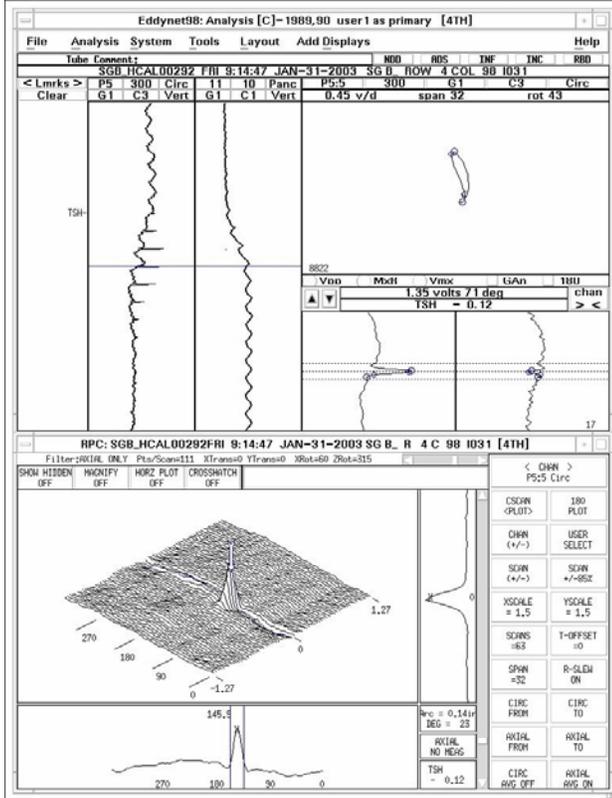
Figure 2. RPC Data: SCI of R4 C98(S/G B)

Younggwang 1 & 2. Younggwang 1 has completed its 14th ISI in May 2003 and Younggwang 2 has completed its 13th in January 2003. Major degradation in both units is wear. Younggwang 1 has no SCC yet, but 4 SCC's have been found at the hotleg top of tubesheet in Younggwang 2 in 2003. The tube ID's are R4 C98 from S/G 'B', R41 C33, R39 C43 and R48 C44 from S/G 'C'. These tubes have not been tested with rotating probe until then. Inspection scope for the RPC test of hotleg tubesheet expansion used to be just 300 tubes covering sludge zone, but it's expanded to 100% of TTS hotleg for all model F and KSNP steam generators since August 2002 after tube rupture accident of Ulchin 4 in 2002. Ironically, thanks to the inspection scope expansion, these cracks could be found, but historical compare with RPC data is not available. And we cannot be sure from when these cracks have existed. There was no leakage before these cracks were detected, and all the 4 tubes were repaired by plugging[3]. No further alternative test like ultrasonic test or visual test to confirm these crack indications was conducted.

Eddy Current Data Review from Younggwang 2. The RPC test data for the 4 tubes from Younggwang 2 are presented in Fig. 2 to Fig. 5, and Fig. 6 provides the flawed tubes location on tubesheet map. Note that *the flawed tubes are not in the conventional sludge zone*. Bobbin data of the recent inspection for the 3 tubes (R4 C98, R41 C33 and R48 C44) show low sludge height of about 0.5 inches, but R39 C43 seems to have partial deposit from the top of tubesheet up to 2.5 inches. The prior inspection(12th) sludge measurements results indicate quite high value of 3 ~ 4 inches for all 4 tubes[4], but it seems to have been soft sludge easily removed by secondary side lancing judging from low sludge height in recent inspection results. And these SCC's differ from those found in Kori 2 in that they have no dents at the expansion transition.

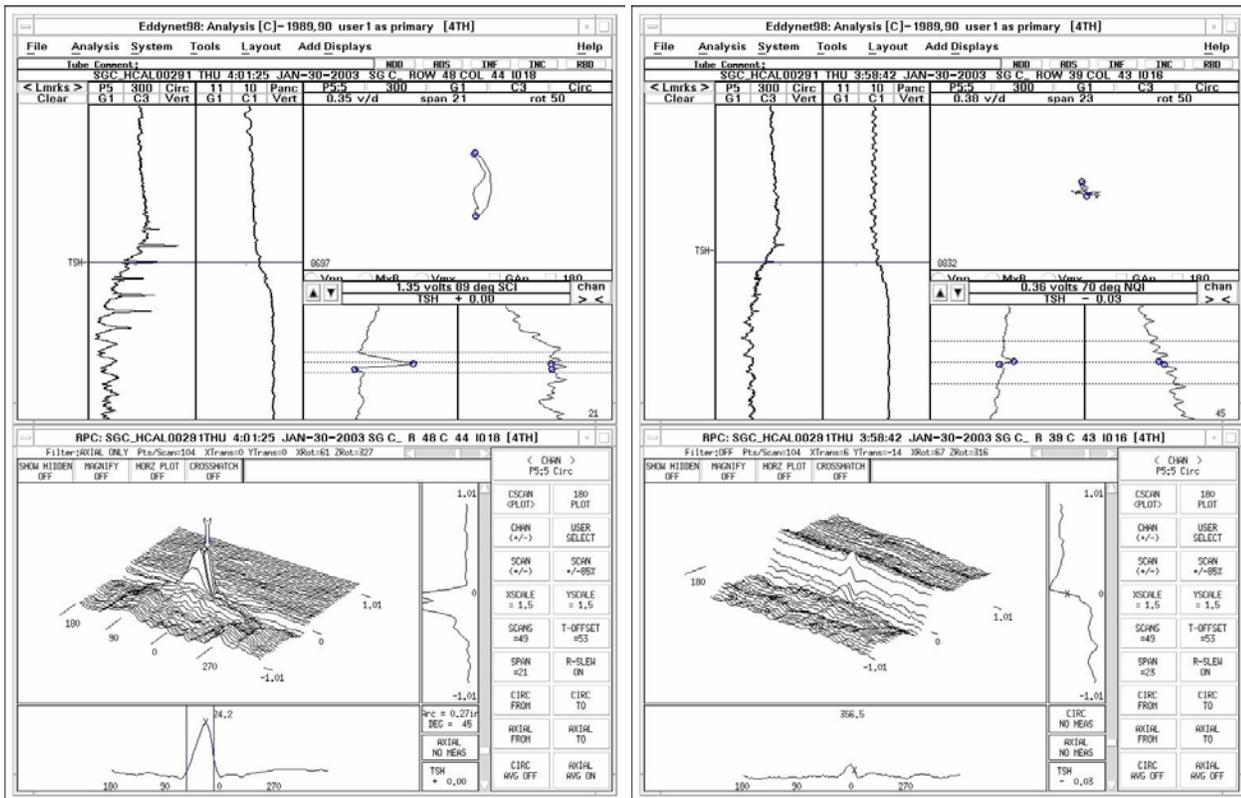
Figure 4. RPC Data: SCI of R48 C44(S/G C)

These 4 tube data were peer reviewed with Kori data by EPRI in late June last year, and results confirmed that all are OD circumferential cracks except R39 C43. There was a discrepancy whether this indication meets flaw criteria or not and concluded as NQI(non-quantifiable indication). Table 2 indicates peer review results for Kori 3&4 and Younggwang 1&2.

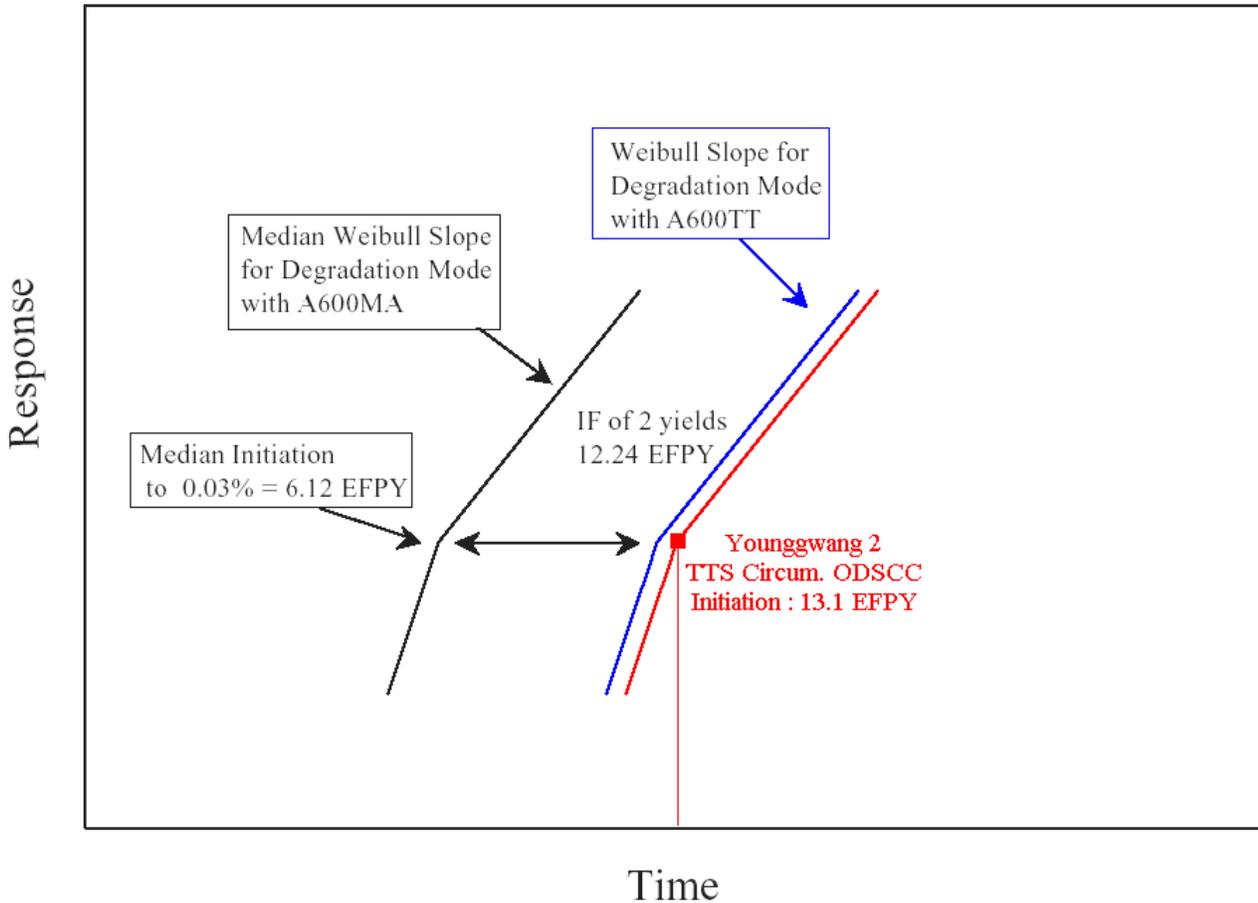
Figure 7. EPRI Weibull Projection

For TTS circumferential ODSCC, EPRI Weibull Median time to reach 0.03% of feedring steam generator tubes repaired is 6.12 EFPY. This median time is multiplied by EPRI estimated improvement factor 2.0 and yields 12.24 EFPY(See Fig. 7). In case of Model F steam generators, each steam generator has 5,626 tubes, so repaired fraction of 0.03% becomes 2 tubes per steam generator. This seems to give a quite good explanation for Younggwang 2(See Table 4). The EFPY values in the table are calculated assuming T_{hot} is 618°F the standard operation temperature, which is the actual operation temperature or a little bit lower.
