## LONG RANGE INSPECTION OF RAIL USING GUIDED WAVES - FIELD EXPERIENCE

P. Cawley<sup>1</sup>, P. Wilcox<sup>2</sup>, D.N. Alleyne<sup>2</sup>, B. Pavlakovic<sup>2</sup>, M. Evans<sup>2</sup>, K. Vine<sup>2</sup> and M.J.S. Lowe<sup>1</sup>  
<sup>1</sup> RCNDE, Dept Mech Eng, Imperial College, London, UK <sup>2</sup> Guided Ultrasonics (Rail) Ltd, 17 Doverbeck Close, Nottingham, NG15 9ER, UK

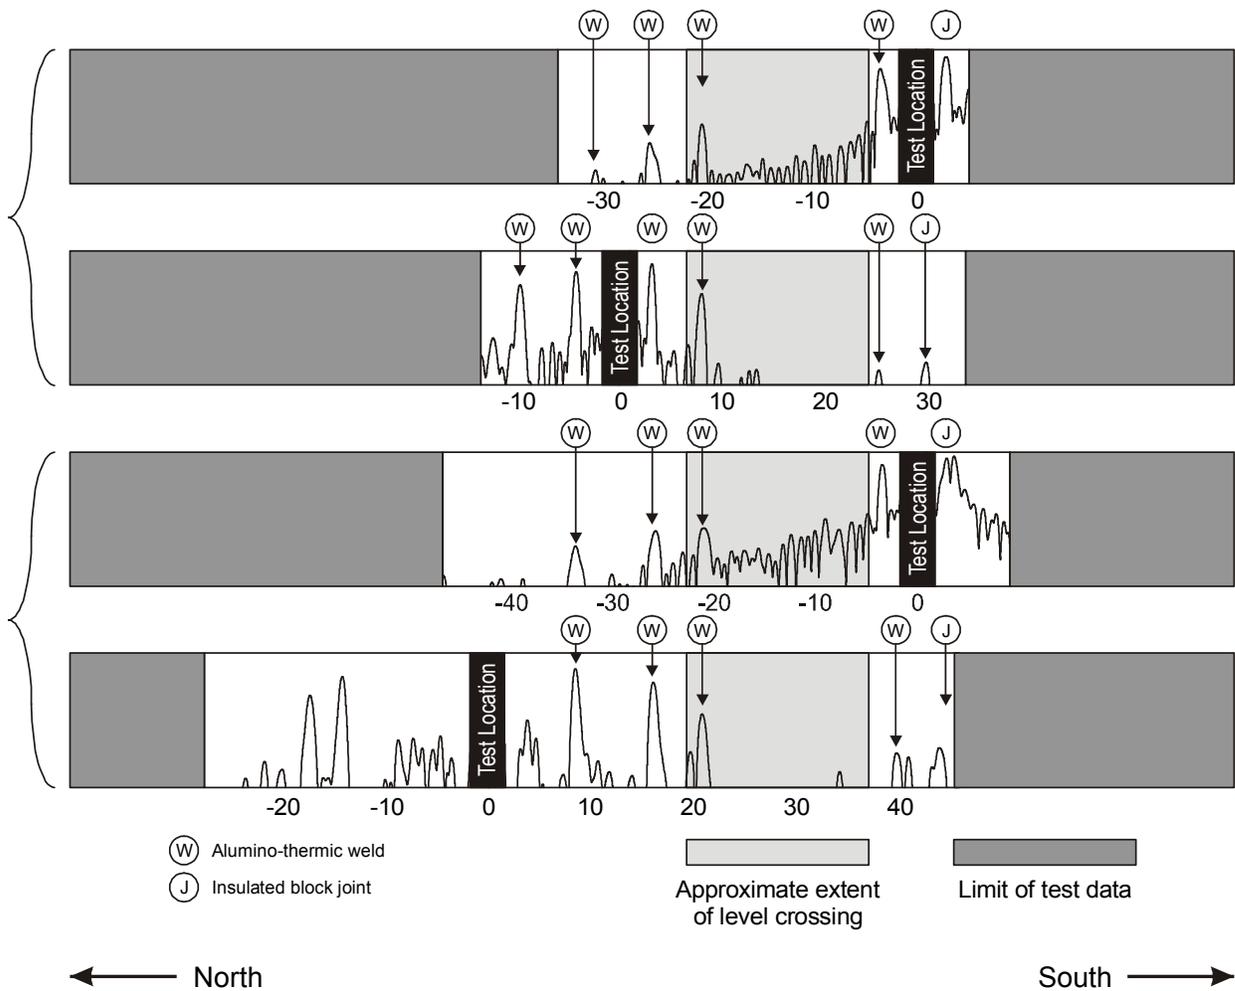
In the 'up' line results shown in Figure 4, signals corresponding to documented alumino-thermic welds and insulated block joints are clearly identifiable in all the results. The results from the rails on the 'up' line are reasonably clean and indicate the level of background coherent noise that may be expected on rail in good condition.

The decaying signals that are visible in the two results when the test location was on the south side of the level crossing are due to reverberations. The mechanism that causes these reverberations is not yet fully understood, but it is thought to be due to the relevant test locations being in-between two large reflectors (an alumino-thermic weld and an insulated block joint) that are in close proximity. These reverberation signals do not correspond to physical features in the rail.

Figure 4. Results obtained from the 'up' line at the level crossing. Distances from the test location are marked in metres.

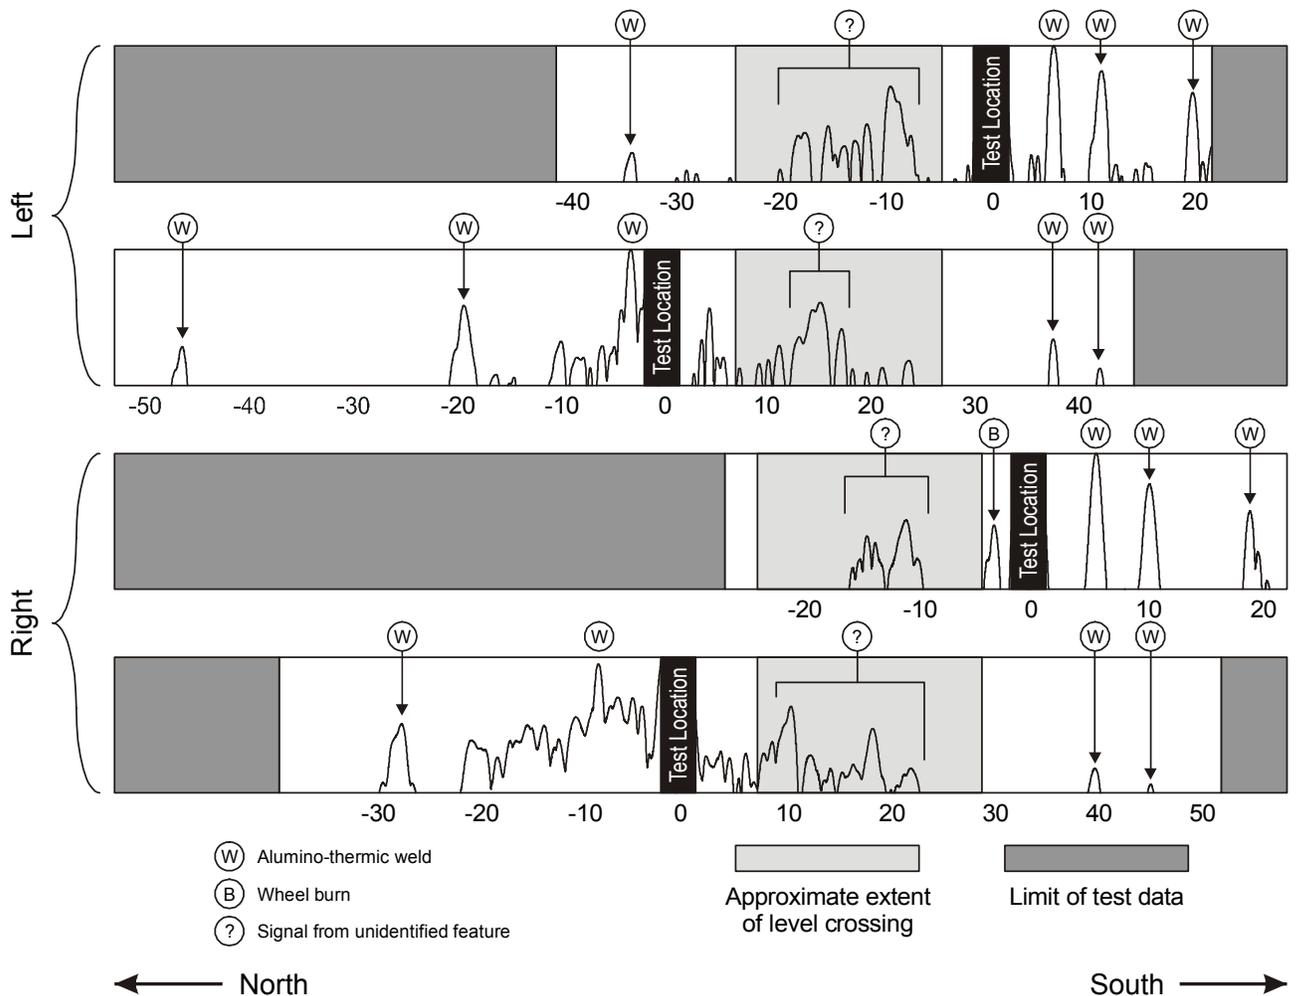
The results from the 'down' line shown in Figure 5 are markedly different from those obtained on the 'up' line. Again, signals from alumino-thermic welds are clearly visible but there are also numerous other distinct signals present that do not correspond to any documented features. When the right hand rail was tested from the south side of the level crossing, a signal was observed just before the rail entered the level crossing area (marked B in Figure 5). Visual inspection revealed that there was a wheel-burn at this location. There were several other wheel-burns in the vicinity on this line, but none of the others gave a significant G-Scan signal, hence indicating that this particular wheel-burn may have had greater transverse penetration of the rail than the others.

There are also a large number of signals present within the crossing on the 'down' line (marked '?' in Figure 5) that do not correspond to known features. The ragged nature of these signals is indicative of corrosion rather than man made features, and the reflection coefficient maps [1] suggest that many of these signals correspond to a loss of material in the foot of the rail. It is therefore reasonable to conclude that the rail on this line has experienced a moderate degree of foot corrosion. The rail on this line was visually observed to be somewhat older than that on the 'up' line.

Figure 5. Results obtained from the 'down' line at the level crossing. Distances from the test location are marked in metres.
