17th World Conference on Nondestructive Testing, 25-28 Oct 2008, Shanghai, China

Computed Radiography and Microtomography of Riveted Lap Joints of Glare™ Subjected to Constant Amplitude Loading (CAL) Fatigue

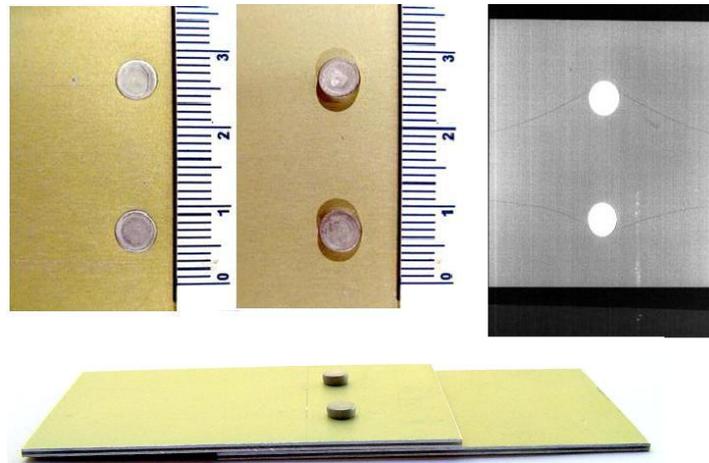
inspected and, although visually intact, cracks were found at the faying surfaces of the aluminum sheets by conventional (film) radiography (Figure 2).

Figure 2 - Test specimen photography and conventional radiography^[3]. From left to right: countersunk rivet heads, bottom rivet heads, radiography and test specimen full image. Those were taken after more than 1,000,000 cycles of CAL. Scale in centimeters.

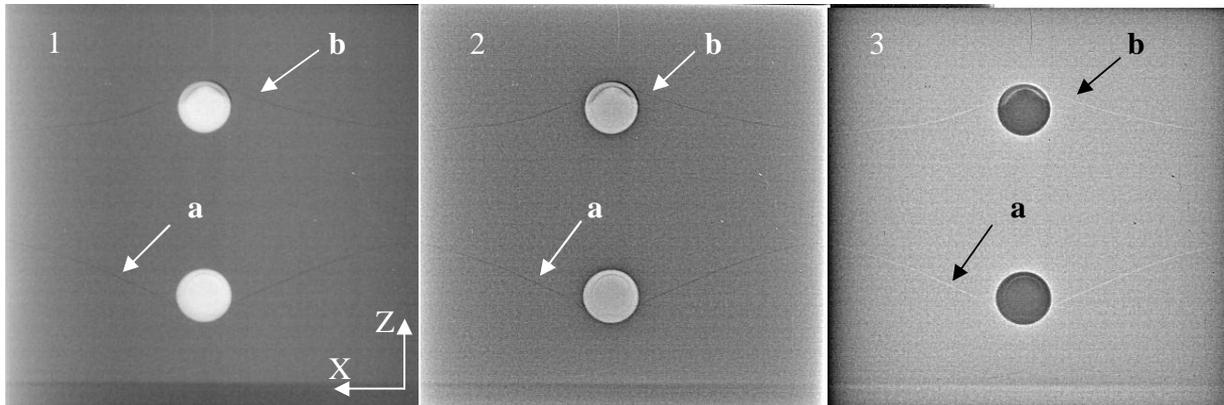
Figure 3- CR1 radiographies

Figure 3 shows the results for experiment CR1. Frame 1 represents the radiography as recorded, with little image manipulation, mainly in gray levels. A subtle change in contrast can be seen near and around the upper rivet head (**b**), which represents a discontinuity of the material in the rivet head itself. The crack, on the other hand, is barely visible. A Fourier Transform high pass filtering was performed at frame 2 to enhance details. Cracks (arrows **a** and **b**) have better contrast against the image, as well as the rivet head damage. In frame 3 a negative image was created in order to give a different view of the cracks.

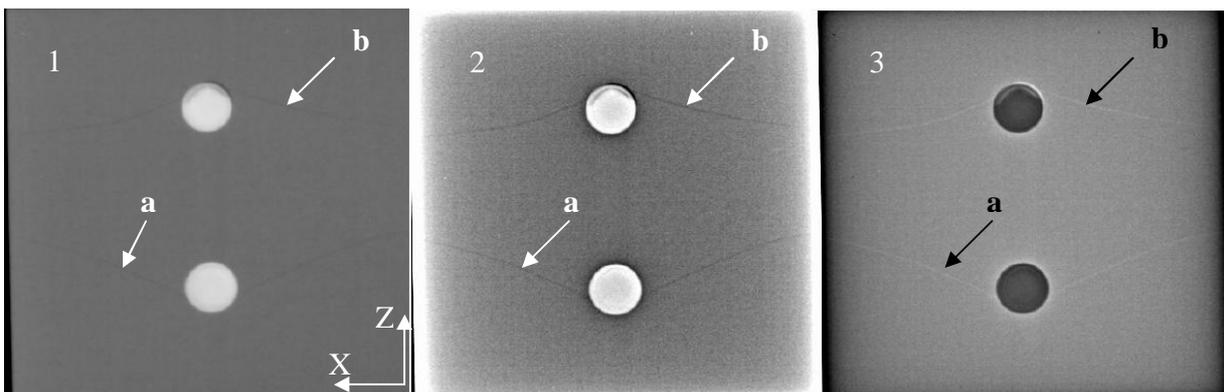
Figure 4 - CR2 radiographies

The experiment CR2 has its frames shown at Figure 4. The same features described for CR1 can be seen. Nevertheless, as a penalty for lower resolution, a little granulation can be seen at the frames. Again, Frame 1 has the untreated image, at Frame two a Fourier transform was performed and Frame 3 has a negative image of the latter.

Comparing the two experiments above, it is clear that even using different CR systems with different basic spatial resolutions, it is still possible to detect these cracks with very good contrast. However, the cracking pattern cannot be solved in terms of which aluminum sheet contains each crack. This is caused by the loss of depth resolution if a 3 dimensional object is projected on the image plane as in standard radiographic inspection.

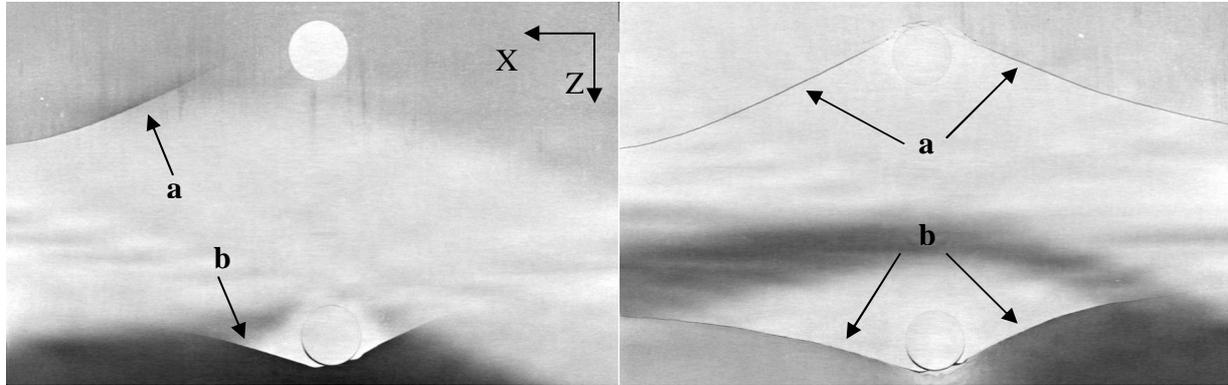
Figure 5 – First μ CT sequence along Y axis (XZ plane cuts)

Figure 5 reveals the same cracks as shown by CR, but details are much more visible. It is important now to start trying to figure out in what aluminum sheet each crack has propagated. As the left hand side image of Figure 5 suggests, a slight misalignment of the Glare™ joint with respect of the table where it was placed may have occurred. The arrow **a** indicates an upper crack that is not completely visible, while the crack pointed by arrow **b** is well defined. This is sufficient for one to suspect that the cracks do not belong to the same plate. Moving on in the tomography, the right hand side image now shows the upper and lower cracks fully propagated. Also noticeable are differences in gray intensity before and after the crack limits. This effect can be caused by small displacements between the two portions of the cracked plate. It is also possible to see that the region above the upper rivet has suffered additional damage.

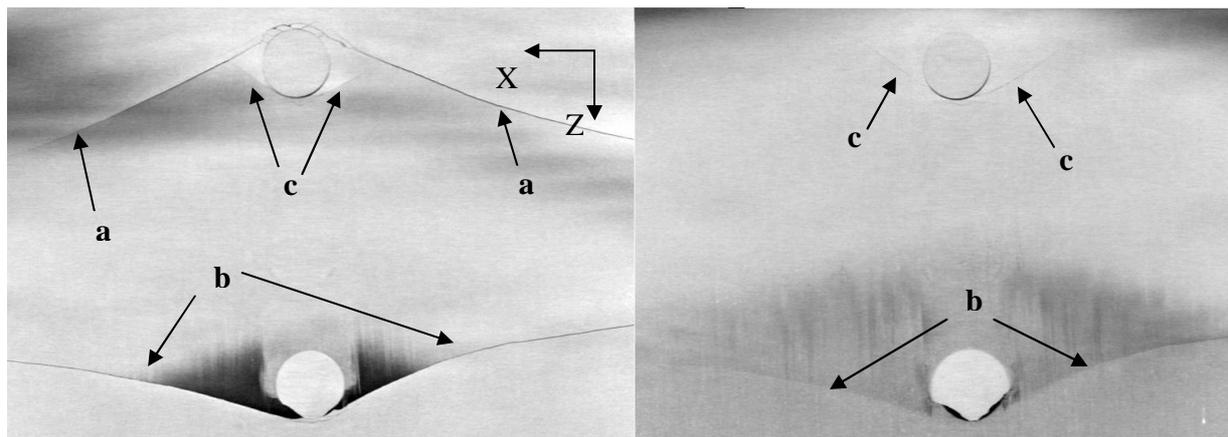
Figure 6 - Second μ CT sequence along Y axis (XZ plane cuts)

The tomography has continued through Y axis, as seen by Figure 6. The left hand side image now reveals the cracks around the rivets, just like shown by CR, but an additional small crack around the upper rivet can be seen (arrow **c**), with an orientation that is reverse to that expected

to happen in this kind of joint^[3]. Also noticeable is a seriously damaged region above the upper rivet, created due to the fatigue process. The right hand side frame of Figure 6 shows the small crack and a slight difference in contrast at the lower end of the picture. Both figures clearly show the failed countersunk head of the lower rivet, which cannot be seen with this quality in the CR images.

It has become clear that the cracking mechanism of the GlareTM riveted joint here analyzed is not trivial. There are multiple cracks propagating in reverse directions around the same rivet head, aluminum sheets misalignments and localized damages near a rivet head. It is not possible to determine in what plate a specific crack is just by inspecting the figures shown until now.

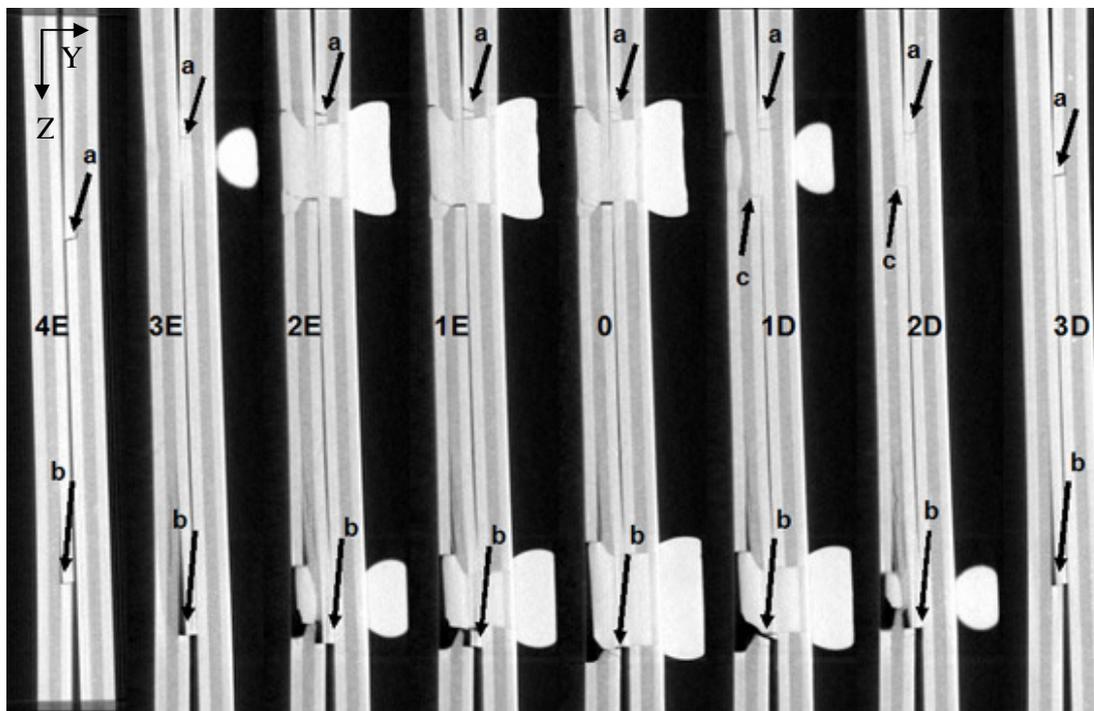
Figure 7 - μ CT images of the riveted joint along the X axis (YZ plane cuts)

One of the most powerful tools of the μ CT is that images are recorded of several planes throughout the entire specimen and along three axes. Figure 7 shows a sequence of images taken from XZ planes of the lap joint along the Y direction (refer to Figure 1). The arrows **a**, **b** and **c** refer to the same cracks discussed above. It becomes clear now that crack **a** belongs to the inner aluminum sheet of the flat bottom hole plate, while cracks **b** and **c** belong to the inner sheet of the countersunk plate.

Also noticeable is the failure of the countersunk head of the rivet at the lower part of image below, with serious loss of mass. The other countersunk rivet head have also been cracked, but did not separate from the body.

The fatigue process caused the fiber glass bonding to fail. It is possible to see separation between the aluminum sheets and the core as well as failure throughout the fiber glass layers themselves. Separation occurs until considerable distances from the cracks are reached to the direction of the center of the riveted lap, suggesting great loss in mechanical performance of the plate.

The misalignment mentioned when analyzing Figure 6 is confirmed throughout Figure 7, especially where the countersunk rivet have failed and lost part of its head.

- d. CR shows that one of the rivet heads is broken and the other may have developed some cracking, although not clearly shown. This is confirmed by the μ CT (e.g. Figure 7, 1E and 2E images);

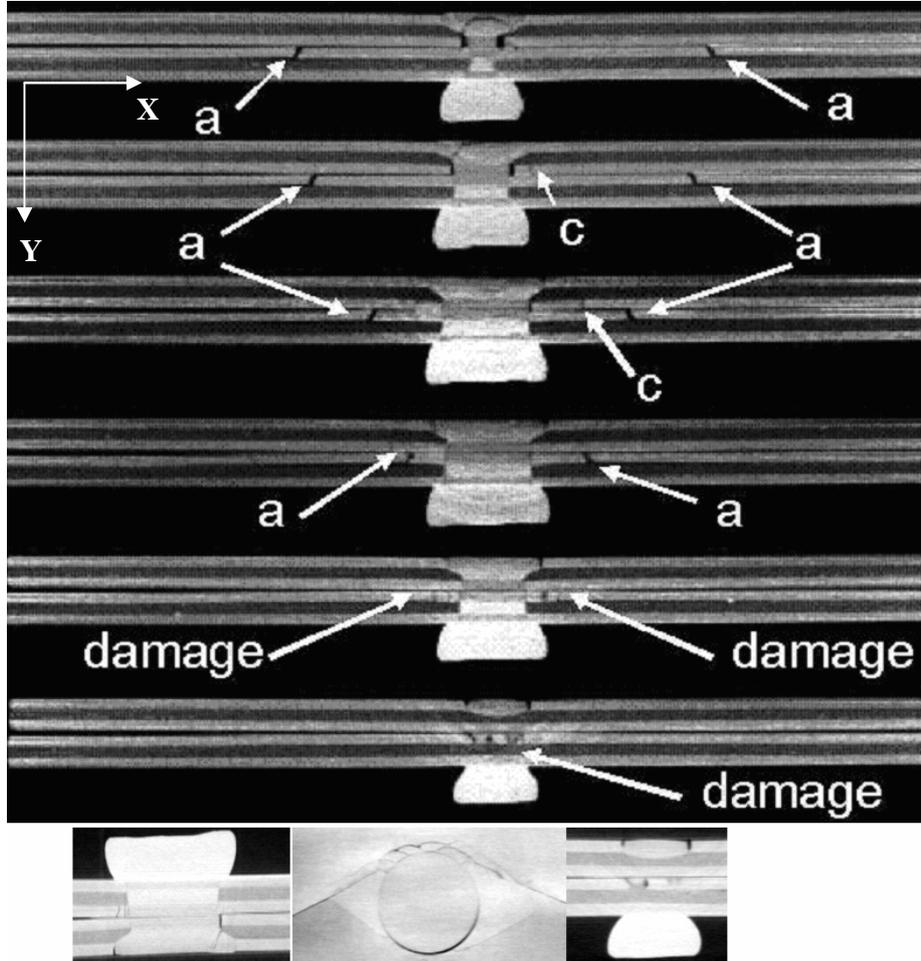
In order to have a better understanding of the damaged suffered by the joint near the upper rivet head, images of the XY plane (Z direction) are presented in Figure 8, showing only cuts of this area. The cracks **a** and **c** are marked and it can be noticed again that the latter belongs to the countersunk plate while the former is in the flat bottom plate.

Figure 8 - μ CT images of the riveted joint along the Z axis (XY plane cuts). Below is an insert showing three axes images of the region with serious damage around the rivet head

The damaged area is visible in Figure 8 and it is also possible to see that small cracks have occurred around the rivet head (insert), in the flat bottom aluminum sheet.
