## AN ASSESSMENT OF THE CONDITION OF TIMBER STRUCTURES

### BASIC PHASES OF TIMBER STRUCTURE ASSESSMENT

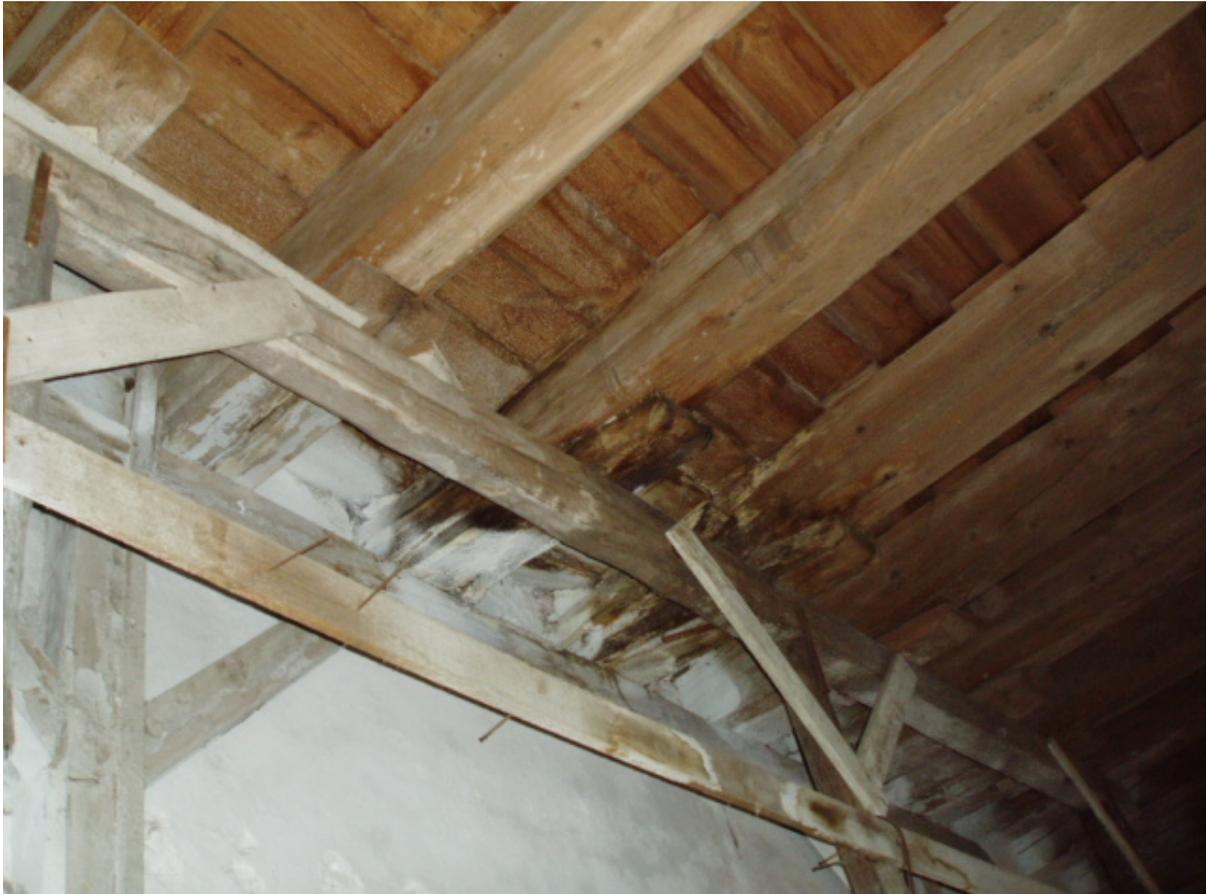
*Figure 1. Roof In-Leak*

Condition of timber structure elements is analyzed as to their deformation (floor supporting beams: deflection; roof elements: distortion, shrink cracks, oversized knags) as well as cross-section reduction whether as a result of decay fungi deleterious effect or other mechanical damage. Also we have to trace in-leak spots, size and arrangement of particular elements (roof construction), and floor structure (horizontal load bearing structures).

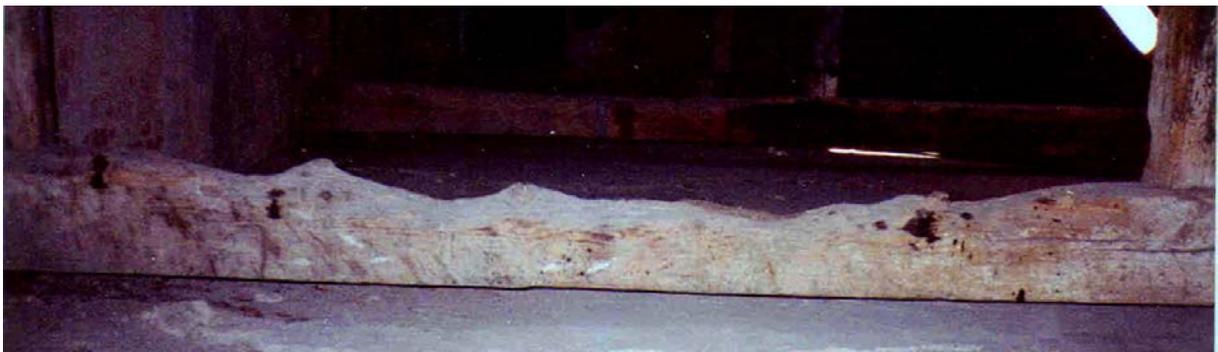
*Figure 2. Beam Mechanical Damage (cross-sections reduction due to wood chopping)*

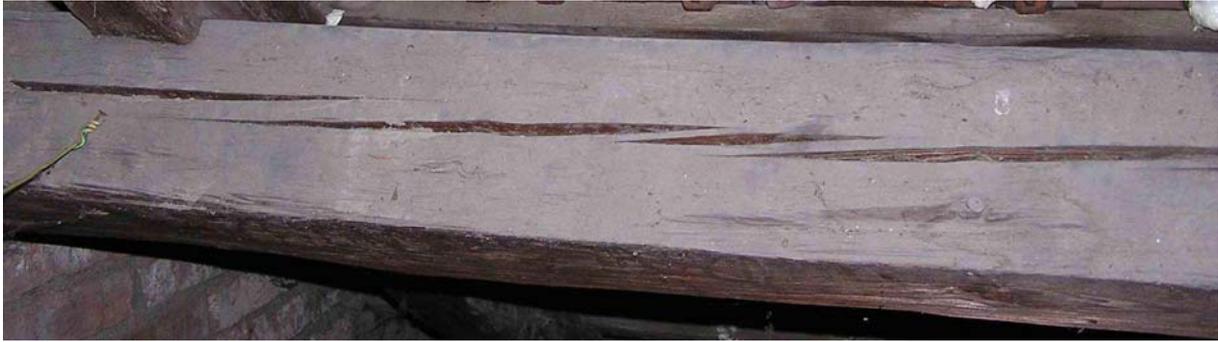
*Figure 3. Shrink Crack in a Roof Element*

- element position: we check position compliance with contract documents and/or general principles covering given roof;
- geometrical shape i.e. height, width (thickness) length (span) through measurement;
- supporting beams spacing and span through measurement or uncovering in case the beams are hidden;
- floor structure through measurement of particular component elements and layers;
- in-leak spots positioning (potential timber failure) – see Figure 1
- element deformation (warping, twisting, deflections) and timber joint quality;
- mechanical damage – see Figure 2;
- element mounting, especially its installation in brickwork;
- cracks (able to reduce bending strength even by 38% ) – see Figure 3

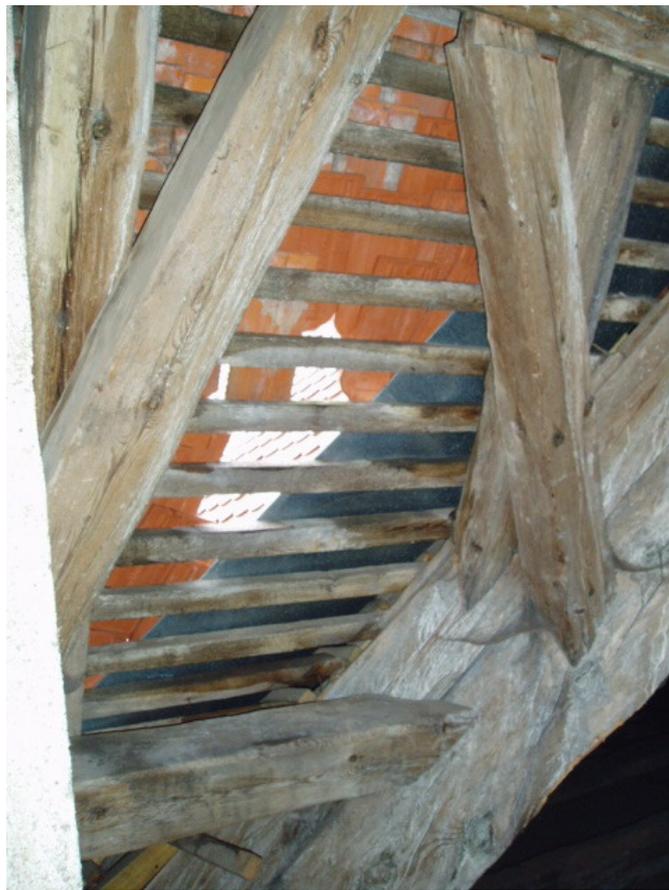
*Figure 4. Knags in a Roof Beam*

- presence of knags (number and size – reducing timber strength) – see Figure 4
- timber health.

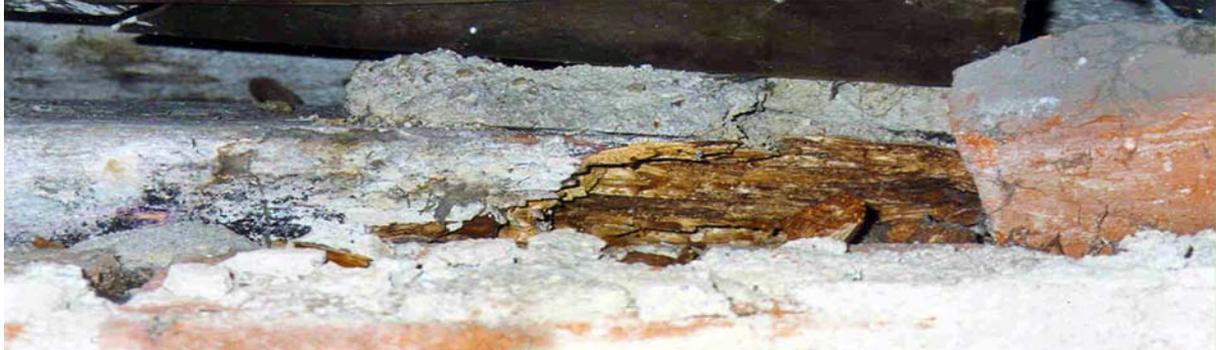
*Figure 5. Roof Failure Due to House Fungus Attack*

On the basis of characteristic features of particular types of wood-rotting borers (change in wood colour and/or structure, fungi fruiting body or mycelium, presence of insect output openings, insect galleries, in-leak spots and so on) – see Figure 5 and Figure 6 for timber failure due to wood-rotting borer attacks.

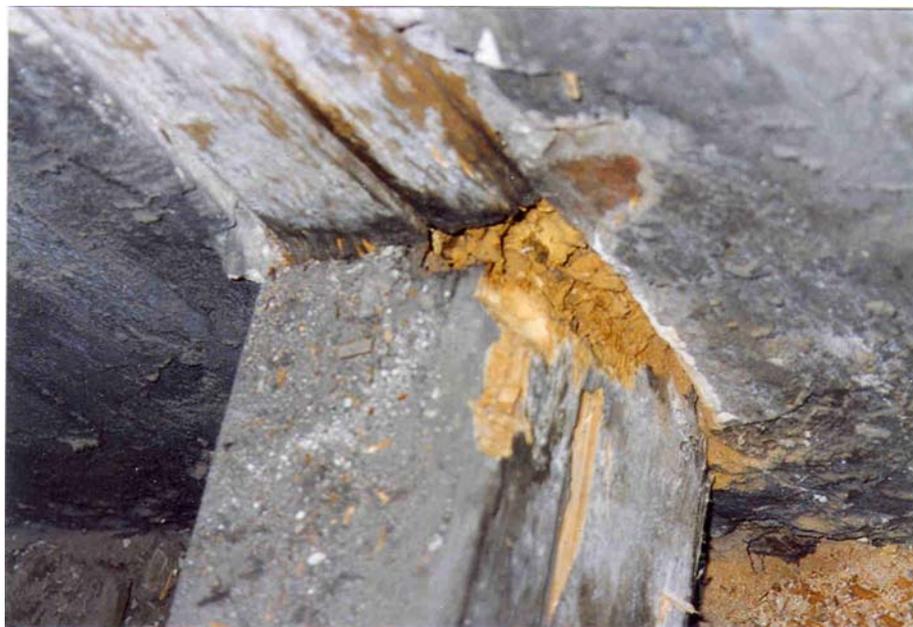
*Figure 6. Beam Head Failure*

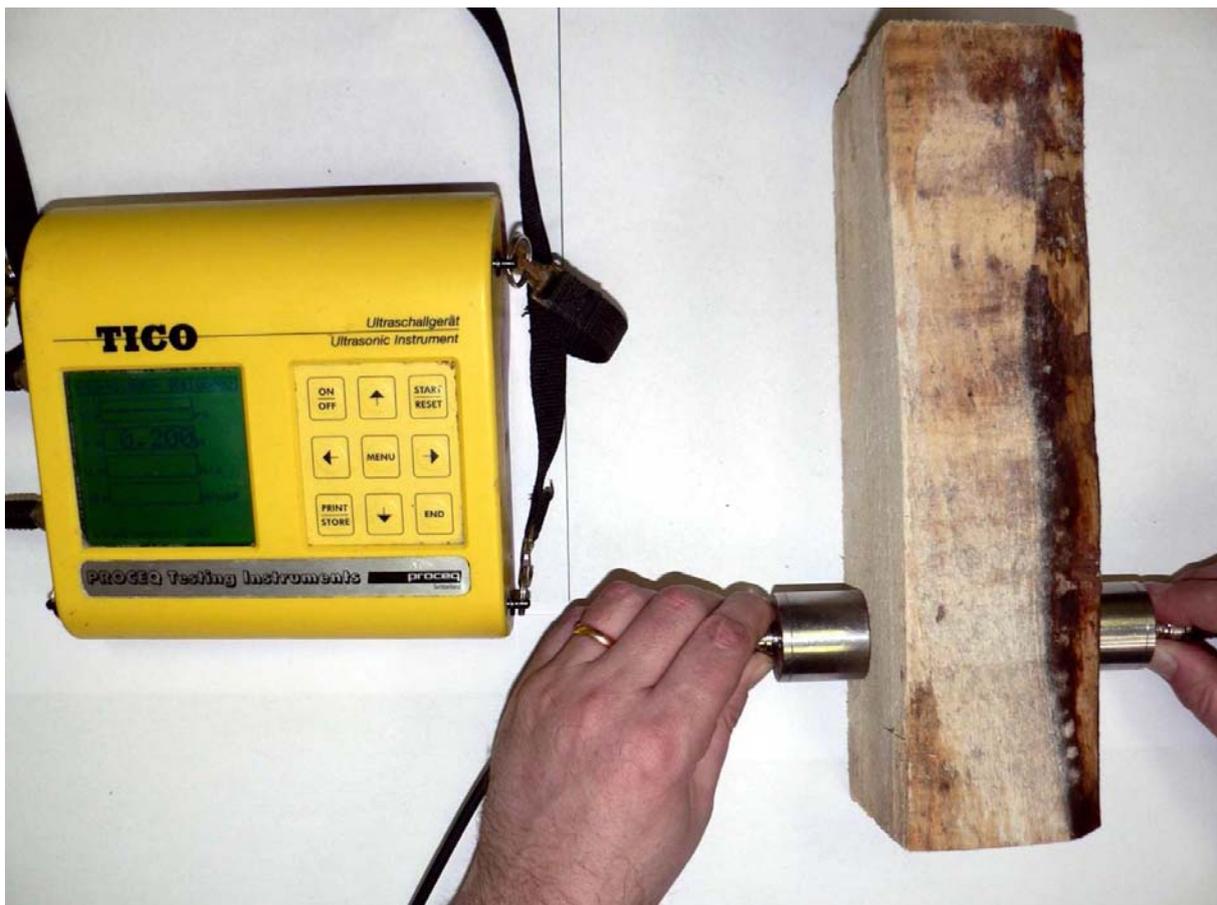
Figure 7. Measurement of Ultrasonic Pulse Transit through a Timber Element – Direct Transmission

- Ultrasonic pulse method – under constant measuring base, we analyze either difference in velocity of ultrasonic pulse velocity, or – directly – difference in transit time (constant measurement means the one differing up to 2 % from nominal measurement along whole length of the test specimen under examination). Exciter natural frequency: 82 kHz. Test specimens are measured through direct sounding – see Figure 7 – along with wood moisture measurement in test spots. Formula (1) is used to calculate ultrasonic pulse velocity as follows:

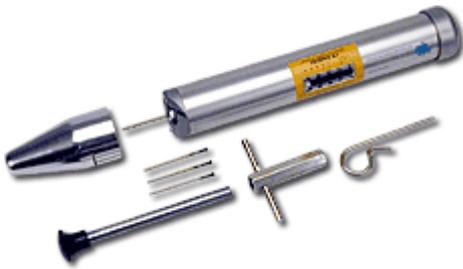
Figure 8. PILODYN Wood Tester

- Sclerometric method – to identify faulty timber elements, it is possible to use PILODYN 6J wood tester made by PROCEQ S.A. – see Figure 8. Its principle consists in driving of a steel impact pin into tested timber using defined power (6J). Penetration depth depends

on condition of wood under testing. We monitor penetration of steel impact pin into healthy wood as compared to the same into affected wood. In case calibration correlations for given kind of wood are at hand, we are able to deduce its strength taking into account appropriate non-destructive testing parameter.
