# THE MURAL PAINTINGS OF THE AJANTA CAVES, PART I: DOCUMENTATION ON EXECUTION TECHNIQUES AND CONSERVATION CONDITION

Annamaria Giovagnoli<sup>1</sup>, Francesca Capanna<sup>1</sup>, Marcella Ioele<sup>1</sup>, Anna Maria Marcone<sup>1</sup>,  
Emanuela Ozino-Caligaris<sup>1</sup>, Lidia Risotto<sup>1</sup>, M. Singh<sup>2</sup>

<sup>1</sup>Istituto Centrale per il Restauro – Piazza S. Francesco di Paola 9– 00184 Rome Italy

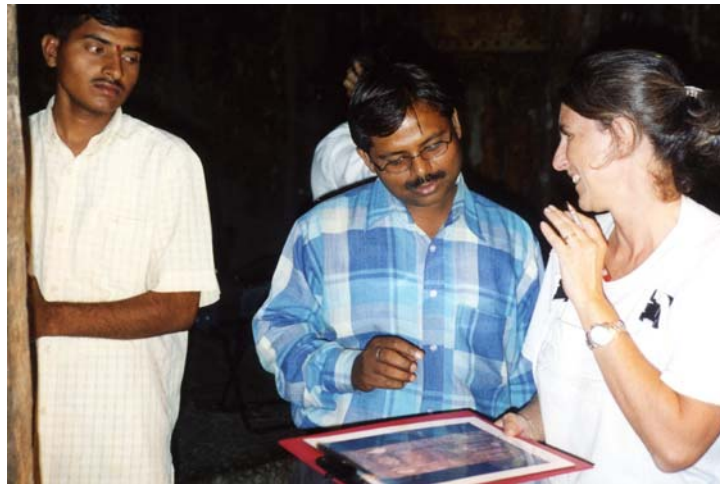
*Fig. 3 - Cave 17, Ajanta, Maharashtra, India*

The data presented is therefore provisional, with symbolic colours on acetate sheets placed over orthophotos, taken for this purpose by the photographer Edoardo Loliva, and on copies of line drawings done by Monika Zin and Matthias Helmdach and published in 1999 in the “Guide to the Ajanta paintings” available at the site. With this system, observations and recordings have been made together with the local experts who will now proceed to extend and complete the work already set in motion (fig. 3).

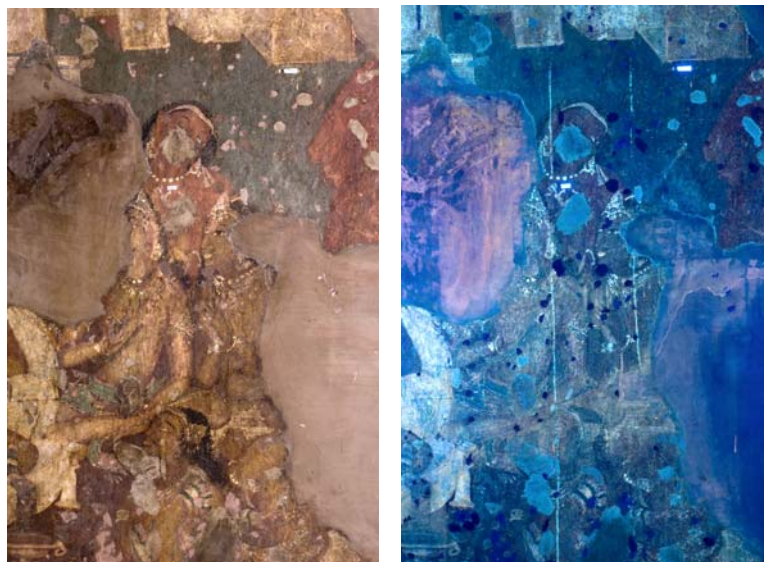
Among the data recorded through conservation data recording and theme-related mapping, one can still cite the example of cataloguing the fills of the lacunae. Correlating the data emerging from UV observation (Fig. 5), different types of mixture and different surface treatment solutions were actually observed and recorded, which indicates the succession of restoration treatments during which different principles of integration were applied.

Fig. 5 Cave 17, Ajanta, Maharashtra, India Visible and UV light.

It was possible to identify five different types of fill.

1. White-coloured rather fine-grained mortar that, according to local experts, is made with 'plaster of Paris' (calcium sulphate dihydrate). It has been used to fill the small and medium-sized lacunae and also for protecting the original fragile mortar along the edges of the lacunae prior to reintegrating those of medium and large dimensions with grey or

reddish mortars. Under UV light it produces a slightly bluish fluorescence that could be indicative of lime. It always appears under the other mortars leading one to believe that it was the first to be applied and must therefore date back to the treatment operation in 1920 by Cecconi Principe.

2. Reddish or grey-coloured mortar whose aggregate may be sand or powdered local stone, while the binder may be lime, gypsum or cement. Used for repairing medium and large-sized lacunae and for consolidating the visible edges. Under UV light it produces a pinkish fluorescence mainly distributed in the central zone and not at the edges with a circular striped pattern that suggests the brush application of a protectant. The chemical analysis of a drip stain from the same fluorescence associates it with the same class of products as shellac. One may hypothesize that also this dates back to the work carried out by Cecconi Principe, who may have chosen coloured mixes to fill the large lacunae and then applied shellac as a final protectant.

3. Pink-coloured mortar. Used for repairing lacunae in the perimeter fills carried out with the mortar described in point 2.
4. Brown-coloured fine-grained mortar, very similar to the original, used by the current team of restorers to integrate minor losses in the preparatory layers. Under UV light it produces no fluorescence.

Although it is not possible to establish a precise date for these retouchings, one can formulate hypotheses based on the observation of UV images. They were certainly carried out after the application of a transparent protectant (visible in the UV images as sizable drips with a pale yellow fluorescence), which though not analyzed is certainly different from the shellac that, as we have seen, produces a pinkish fluorescence. The retouchings appear on top of the drips interrupting the vertical path they leave on the wall. They are, however, earlier than the cleaning operations during which they were partially removed [6].

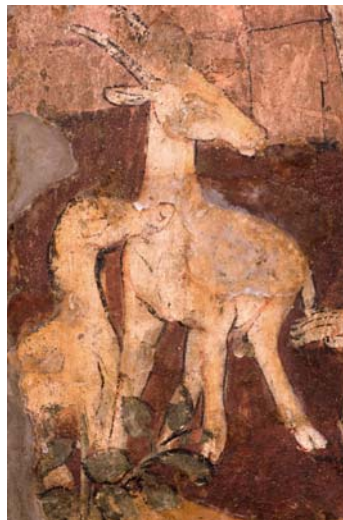
On the fills carried out with the mortar described in point 1, and perhaps on that indicated in point 4, chromatic surface treatments with covering or glazed colours are present at times. The treatment generally aims to reduce the disturbance in the reading of the pictorial text with a uniform application over the entire surface, although in some cases it may be considered in every respect a chromatic integration in tone (Fig. 6).

*Fig. 6 - Cave 17, Ajanta, Maharashtra, India - reintegrated fills*
