Atypical Applications of Ultrasonic Method in Testing of Concrete Structures

Jerzy HOŁA, Krzysztof SCHABOWICZ, Bohdan STAWISKI, Institute of Building Engineering, Wrocław University of Technology, Wrocław, Poland

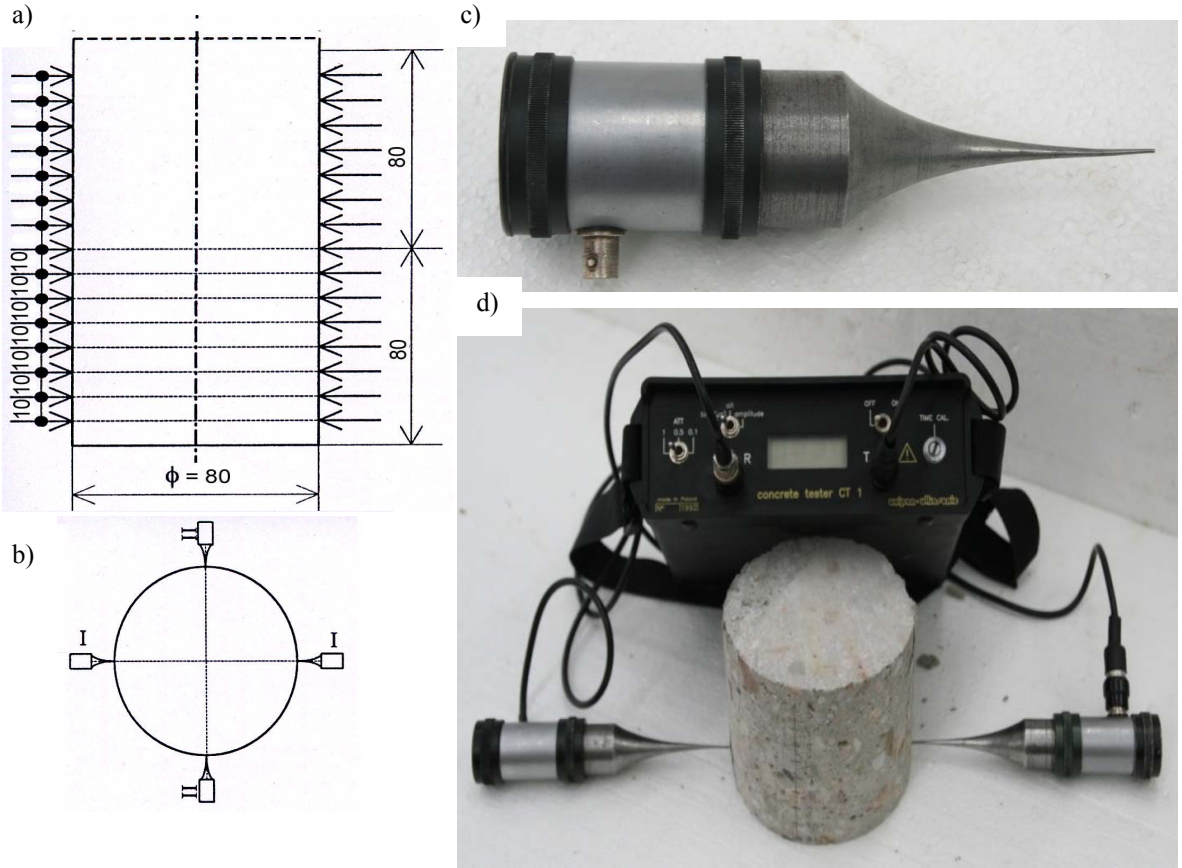
their diameter at the tip is 1 mm. The test consists in drilling cores 80 or 100 mm in diameter from a structural floor or an industrial floor. Then the cores are investigated by exponential ultrasound heads with a point contact with concrete [2, 3]. Thanks to this shape of the heads the distance between neighbouring measuring points can be small. The longitudinal velocity of the ultrasonic wave is measured in two mutually perpendicular directions in planes spaced at every 10 mm, as shown in fig. 1. Then one or two cylindrical specimens (with the height and the diameter approximately equal) are cut out from a core and crushed in a testing machine. In this way the correlation between longitudinal ultrasonic wave velocity C_L and tested concrete strength f_c is determined. Finally, the compression strength of the concrete in the core along the latter's thickness is determined.

Fig. 1. Measurement of longitudinal ultrasonic wave velocity by means of exponential heads: a) spacing of measuring points, b) investigation direction I and II, c) exponential head, d) view of measuring stand

For this purpose 3 cores 80 mm in diameter were drilled from the floor's part where the concrete was frozen and 3 such cores were drilled from the part undamaged by frost. The cores were investigated along their thickness by the ultrasonic method using exponential heads, as shown in fig. 1. The obtained longitudinal ultrasonic wave velocity distribution along the thickness of the monolithic layer is shown in fig. 2.

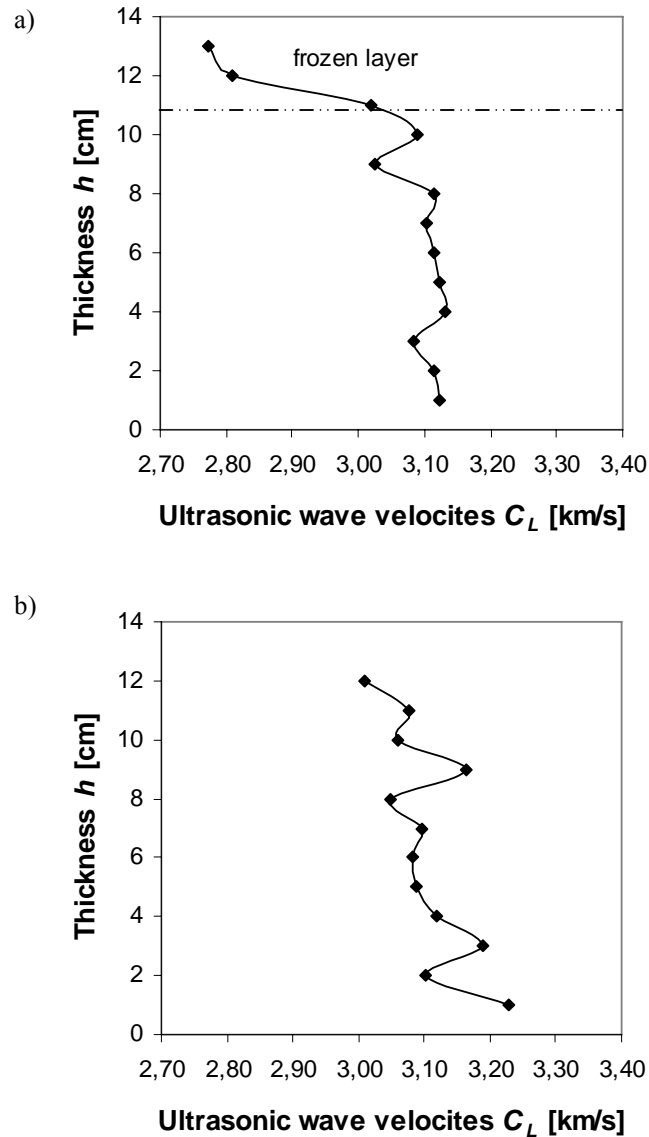
Fig. 2. Longitudinal ultrasonic wave velocity distribution along monolithic layer thickness for: a) part of floor where concrete was frozen at an early stage of curing, b) part of floor with concrete undamaged by frost

Both the frost-damaged concrete and the undamaged concrete are characterized by a similar ultrasonic wave velocity graph shape, but the frozen concrete (fig. 2a) shows a much lower ultrasonic wave velocity (considerably below 3.0 km/s) in the top layer. For comparison, the ultrasonic wave velocity in the top layer of the concrete not damaged by frost is 3.05-3.10 km/s. According to fig. 2, the layer of concrete damaged by frost is about 30 mm thick, which is marked in fig. 2a.

The distribution of longitudinal ultrasonic wave velocity along the floor’s thickness is shown in fig. 3a while the distribution of concrete strength in this floor, determined from the hypothetical relation, is shown in fig. 3b. It becomes apparent that the longitudinal ultrasonic wave velocity distribution in fig. 2b is similar to that in fig. 3a. This confirms that the top monolithic layer of concrete is damaged to a depth of about 30 mm, as shown in fig. 2a.

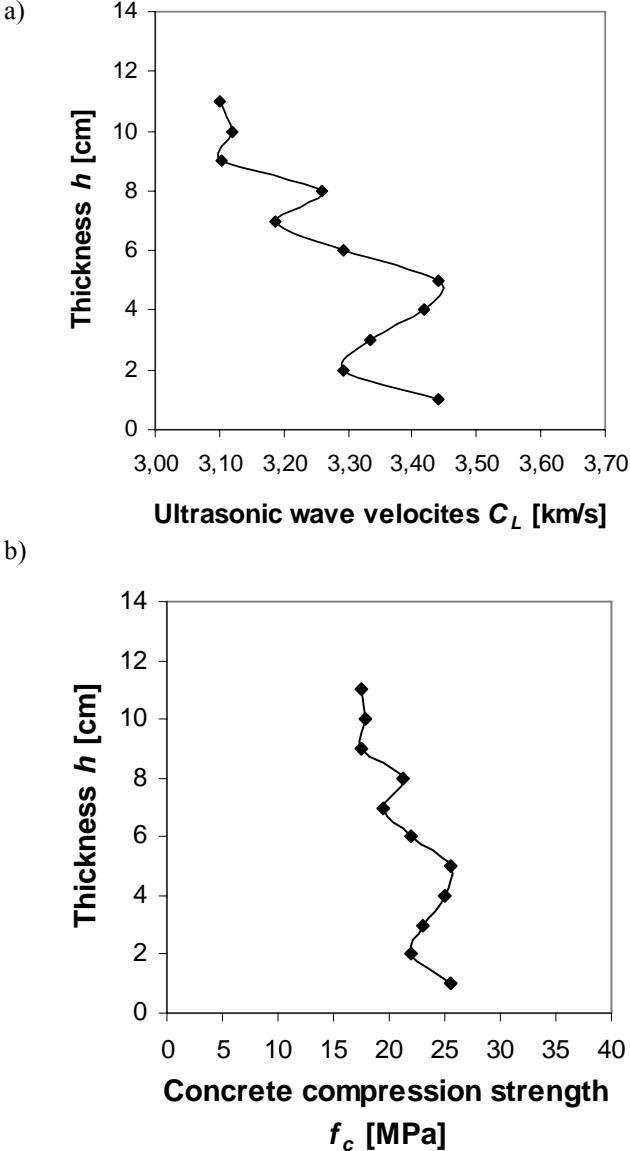
Fig. 3. Distribution of: a) longitudinal ultrasonic wave velocity and b) concrete compression strength along thickness of floor made a few weeks earlier

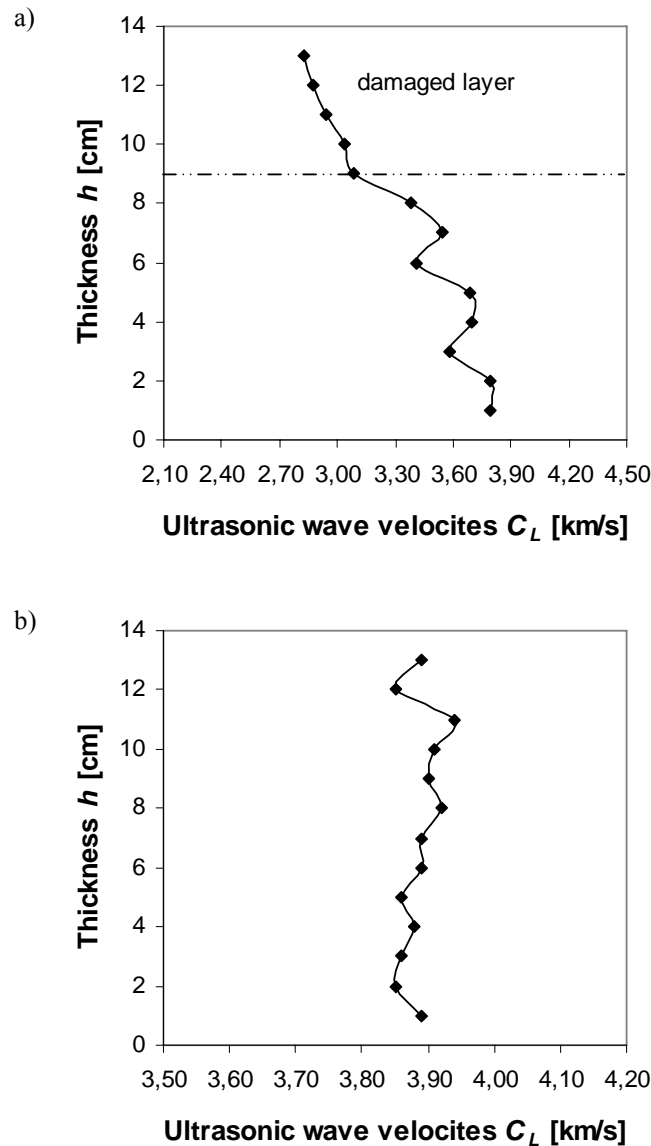
Fig. 4. Longitudinal ultrasonic wave velocity distribution along floor thickness for: a) floor in first hall, b) floor in second hall

The two graphs shown in fig. 4 have similar shapes, but the damaged concrete (fig. 4a) is characterized by a much lower ultrasonic wave velocity in the top layer – considerably below 3.0 km/s. This indicates that the top layer may have lower strength than the bottom one, which means that it was not made properly. For comparison, the longitudinal ultrasonic wave velocity in concrete in the undamaged floor's top layer (fig. 4b) is 3.80-3.90 km/s. According to fig. 4, the damaged layer is about 40 mm thick, as marked in fig. 4a.

The floor in one production hall showed numerous cracks while in the other production hall situated nearby, the floor, made of the same material, was undamaged. In order to determine the causes of the damage, three cores (80 mm in diameter) were drilled from each of the floors. The cores were investigated using the ultrasonic method according to the procedure described in pt. 2. Sample diagrams showing the longitudinal ultrasonic wave velocity distribution along floor thickness are presented in fig. 4.

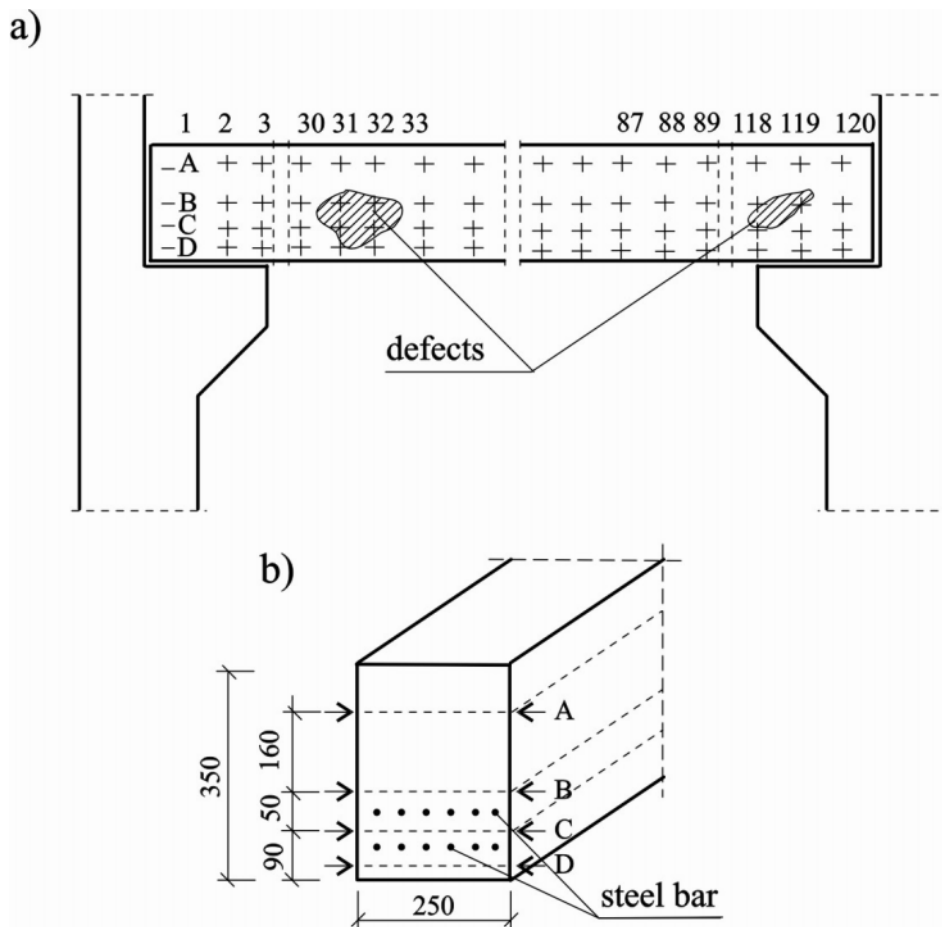
The investigations were carried out as follows. Measuring points, spaced at every 50 mm in four planes: A, B, C and D, were marked on the girders, as shown in fig. 5. Then a Fe-meter was used to nondestructively localize the reinforcement bars in the girders. Exponential heads were used for ultrasonic testing. The tests were conducted across the girders. The determined longitudinal ultrasonic wave velocities are shown in fig. 6 where the X-axis runs along the beam's length.

Fig. 5. Procedure for ultrasonic investigation of reinforced concrete girders aimed at detecting large air voids and caverns: a) girder with marked measuring points and places where defects were detected, b) cross section of girder

Areas in which the recorded velocity would be significantly lower than the average determined for flawless concrete were sought. In planes B and C, among others in the regions of measuring points 30 to 33 and 118 to 119, material defects in the form of large air voids were detected, as shown in fig. 5a.

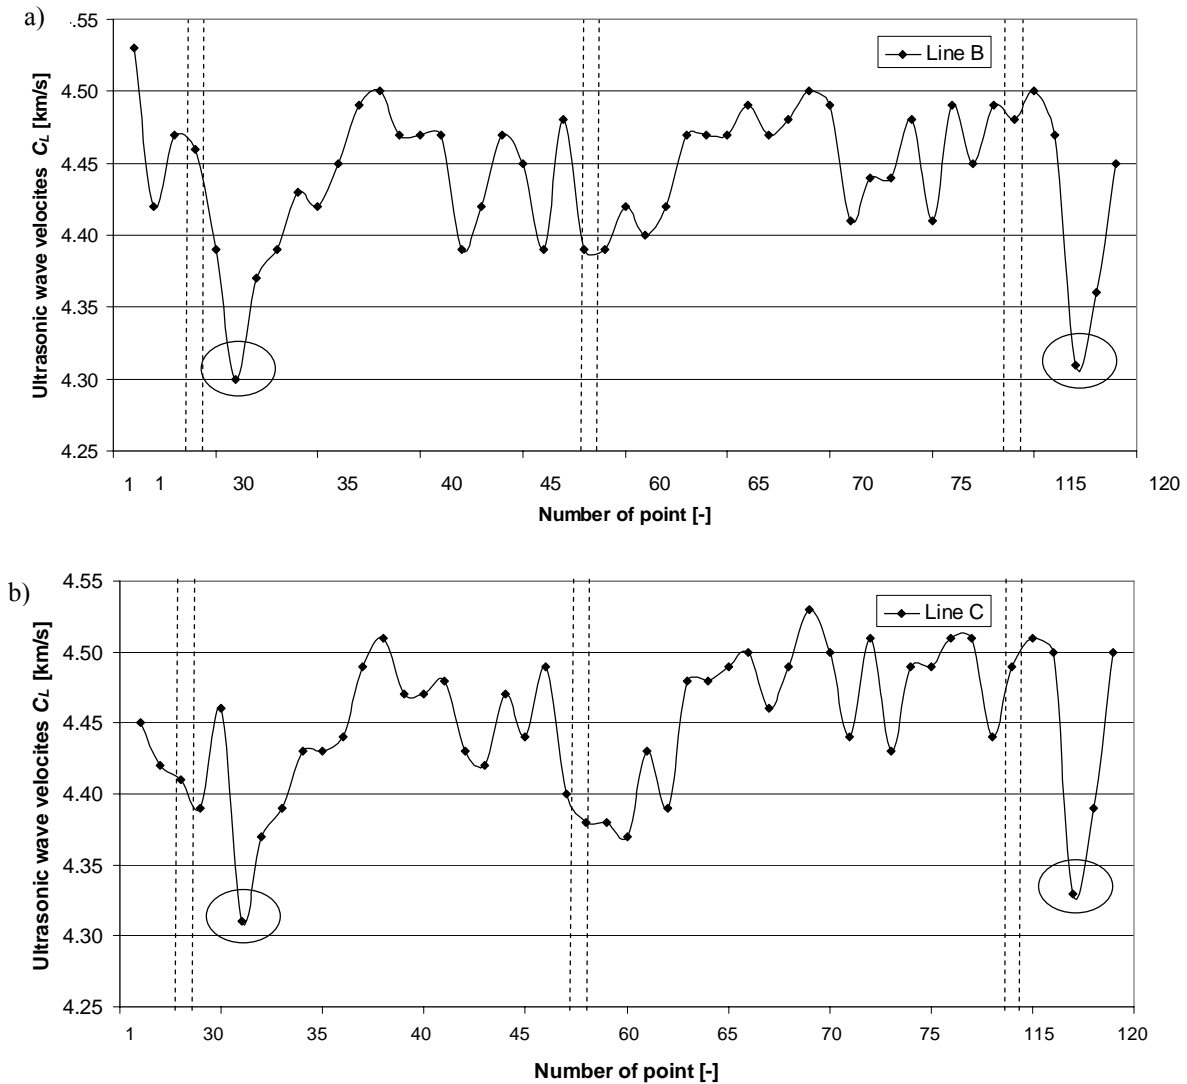
Fig. 6. Diagrams of longitudinal ultrasonic wave velocity in tested section of reinforced concrete girder: a) plane B, b) plane C
