Laser-Based Non-Destructive Detection of Inner Flaws in Concrete with the Use of Lamb Waves

Oleg KOTYAEV, Yoshinori SHIMADA, Kazuhisa HASHIMOTO, Institute for Laser Technology, Osaka-fu, Japan

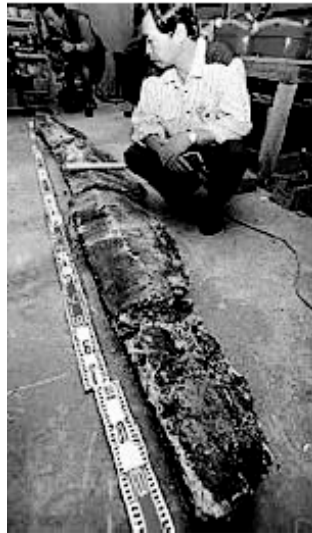
Fig. 1. A giant concrete chunk fell from the wall of a tunnel.

Accident prevention is one of the most important conditions of providing safe transportation. However, in spite of taking safety measures, sometimes accidents happen suddenly. In October 1999, Mainichi Shimbun (Tokyo) reports a giant 226-kilogram concrete chunk fell from the wall of a tunnel on the Sanyo Shinkansen Line, stopping bullet train services on the line and stranding thousands of passengers. The original block was 3.3 meters long, 40 centimeters wide and 15 centimeters thick (Figure 1). Fortunately, there was no train that time in the tunnel. No one was injured and nothing else was damaged. However, this fact shows that it is impossible to guarantee 100% safety in bullet train transportation. After the accident, the JR West Company inspected 142 tunnels and found 2,049 points with faults where concrete was not properly attached to the tunnels.

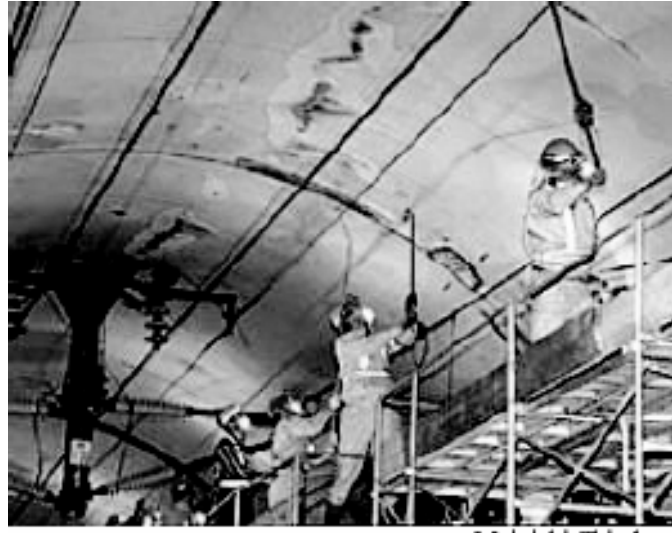
Fig. 2. The JR West Company inspected 142 tunnels and found 2,049 points with faults.

Development of reliable inspection technique still remains one of the most important tasks. The JR West tunnels were inspected with the use of conventional contact methods like hammering and piezo-sensing (Figure 2). However, it is believed that there exists more promising technique: laser based inspection can provide real remote inspection with acceptable sensitivity, insensibility to surface roughness and high operation rate.

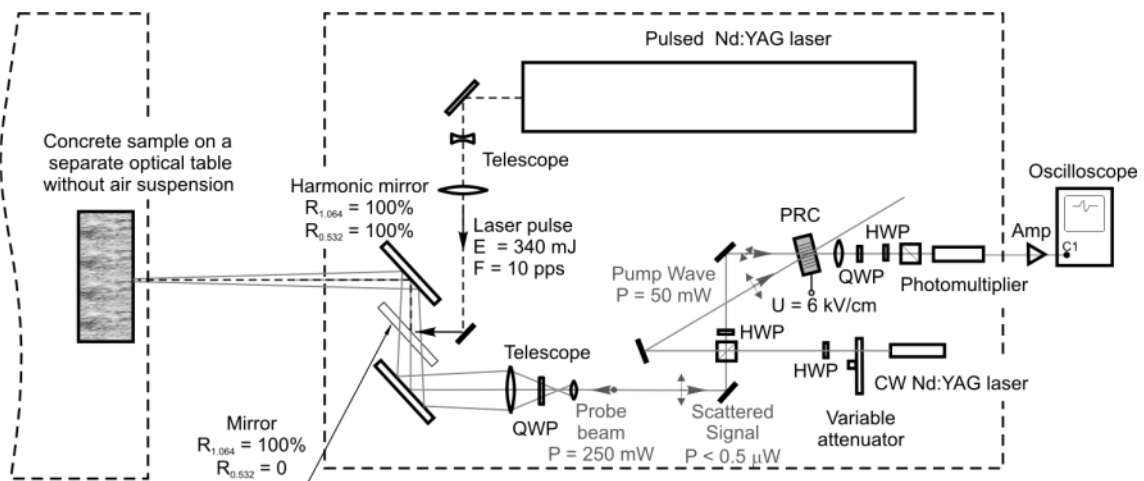
Fig.5. Schematic diagram of laboratory experimental setup.
 PRC – photorefractive crystal, QWP and HWP – quarter- and half-wave plates.

Schematic diagram of the experimental setup is shown in Figure 5. Pulsed Nd:YAG laser produces laser impact beam. In the experiments, the weak ablation mode of laser impact is used. Impact energy is 340 mJ. Impact beam size is about 4 mm, producing laser peak intensity of 270 MW/cm^2 . Pulse repetition rate is 10 pps. To average the recorded waveform and increase signal-to-noise ratio (SNR), 15÷50-shot series are used.

A CW Nd:YAG laser at the second harmonic is used for detection of initiated Lamb waves. Output radiation is split into two beams: the pump beam with power of 50 mW and the probing beam with power of 250 mW. Probing beam is focused on the sample surface. Power of radiation scattered by concrete and used as a working signal does not exceed 0.5 μ W.

The pump beam and scattered signal record a dynamic hologram in the BSO photorefractive crystal (PRC) and produce the homodyne signal which is detected by a photomultiplier tube and analyzed by an oscilloscope. The PRC is used in the drift mode. Applied electric field strength is 6 kV/cm.

In the experiments, the surface of concrete samples is scanned by impact and probing beams. Direction of both beams is controlled by a single harmonic mirror simultaneously. Distance between impact and probe beams is 5 mm. Both beams scan the surface of a sample from its center to edge with 1 cm steps.

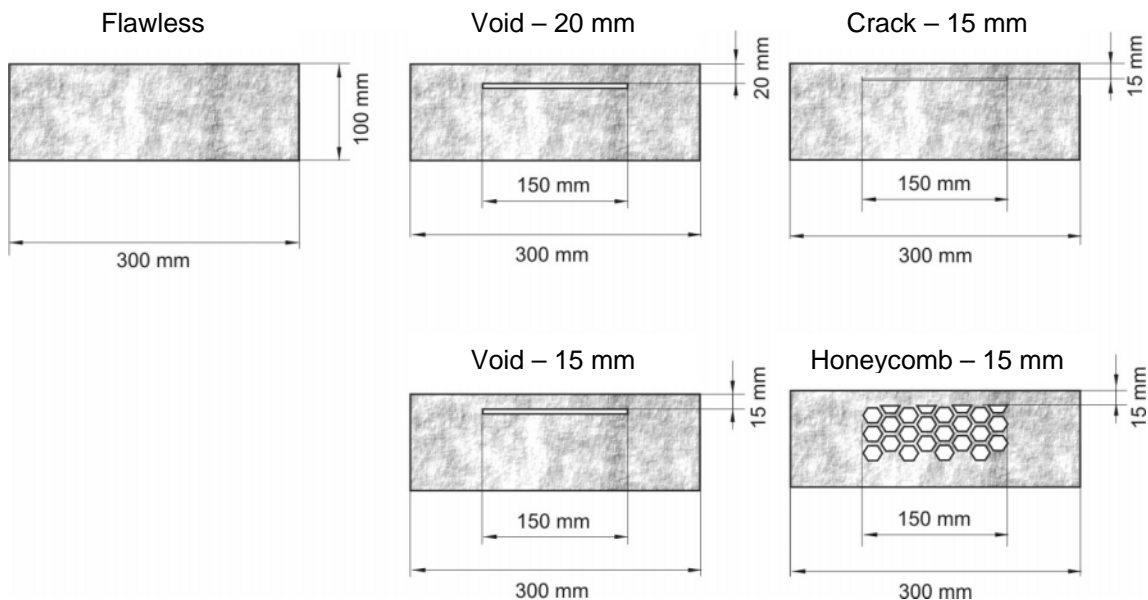
Fig.6. Details of the concrete samples.

The samples used in the experiments are made form concrete which is actually used in the transportation tunnels in Japan. We have ordered from JR West Company five samples with different defects (Figure 6). All of the samples are 30×30×10 cm concrete plates. One sample has no defect inside. And four samples have inner void, crack and honeycomb defects.

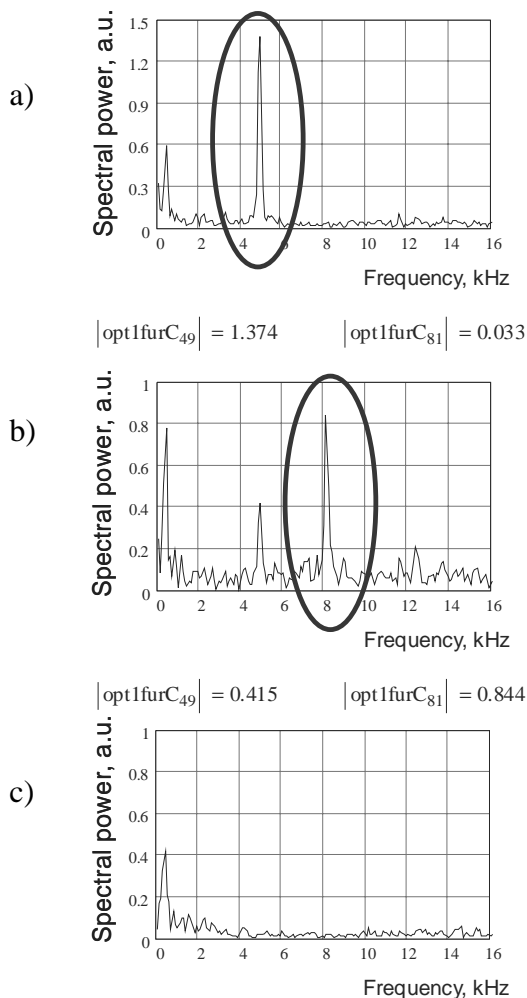
Fig. 8. Sample with the honeycomb defect (15×15 cm, depth – 15 mm). a) impact/probe position: the sample center – the first harmonic (4.9 kHz) is dominant; b) impact/probe position: 4 cm from the sample center – the second harmonic (8.1 kHz) is dominant; c) impact/probe position: 11 cm from the sample center – no detectable Lamb wave is observed.

Inspection of the defected samples has revealed the different responses. Figure 8 shows typical spectra obtained in the defected samples. The scanning of each sample

surface results in initiation and detection of various modes of Lamb waves. For example, in the sample having a honeycomb defect (Figure 8), central impact/detection position produces the first harmonic of standing Lamb wave (4.9 kHz – Figure 8-a). Moving impact/detection position away from the sample center leads to gradual decrease of the first harmonic power and increase of the second harmonic power. The most powerful second harmonic is initiated when impact/detection position is located in the middle between sample center and the defect edge – about 4 cm from the sample center. Figure 8-b shows that in this position the second harmonic (8.1 kHz) is dominant. When the scanning reaches the defect edge (7.5 cm from the sample center), detectable Lamb waves are no longer initiated. Figure 8-c shows the result of detection when impact/probe position is located over no-defect area: 11 cm from the sample center – no detectable Lamb wave is observed.

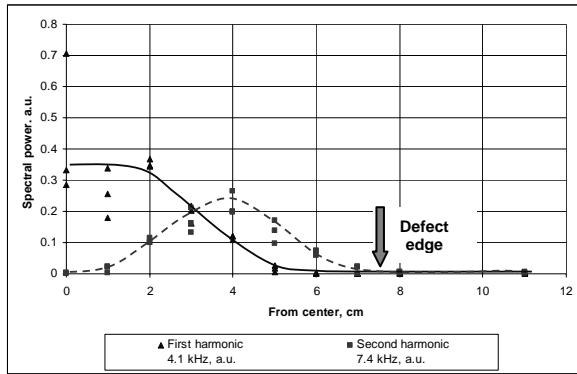
Fig. 9. Sample with the VOID (depth – 20 mm). Detection accuracy is about 1 cm.

The results of the scanning of the defected samples are presented in Figures 9 ÷ 12. Each figure shows the distribution of Lamb wave spectral power over sample surface when scanning from its center towards its edge. Solid lines represent the first harmonics, dotted lines – the second harmonics.

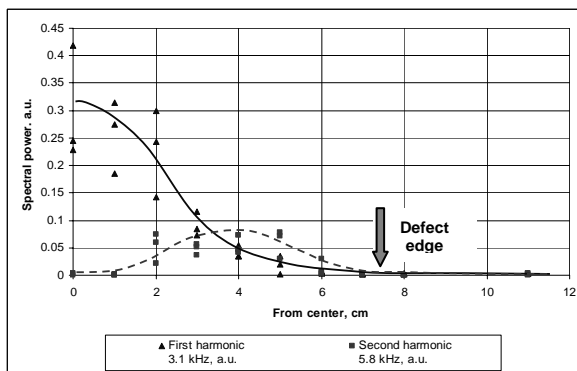
Fig. 11. Sample with the CRACK (depth – 15 mm). Detection accuracy is about 2 cm.

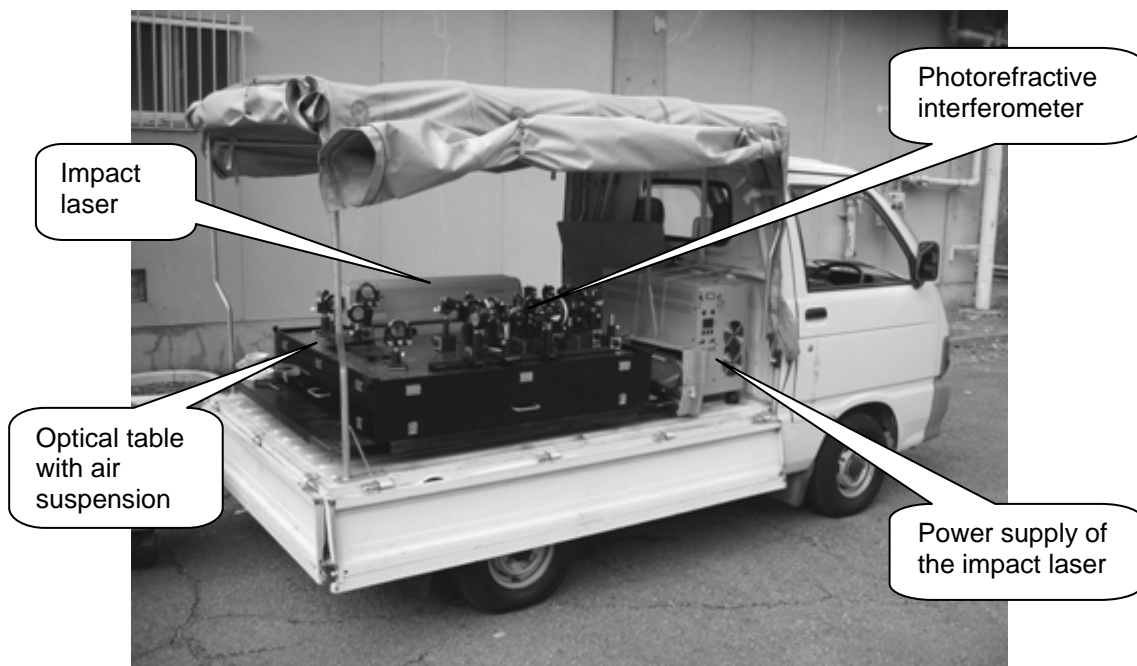
Fig. 14. The laser system is loaded on a small track.

The mobile prototype of the laser-based system for non-destructive testing of concrete walls was assembled and loaded on a small track (Figure 14). Overall dimensions of the loaded system did not exceed $1 \times 1.5 \times 0.5 \text{ m}^3$. The system was equipped with air-suspension and covered by a plastic box (shown in Figure 15).

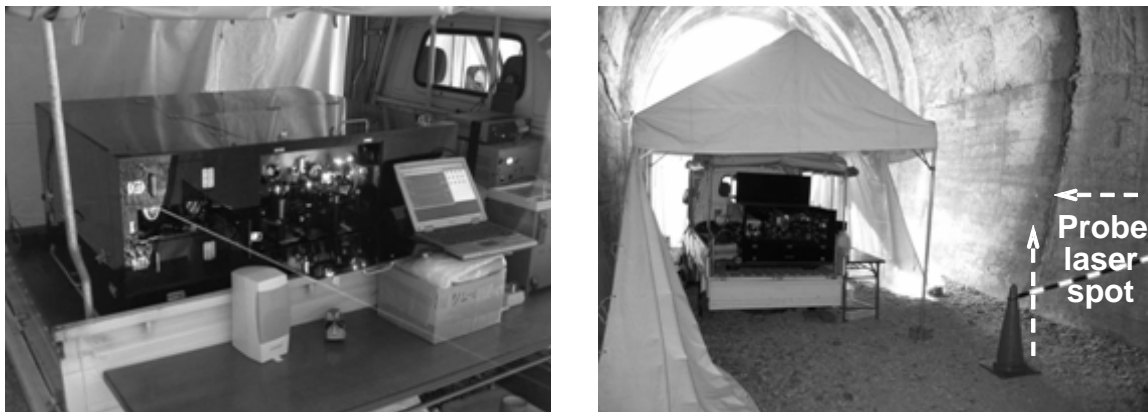
Fig. 16. The system is on operation.

The operating system is shown on Figure 16. The tent walls have been removed and the box doors have been opened just to get these pictures. The probe beam is clearly seen on the left picture. On the right picture, bright spot on the wall corresponds to current impact/detection position.

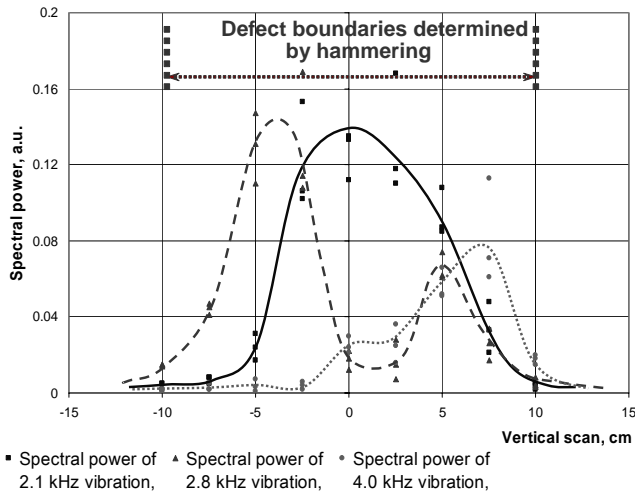
Fig. 18. The defect area – vertical scanning. Distribution of spectral power Lamb wave over the sample surface. The inner flaw can be detected with accuracy of 1.5 cm.

directions. The vertical distribution of spectral power of three modes of standing Lamb wave is shown in Figure 18: solid line represents 2.1 kHz mode, dotted line – 2.8 kHz and punctual line – 4 kHz mode. The total area covered by the spectral power distribution corresponds to the defect area determined by light hammering. Accuracy of detection using these three modes is about 2 cm. However, in reality, detection will not be limited by three first modes. Figure 17-c shows that the defect can be detected using higher mode of Lamb wave even in the area where light hammering is not sensitive. It should be noted again, only the presence/absence of detectable Lamb wave can be a criterion of quality, no matter what mode of Lamb wave is initiated.
