MONITORING OF GAS TURBINE OPERATING PARAMETERS USING ACOUSTIC EMISSION

R M Douglas, S Beugné, M D Jenkins, A K Frances[¶], J A Steel, R L Reuben and P A Kew.

School of Engineering and Physical Sciences, Heriot-Watt University, Edinburgh, UK.

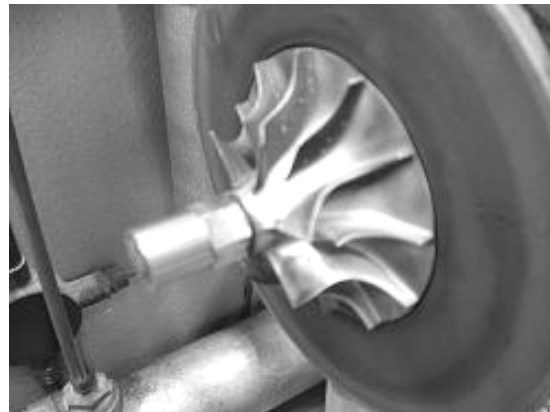
Figure 4: Gas generator compressor impeller.

Blade damage was simulated in two opposing blades of the 10-blade free-power turbine impeller by rounding the sharp corner off first to a radius of 4mm and then running the turbine again under the previous conditions. Thereafter, 4mm incremental increases of the radius were applied, an example of this induced damage being shown in Figure 3. The impeller itself had a maximum diameter of approximately 90mm. The gas generator compressor impeller, shown in Figure 4, was of different construction, consisting of 6 inner and 12 outer blades.

for each record at around 12 times the shaft speeds identified in Figure 6a. The gas generator compressor impeller consists of 12 outer blades and therefore it is not unreasonable to conclude that the turbulent interaction of the airflow and each of the impeller blades is represented in the AE. This feature was also evident, and somewhat clearer, from data acquired at the backplate of the gas-generator compressor impeller, sensor position A. It should be noted that a plain bearing supports the gas generator common shaft and that the AE records were of the type shown in Figure 5a.

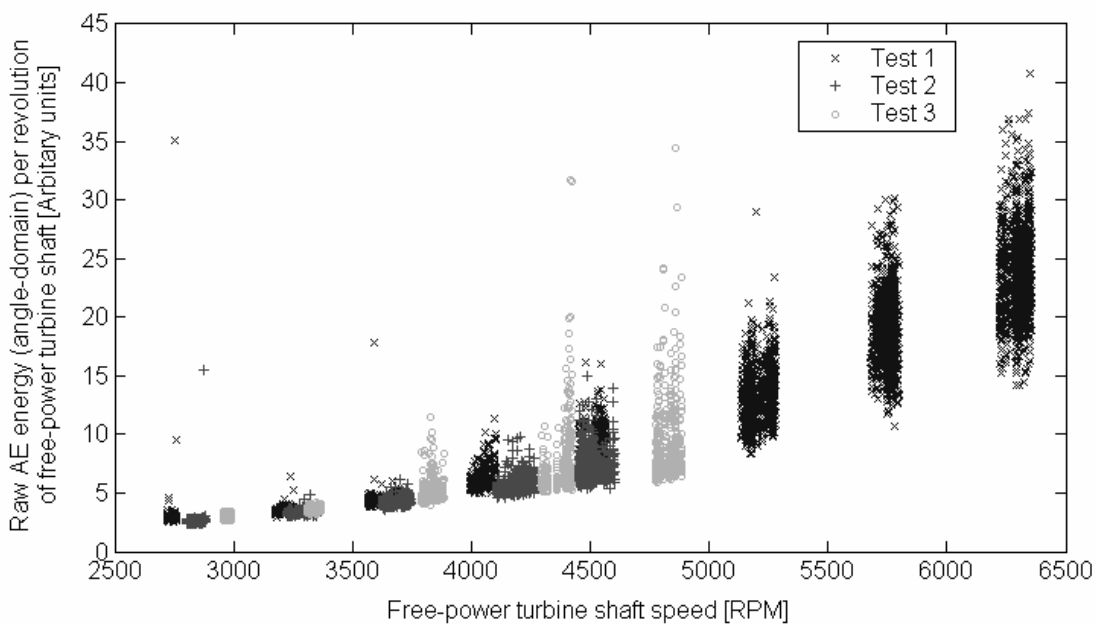
Figure 7: Increasing AE energy content with increasing shaft speed

Figure 7 shows the results from 3 separate test runs in which the relationship between free-power turbine shaft speed and AE energy per revolution of the free-power turbine was investigated (the range of gas generator shaft speeds varied from 50,000 to 67,500 RPM). Data were acquired from the waveguide, sensor position C, and were predominately of the type described in Figure 5a, except for a few records which showed isolated bursts of the type seen in Figure 5b. These occasional events account for the outlying points seen in Figure 7 and also a few additional points that are not shown in Figure 7 up to a value of 150.

It is clear that there is a relationship between the shaft speed/power output and the AE energy per revolution of the free power turbine shaft. A similar relationship could have been constructed with the energy per revolution of the gas generator shaft since, in these tests, the free-power turbine speed was dependent upon the gas generator shaft speed. Indeed, the background AE energy may be attributable to a number of sources from both turbines, notably fluid flow; exhaust gas and blade turbulence, and also bearing-related sources. All these mechanical or fluid events would be expected to increase in intensity with increasing speed/power output of the turbine unit and hence the trend seen in Figure 6 for the background type AE records can be considered to be that produced by normal operation of the turbine unit.

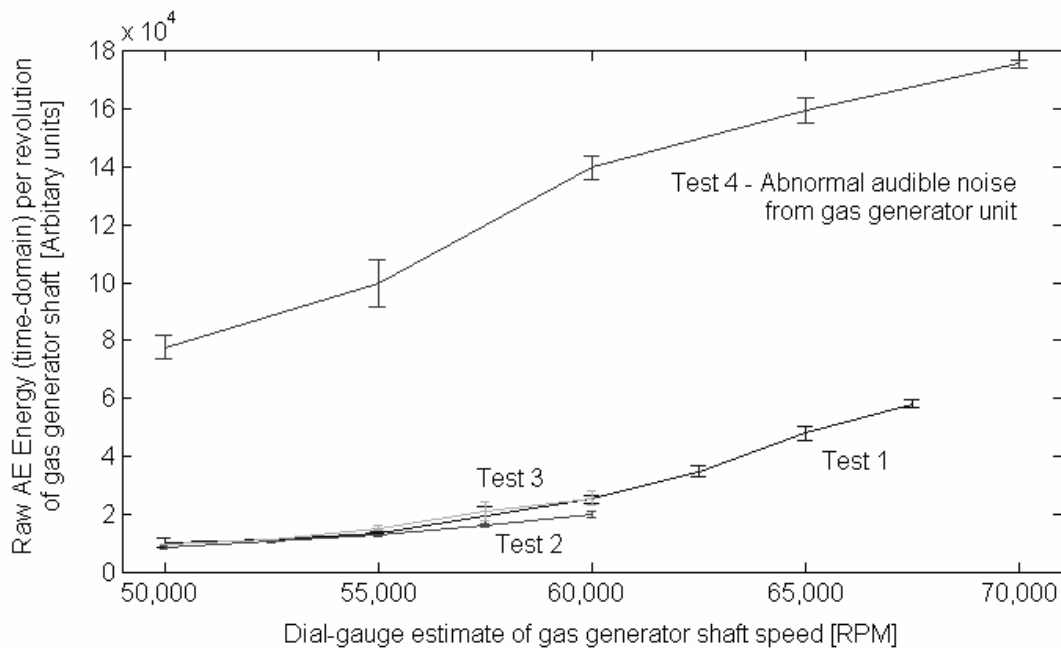
Figure 8: Effect of further AE source from gas generator turbine unit, indicative of abnormal running conditions

The results of a further test, test 4, are shown in Figure 8 together with the results previously given in Figure 7, for tests 1, 2 and 3. The data in this case is presented as AE energy in the time-domain per revolution of gas generator shaft against estimated gas generator speed. During this test, an audible noise was heard to originate from the gas generator area and the AE acquired was of the nature exhibited in Figure 5b. The results indicate a similar trend to that established in Figure 7 but with increased AE energy levels. The precise mechanical or fluid origin of this increased AE is unknown at present, but is almost certainly related to the audible noise from the gas generator area and indicative of rubbing, either within the bearing or between the turbine or compressor impellers and their respective housings.

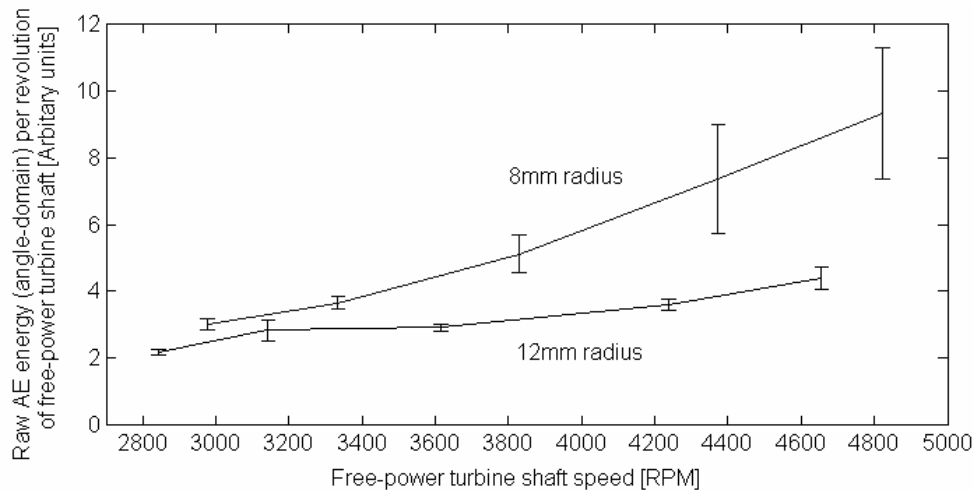
Figure 9: Effect of simulated damage to blades of free-power turbine

Blade tip degradation was simulated by applying a radius to the originally sharp edges of two opposing blades of the free-power turbine impeller (see Figure 3a). The results of running the turbine over a range of gas generator speeds where 8 and 12 mm radii were applied are shown in Figure 9, AE observed during these tests being of the type described in Figure 5a. The reduced levels of AE energy associated with the larger fault radius may be due to the fact that with a larger gas-leakage area, i.e. the 12mm radius, the gas-leakage velocities, assuming a constant flow-rate, will be reduced and hence less AE generated.
