## Comparison of Infrared Thermography with Ground-Penetrating Radar for the Non-Destructive Evaluation of Historic Masonry Bridges

by S. Lagüela\*, M. Solla\*, J. Armesto\* and H.González-Jorge\*

\*Photogrammetry and Remote Sensing Research Group, Mining Engineering Technical School, University of Vigo, Campus Lagoas – Marcosende, Rúa Maxwell s/n – 36310 Vigo, Spain, <susiminas, merchisolla, julia, higinio@uvigo.es>

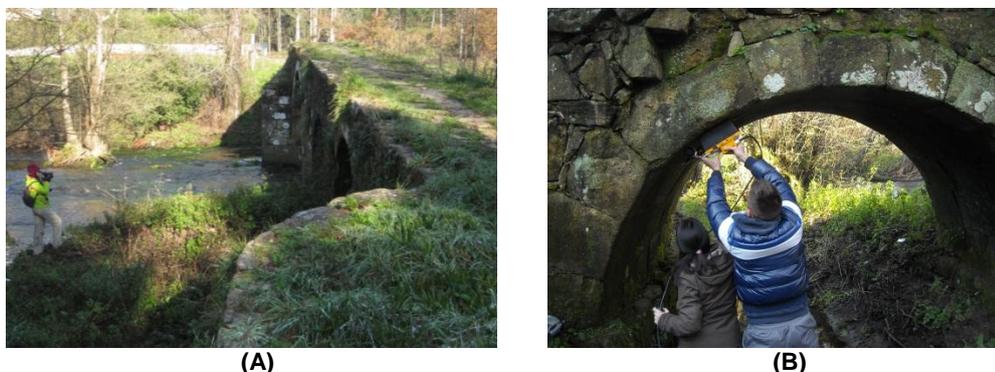
Fig.1. Thermographic survey on the first arch upstream (A) and GPR survey over the vault of the same arch (B)

The average working distance between the camera and the bridge was 5m, as shown in figure 1A, and environmental conditions were 10°C and 40% relative humidity. Emissivity corrections were also considered, by applying to the radiation captured by the camera an emissivity value of 0.80. This value is obtained through the performance of an emissivity test in situ following the standard [14].

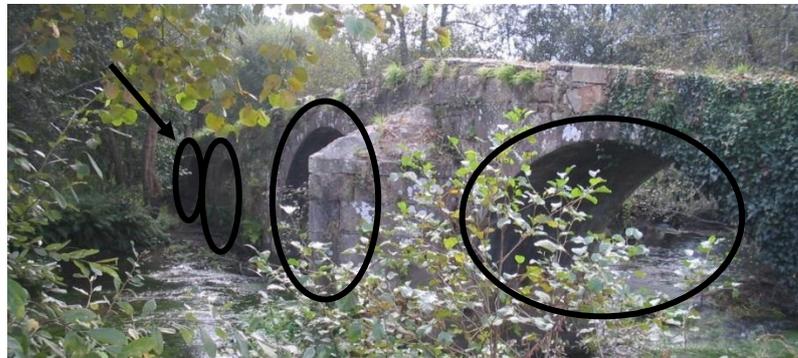
**Fig.2.** Side view of the Lubiáns Bridge, with its four arches highlighted by black circles. The arrow points the arch subject of deeper study due to a previous detection of moisture in it.

The thermographic and GPR surveys were developed in the Lubiáns Bridge, located in the municipality of Coristanco, in Galicia (Northwest of Spain). This bridge goes over the Anllóns River, and has been classified as "of historical interest" because of its Roman origins and the later reconstruction it was subjected to in the Medieval Age, when the round vaults were built. The bridge is constituted by 4 asymmetrical round arches, with a cutwater in their central part. The material used is granite, rock that has been extensively exploited through history in the region given its local nature. The deck is formed by granite flags and presents no side protection. A view of the bridge is shown in figure 2, where the four arches are highlighted by black circles, and the arch subject of deeper study is marked with a black arrow. The dimensions of the bridge are 40.5m long, 5.40m high and 2.60m wide, being the narrowest bridge in the region.

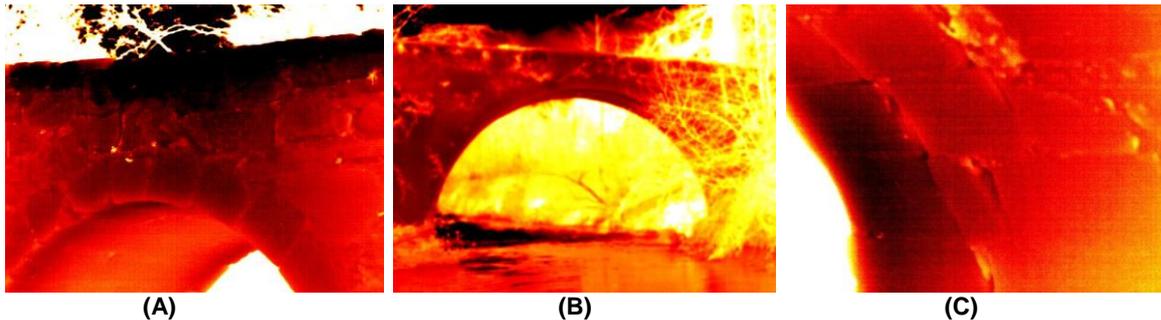
**Fig.3.** Example of thermographies acquired from the walls of the bridge downstream (A) and upstream (B), and of the inner part of the vault of the first arch upstream (C). The colour palette applied goes from 6°C (dark red) to 12°C (white).

The thermographic survey included the walls of the bridge, both for the upstream and downstream side, and also the inner part of the vault of the arch under deeper study. An example of the thermographies acquired is shown in figure 3.

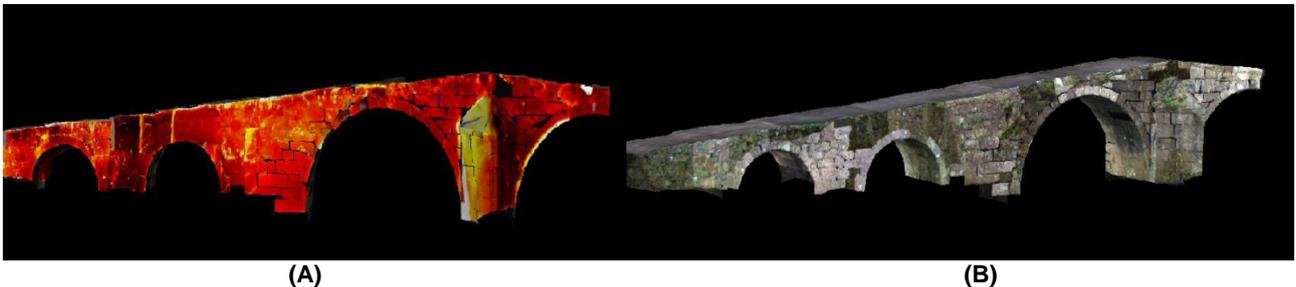
**Fig.4.** Upstream view of the thermographic 3D model (A) generated through the registration of thermographic images in the photogrammetric 3D model of the bridge (B).

Given the small field of view of the thermographic camera used for this study, the 3D model reconstruction of the bridge was accomplished by means of terrestrial photogrammetry, as performed in [16]. Consequently, images taken from different points of view of bridge's structure were used to build the 3D model. The 3D model was completed through the union of several "models" or portions. Each individual model was constituted by three or four pictures taken from different points of view with a convergence angle of approximately 90°, using a digital camera Nikon D200 that had been geometrically calibrated by using the procedure explained in [16]. The whole photogrammetric processing was carried out through the low cost photogrammetric workstation Photomodeler Pro®. First, camera calibration was performed with the same settings during data acquisition and then, all images were oriented in a common coordinate system, thereby producing a 3D model of the whole structure, as shown in figure 4B.

Then, each thermographic image was registered with the 3D model through the marking of at least 6 corresponding points between each thermography and the model. This way, the thermographic texture could be applied to the 3D model, as shown in figure 4A. The thermographic 3D model allows the thermographic interpretation of the bridge as a whole, facilitating, for example, the identification of the arch with more humidity, since it appears as having lower temperature.

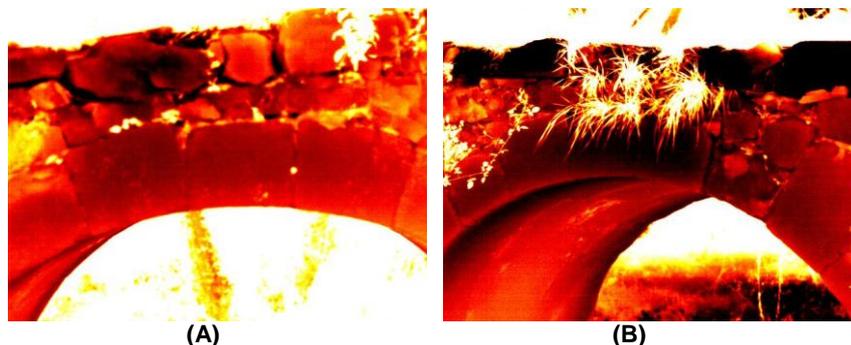
**Fig.5.** Thermographies of the first arch looking upstream (A), and downstream (B).

The thermographic study is performed on the thermographic 3D model of the bridge, as mentioned before, due to the possibility of analysing the whole bridge in the same image, or each arch independently. The direct performance of these studies on the thermographies is not possible due to their small field of view. As can be seen in figures 5 and figures 6, the thermographic resolution is the same in both thermography and orthothermogram, but on the first one only the upper part of the arch can be studied, whereas on the second the whole arch can be analysed.

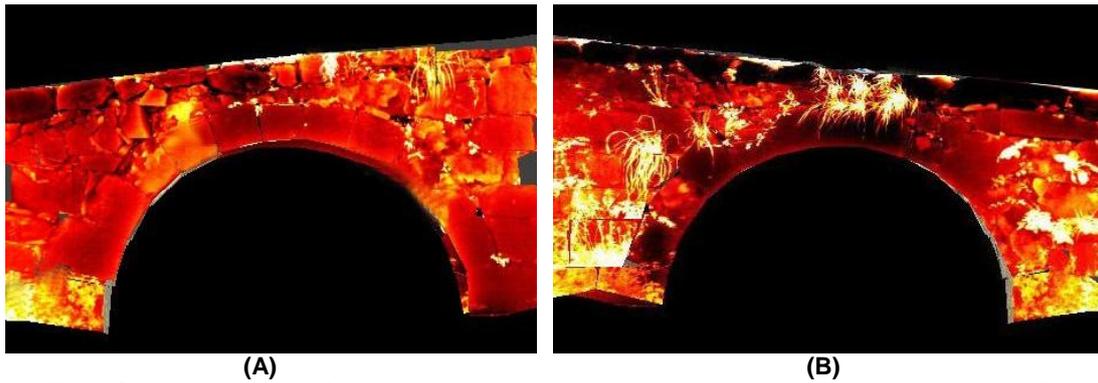
**Fig.6.** Orthothermogram of the walls of the arch under study, upstream (A) and downstream (B).

An analysis of the orthothermogram of the upstream wall of the arch (figure 6A) leads to the detection of moisture in the central part of the arch, and near the border with the pathway. This water content becomes more evident in the downstream wall of the same arch (figure 6B), where water can be detected all around the arch in spite of the presence of a large quantity of vegetation hiding part of the faults. From a different point of view, warm temperatures appear in those areas covered by vegetation, which grows mainly in the joints between rocks.

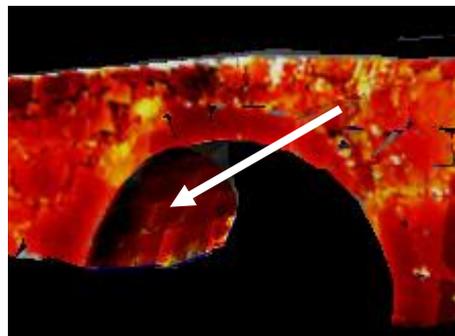
**Fig.7.** Detail of the thermographic 3D model, focusing on the vault of the arch under study. The white arrow highlights the presence of water detected due to the considerable reduction in the temperature value in comparison with the rest of the vault.

Regarding the vault of the arch under study, the thermographic 3D model shows a more critical presence of water at the edge of the vault, towards the face of the upstream wall. This water content can be seen through the low temperatures appearing as a black red region, marked with a white arrow in figure 7. The walls of the vault were also orthogonally projected to a plane parallel to their main direction in order to obtain orthothermograms, shown in figure 8, where geometric measurements can be performed together with thermographic studies.

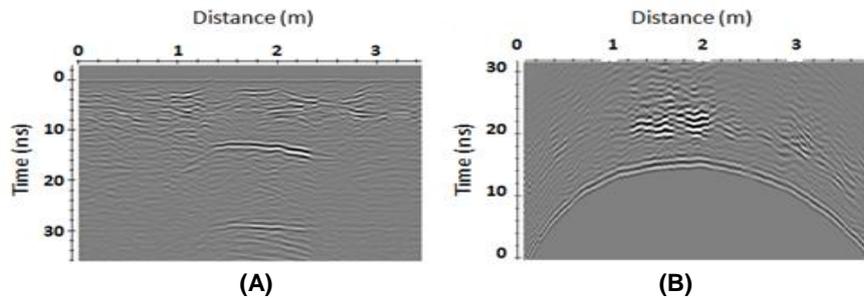
**Fig. 9.** Processed 1 GHz data over the pathway of the bridge (A) and over the intrados of the vault arch surface (B).

Figure 9A shows the processed data acquired with the 1 GHz antenna along the pathway of the bridge, which shows attenuation of the GPR signal. The reflection produced by the arch-air interface is only clearly identified in the central zones of the bridge (from 1.5 to 2.5 at 14 ns). The GPR data recorded over the intrados of the vault arch surface is shown in figure 9B, where the reflection due to the stone-masonry interface was only clearly identified in the zones contiguous to the keystone of the arch (from 1.0 to 2.0 m at 20 ns). Attenuation of the GPR signal was observed in the regions next to the bridge main walls at both sides of the arch, which most probably indicates that these zones have a higher content of moisture.

GPR field data confirmed high moisture content in the internal lateral walls at both sides of the arch in both data acquisition configuration (figure 9). To ratify this interpretation, exhaustive FDTD modelling was used, with the assumed values for the electromagnetic properties shown in table 2. The orthothermograms generated from thermographic 3D model were used to elaborate profiles of the bridge using Matlab © software, and large scale and more realistic models were built. As shown in table 2, three different media were considered based on the results provided by thermography. Yellow areas were assumed to be low moist areas, medium moist for orange areas, and dark red areas were identified as presenting high water content.

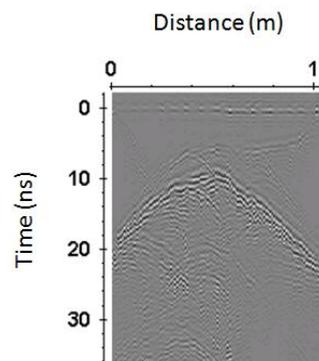
**Fig. 10.** Synthetic data obtained for the upstream side of the arch. The model was built from the orthothermogram provided in figure 6A

Figure 10 shows the synthetic data obtained from the upstream side of the arch, where no attenuation of the signal was observed.

However, regarding the GPR results, some difference have been found in results of the field data and the simulation data, since no signal attenuation appears in the synthetic data generated using profiles extracted from the orthothermograms (figure 10), in contrast with the attenuation observed in the field data (figure 9). This difference can be explained by the fact that, in the field data, only the central part of the arch was not attenuated and clearly identified (figure 9A), and the simulation was built from the interpretation provided by thermography, which indicated non critical moist areas in the external stonework of the bridge at the upstream side (figure 6A). The GPR field data was not collected at exactly the same point of thermography, and the difference observed between the synthetic and field data can be produced by the behaviour of the moisture in masonry. Observing the field data, the most relevant attenuation occurs at the lateral walls of the vault, so it seems to indicate that water could be drained from the upper backfill and accumulated in these areas. The orthothermograms produced at the intrados of the vault (figure 8) agree with the field GPR data, and ratify this hypothesis.

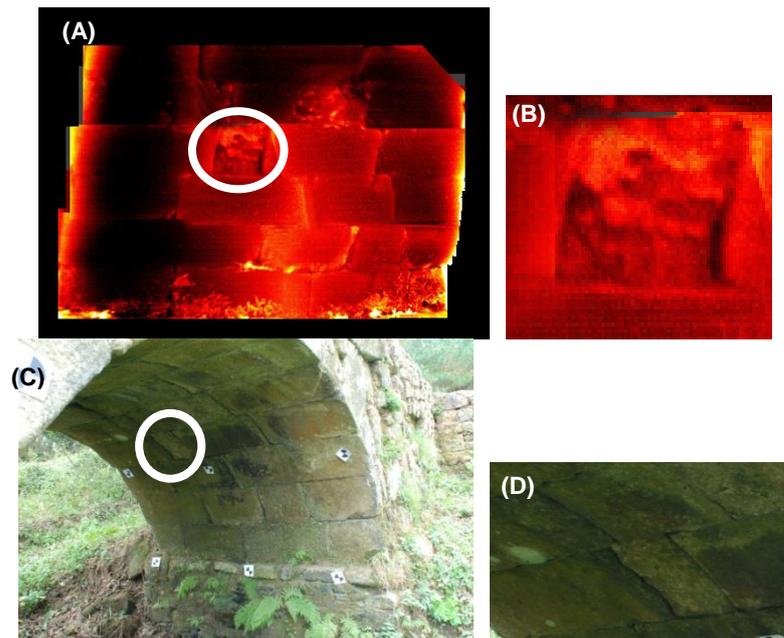
**Fig.11.** Anomaly detected in the thermography not corresponding to a damp area but to defect in the surface of the stone, (A) and (B) for detail. This confusion was solved by checking the corresponding visible image, (C) and (D) for detail.

Thermographies were analysed in order to determine whether the cold areas detected were due to water infiltrations in the bridge and not to irregularities in the surface of the stones. This analysis was performed through the study of their location and shape. In the case of the arch with higher water content, this study led to the detection of anomalies due to damage in the surface of the stones, as shown in figure 11A. In this image a cold area detected in the left wall of the vault is highlighted with a white circle, shown in detail in figure 11B. Although low temperatures are associated in this paper with humidity areas, checking with the visible image (figures 11C and 11D) allowed for the rejection of humidity as the cause for the detected anomaly.
