## How Reliable is Your Call? OPG Phased Array Ultrasonic Inspection Experience on Siemens- Parson Turbine Blade Roots 2001-2007.

Peter Ciorau, Lou Pullia

Ontario Power Generation Inc- Pickering – Canada

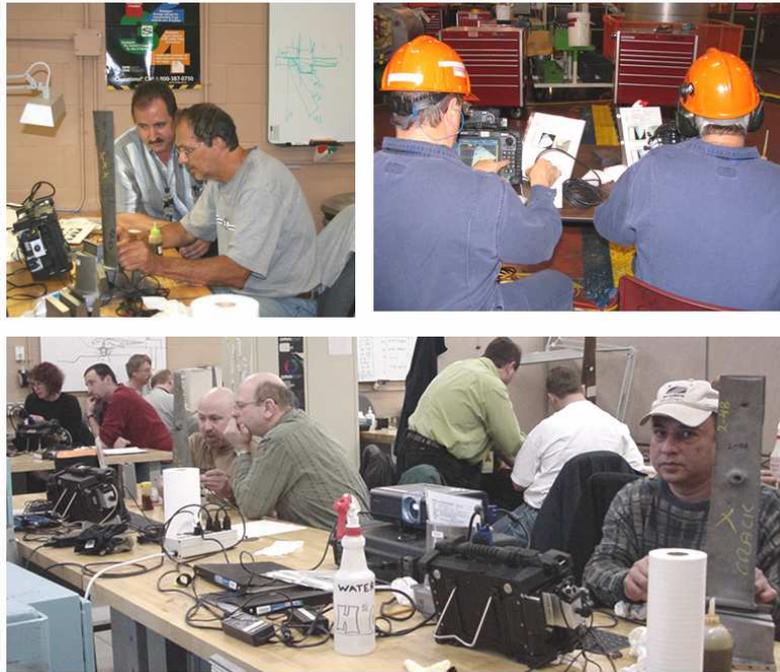
**Figure 8:** Examples of training activities using retired-for-cause blades with cracks and actual PAUT techniques.

The number of inspection points is 1,200 to 9,000. The inspection window is very limited, so multiple teams working 24/7 are required. Technician training is one of the major activities of PAUT reliability chain. The training is performed on specific techniques with 14 to 20 lab exercises, including detection and sizing cracks in the retired-for-cause blades. Procedures, technique sheets, confirmation and sizing techniques are presented and exercised in depth. Examples of training activities are illustrated in Figure 8.

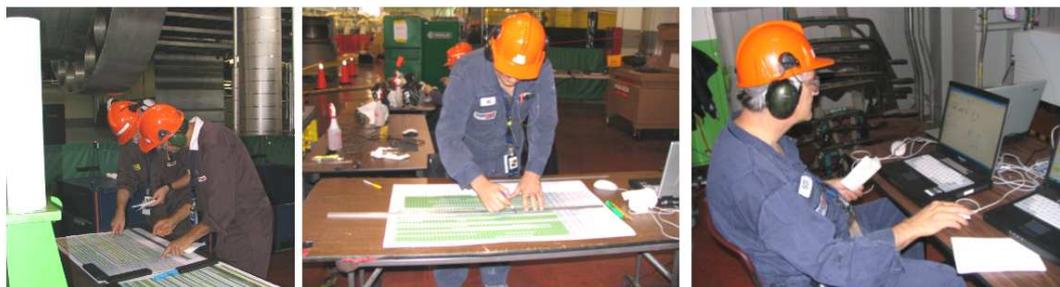
**Figure 9:** Examples of peer verification and data entry on the general sheet and in the d-base.

Where possible, refresher training is performed prior to commencing inspection, and on-the-job technical support is provided for the duration of inspection window. Observation and coaching is also in place. Another factor which contributes to reduce the human error is the peer verification before and after the inspection is performed. A small technician note book titled Correct Component Verification, coupled with a very useful d-base are in place as human performance tools throughout the shift activities (see **Figure 9**).

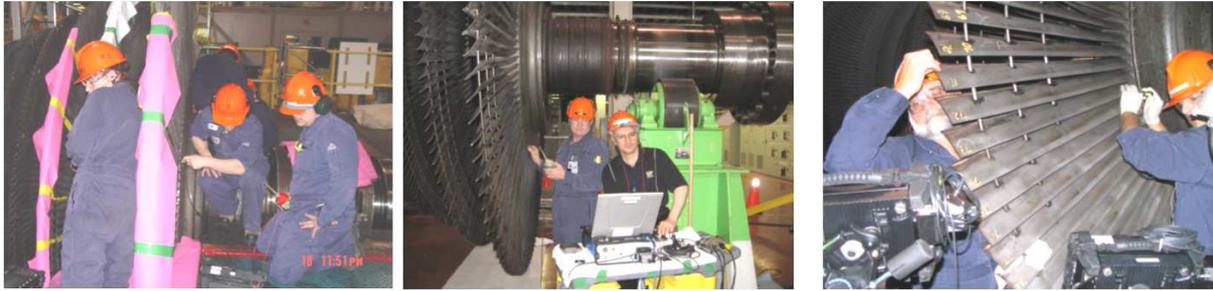
**Figure 10:** Examples of in-situ and on the stands inspections.
