# VALIDATION OF FRP COMPOSITE TECHNOLOGY THROUGH FIELD TESTING

**Abstract:** This paper identifies assessment techniques for critical parameters relative to installation and performance of fiber reinforced polymer (FRP) materials as a way to strengthen structurally deficient concrete bridges. Various Nondestructive Testing (NDT) techniques, representing viable solutions for identification and monitoring of such critical parameters on structural members strengthened with FRP, were implemented in a research program consisting of five upgraded concrete bridges in the State of Missouri. The research program was designed to provide information on installation aspects such as optimal roughness of the concrete substrate surface, fiber alignment, FRP debonding, FRP-concrete bond quality, concrete cracking, and FRP strain level. These parameters are related to both initial and long-term performance of a bridge structure. The five upgraded concrete bridges strengthened with composite materials are to be monitored semiannually for five years, including load tests. The NDT evaluation mainly focused on one of the bridges, where three different FRP strengthening systems were used.

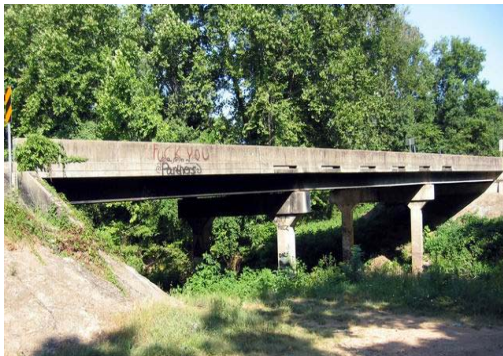
Side View of the Bridge

- Total length is 127 ft. Height of the bridge is 18 ft. Width of deck is 23 ft.
- Deck consists of three RC T-beams spaced 9 ft on centers. All spans have three transverse beams
- The thickness of the slab is 6 in.
- Concrete is in good condition. No spalling detected. Abutments and piers are in good condition.
- Load Posting: trucks over 18 ton, 15 mph on the bridge

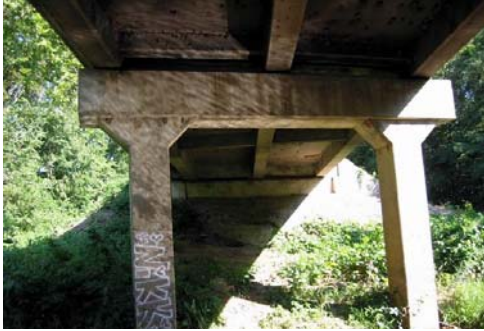
RC Bent, Girders and Slab

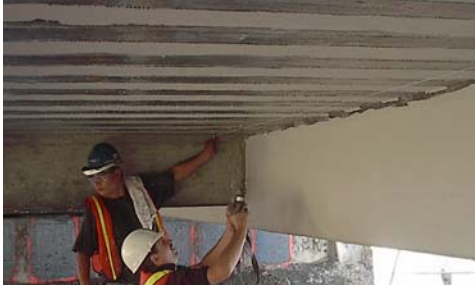
Figure 2. Fiber Misalignment Detection.

The process of installation of FRP laminates on a selected bridge was monitored and fiber misalignment was detected with the NDT method briefly described here and presented in details in Reference [7]. Fiber plies with tracers were installed using transparent epoxy on deck and girder on one span of the bridge (Figure 2). Image analyses were used to measure the angle between the fiber and tracer using a white string reference. Digital pictures from ordinary cameras could be used to measure fiber alignment to an accuracy of less than 1 degree. A simple imaging test allows the measurement of the misalignment. Immediately after installation, a colored string is stretched along the proper orientation of the fibers, and a simple digital photograph is taken. The digital photograph is then input into a computer program, which automatically measures the angle between the tracers and the string to an accuracy of less than 1 degree.

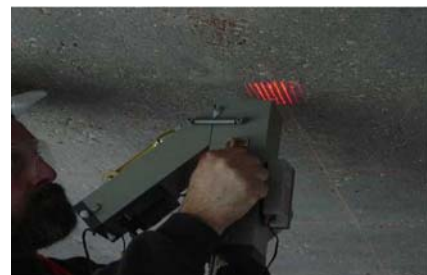
A prototype laser profilometer (Figure 3-b) has been developed at the University of Missouri – Rolla (UMR) to rapidly and accurately quantify the roughness of the prepared surface prior to installation of the FRP. This device and its features are presented in details in Reference [7]. The profilometer is a portable device that characterizes a roughened surface by means of laser light and transmits the image to a laptop computer used for analysis.

b) Roughness Detection by Laser Profilometer

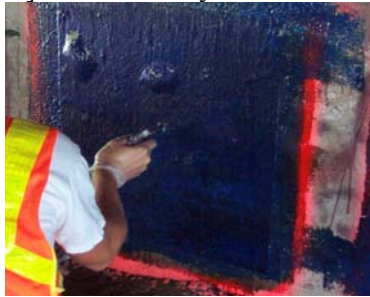
Figure 4. Intentional Delaminations on FRP Laminates.

For the bridge inspected in this research program, strengthening systems were installed with intentional defects at non-critical locations as shown in Figure 4 [9] and three different NDT detection techniques, based on new approaches developed at UMR, were used for monitoring. The techniques are explained in detail in References [7, 9, and 10] and are briefly summarized here.

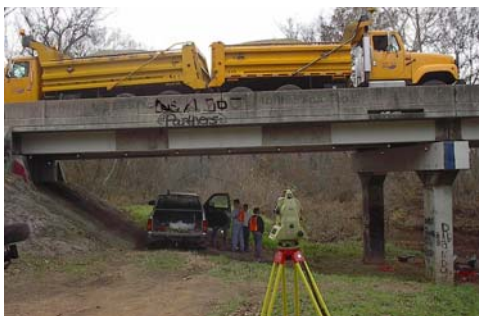
The Total Station sends a laser ray to the reflecting magnet-mounted prisms, and, by comparing the displacement with fixed reference points outside the structure, the operator can determine how much the element has moved in a three-dimensional array.

a) Surveying Equipment.
