NDT PROTOCOLS FOR THE DIAGNOSTICS AND MAINTENANCE OF EARLY REINFORCED CONCRETE STRUCTURES: A CASE STUDY

G. Uva¹, M. Mezzina¹, C. Dentamaro¹ and F. Porco¹

Abstract: The research work presented is focused on the diagnostic and rehabilitation of historical structures in reinforced concrete, and has been carried out within a scientific collaboration program with the Railway Company “Ferrovie Appulo Lucane”, aimed at monitoring the maintenance state of their architectural and infrastructural patrimony. In particular, the case of the Viaduct of Corso Italia in Bari is illustrated.

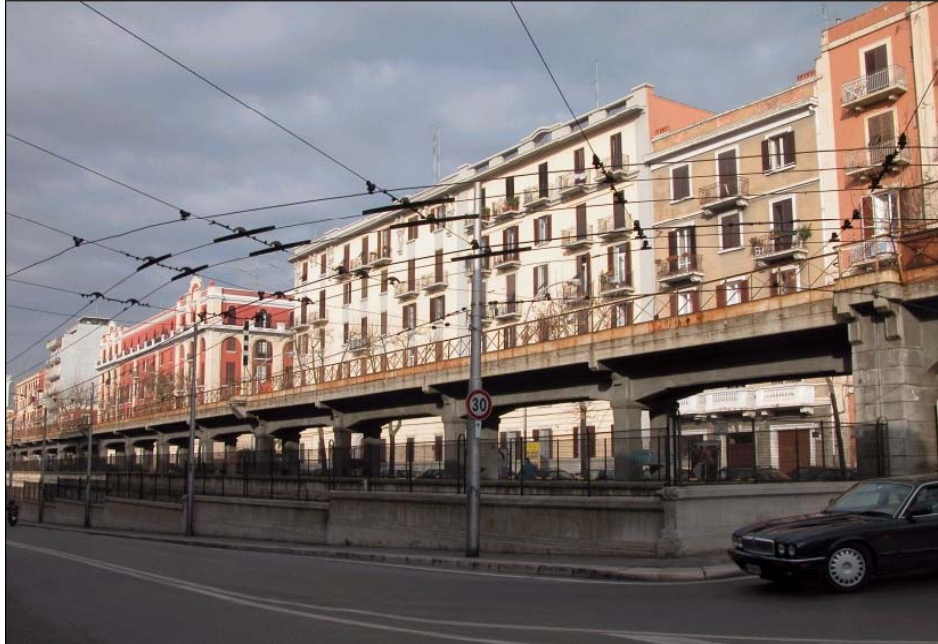
Introduction: The Viaduct of Corso Italia in Bari, built in 1915, was one of the first realizations in Europe of a superelevated railway using the RC technology (fig. 1). Together with other buildings of to the same period property of the FAL Railway, it represents a significant historical example showing the high technological and formal level achieved in the field of concrete construction at the beginning of XIX century (for a more detailed description, see [1-3]).

Figure 1. Views and drawings of the Railway Viaduct in Bari.

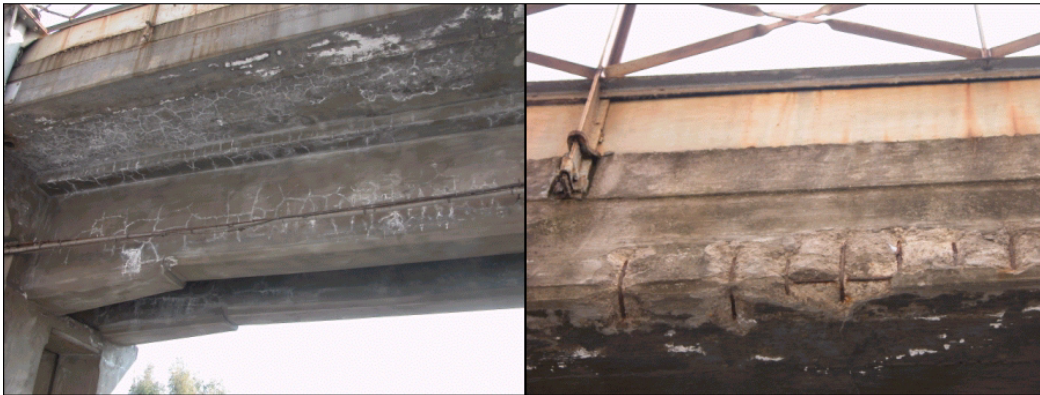
Design and time scheduling of in situ investigation program. In this phase, some preliminary inspections have been carried out in order to preview the structural conditions, identify the structural elements and perform all the needed preliminary routine operations. This inspection has pointed out a widespread deterioration of the materials in all the bays. In many points, the spalling of the concrete and a significant corrosion of the reinforcement, often resulting in the complete expulsion of the rebar covering (especially in the beams) has been noticed (fig. 2).

Figure 2. Visual inspection: conditions of the materials.

beams, therefore it is urgently needed the design and execution of an intervention able to account for the actual scenery: the carbonation has by far overcome the rebar covering depth, and the propagation of corrosion has caused a widespread damage of the external concrete layer. A traditional technique could be for instance adopted: complete removal of the carbonated concrete layer, and substitution with an alkaline mortar, specifically designed, that brings the reinforcements again in a passivation state. In order to guarantee an acceptable service life for the intervention, it is necessary, of course, to remove a relevant amount of carbonated concrete even if the mechanical strength is not compromised yet [10]. The ND tests have also revealed a certain unhomogeneity of the concrete in the different structural elements. For this reason indeed, and for the high carbonation depth, the values of the rebound indexes can not be considered reliable, and have not been used in the determination of the correlation curve. Different is the case of the ultrasonic tests. Results are definitely more reliable, and have been correlated to the experimental compressive strength through a regression curve. The obtained curve will be possibly used, in the future, for the on site control of the mechanical strength of the concrete through the execution of ND controls. Presently, the mechanical strength detected on the extracted samples are high enough, and can guarantee acceptable safety factors. Considering the importance of the construction, it is however advisable a constant and systematic monitoring.

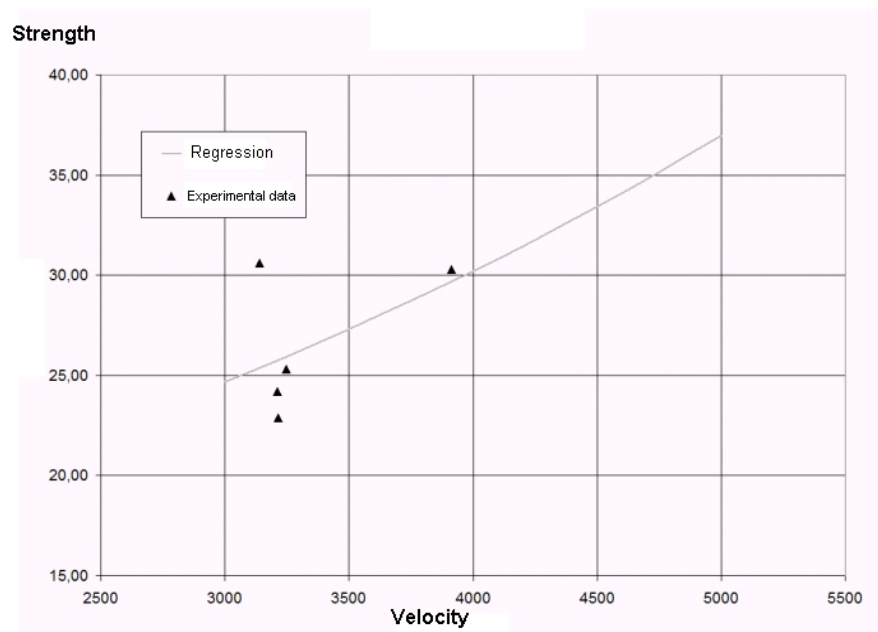
In particular, in order to determine the mentioned correlation curve between the ultrasonic velocities and the compressive strength of the samples, we have used a logarithmic regression:

$$R = A \times B^V$$

The regression curve obtained for the ultrasonic velocities is reported in fig. 6. This curve, even if obtained on the basis of a quite reduced number of experimental data, represents a very useful tool for the investigation. In fact, it will allow an easy systematic time monitoring of the decay of the mechanical concrete properties thanks to the measure of the ultrasonic propagation velocity alone, and therefore with no disturbance at all on the structure, that is in a full service and, moreover, is characterized by an architectural and historical relevance.

Figure 7. Correlation curve for the ultrasonic measures.
