RECENT PROGRESS IN DIAGNOSTICS OF CIVIL STRUCTURES BY LASER VIBROMETRY

E. Esposito¹, S. Copparoni², and B. Naticchia²

¹ Dipartimento di Meccanica, UPDM, Ancona, Italy; ² IATPE, UPDM, Ancona, Italy

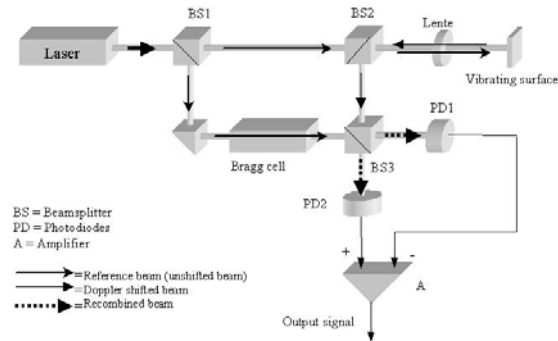
Figure 1 – Scheme of SLDV.

As its own name says, this type of vibrometer uses the Doppler phenomenon to remotely acquire vibration velocities: surface vibrations induce a Doppler frequency shift on the impinging laser beam, and this shift is linearly related to the velocity component in the direction of the laser beam. In this way we have established a linear connection between laser beam frequency variations and velocity values. The obstacle facing us now is that Doppler shifts are usually very small when compared to the laser fundamental frequency, typically 1 part out of 10^8 ; the only way to appreciate such small quantities is to use interferometry, so that high frequency oscillations are combined and reduced to much lower values that can be dealt with by standard electronics. A scheme of a vibrometer incorporating a Mach-Zender interferometer is presented in Figure 1. Laser emission is split in two equal power beams by beam splitter BS1, and, while one beam is focused on the vibrating object, the “measuring beam”, the other one stays in the laser head and becomes the so-called “reference beam”. After being reflected, the measuring beam re-enters the laser head and is recombined with the reference beam. Surface displacement varies the optical path difference between the two laser beams and this results into a phase lag varying with vibration velocity v . So we have a time varying phase difference corresponding to an instantaneous frequency component that follows v . This frequency shift is equal to the Doppler shift (f_D) and we know from basic physics that f_D depends on v and source wavelength (λ): $f_D \propto 2v/\lambda$. Demodulating this FM Doppler signal it is possible to extract the amplitude of v , but we still lack the information on the direction of the surface displacement. To solve this problem there exist two solutions, based on electro-mechanical-optical shifting of the frequency of the reference beam by a Bragg cell (like in Figure 1), or on electronic manipulation of the recombined beams.

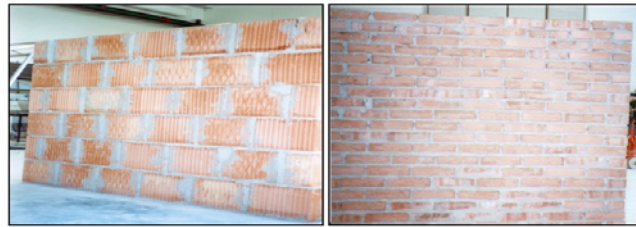
Figure 5 – Sample brick walls (Poroton bricks, left, normal bricks, right), walls 1.8 (L) x 1.5 (H) x 0.25 (W) m.

To start testing the possibility of using SLDVs on civil structures, in a laboratory of the University two brick walls have been built, as depicted in Figure 5. Both walls have been excited by acoustic sources and by using a pneumatic drill, see Figure 6. In the first case, the reference signal has been provided by the white noise used to drive the loudspeakers, in the second case, an accelerometer has been placed close to the drill, with the laser head positioned at about four meters in front of the walls. After this first measurement by SLDV, both walls have been damaged by hitting them with a heavy hammer, creating an irregular groove with a width of some centimetres and a depth of about two centimetres, see dark area in Figure 7. Measurements using the SLDV have been repeated and finally in Figure 7 we show a sample of the results: we may clearly observe how the same vibration mode shifts from 77.5 Hz down to 57.5 Hz after the wall has been damaged; this result is also confirmed by the spectra in Figure 8, where other important modifications of the frequency responses are clearly observable.

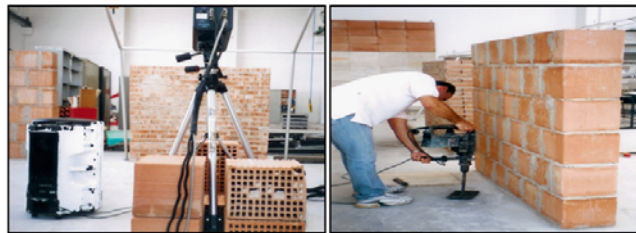
Figure 6 – Excitation of sample walls.

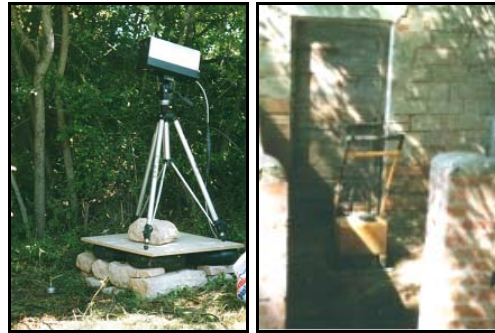
Figure 10 – SLDV mounted on isolation platform and road plate compactor used to excite the building.

Experiments concerning the dynamical behaviour of structures have been successfully done in the lab and on a small building, but due to the high level of excitation and to the low frequencies required to excite structures, an issue is represented by the isolation of the SLDV. Different solutions have been tested, such as positioning the laser head in sand or on a heavy platform posed on rubber supports. Further studies are required, also because it is not feasible to transport heavy isolation tables. Anyhow, even the use of simple solutions like the platform in Figure 10 leads to substantial improvements. In Figure 14 we compare the averaged spectra of the vibrations of the ground close to the SLDV, of the ground close to the compactor and of the platform which the SLDV was positioned on, and we observe how the RMS level of acceleration is decreased between 10 and 250 Hz of about 13.5 dB by the use of the platform.

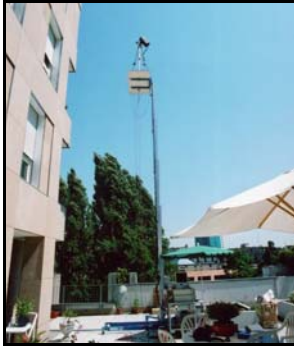
Figure 13 – SLDV on lifter.

The test in Pompei also demonstrated the capability of the SLDV to unintrusively acquire vibrational data on not-treated surfaces up to ten meters, a real asset when dealing with such precious structures. Regular monitoring of important parameters related to the state of conservation of the objects, like damping ratio and frequencies of resonance, is thus possible with no external intervention on the structure and may be performed quickly and with a high degree of accuracy. If there arises the need to put the SLDV closer to the structure, it is possible to use industrial lifters, as shown in Figure 13.

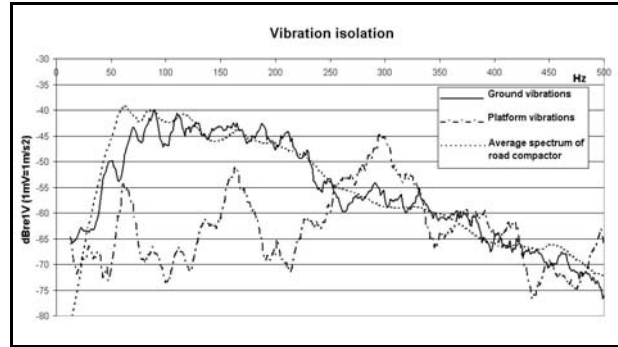
Figure 14 – Degree of isolation provided by platform in Figure 10.
