MICROWAVE FIELD MEASUREMENT OF DELAMINATIONS IN CFRP CONCRETE MEMBERS IN A BRIDGE

V. Stephen, S. Kharkovsky, J. Nadakuduti, R. Zoughi; Applied Microwave Nondestructive Testing Laboratory (*amntl*), Department of Electrical and Computer Engineering, University of Missouri-Rolla, Rolla, MO 65409, USA.

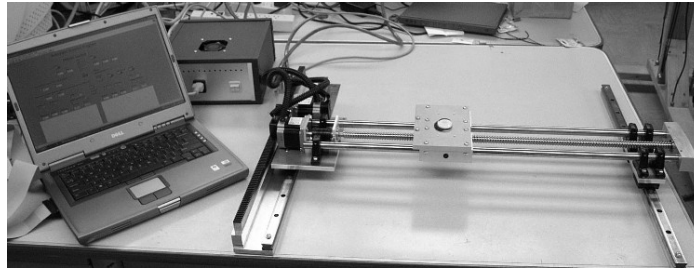
platform is easy to use and suitable for on-site measurements. A picture of this scanner is shown in Figure 1.

Figure 1: Automated 2D scanning platform suitable for on-site measurements.

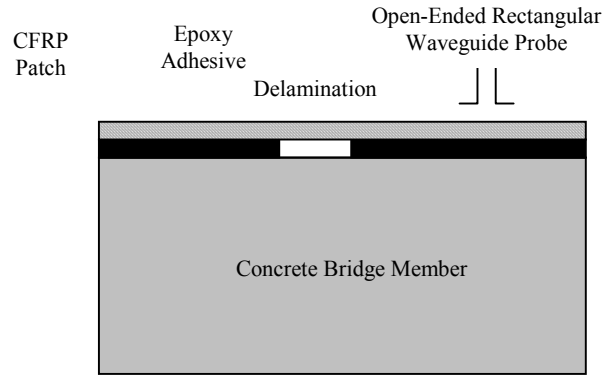
The near-field microwave probe consisted of a simple reflectometer. The reflectometer transmits an incident microwave signal onto the region under test, via an open-ended rectangular waveguide probe, and receives the reflected microwave signal. Subsequently, the incident and the reflected signals are combined and detected using a microwave detector which produces a dc voltage output. This voltage is proportional to the magnitude and/or phase of the reflected microwave signal from the CFRP laminate under test. As the probe scans over different regions the reflected signal changes and so does the probe output voltage. This voltage, in concert with the scanning process, which gives the precise location of the open-ended probe at any given time during the scanning process, is used to produce a raster scan or microwave image of the scanned region of interest. Due to the fact that CFRP contains carbon fibers, the dielectric constant contrast between CFRP and air (i.e., delamination) and the concrete substrate is relatively large. Thus, usually, detection of a delaminated region is relatively easily using this technique, since this dielectric contrast results in a relatively distinct reflection at these boundaries [9-10]. X-band (8.2–12.4 GHz) frequency range was used as the operating frequency range of choice for this investigation based on the results of previous findings [9-10]. Figure 2 shows a simplified schematic of the measurement setup. The scanner is placed over the bridge member bonded with a CFRP laminate using scaffolding or suction cups. The microwave probe is fixed to the probe holder at a certain standoff distance (distance between the waveguide flange and the CFRP laminate). The standoff distance is optimally chosen such that a relatively large voltage difference between delaminated and non-delaminated areas is produced while providing small voltage output variations as a function of standoff distance and surface roughness variations [10-11]. The output from the microwave probe along with the positional information of the probe is fed into a laptop using a National Instruments data acquisition card. LabVIEW-based automation software was used to control the motion of the probe as well as to obtain the output voltage from the microwave probe. In this way, raster scan of a region under the scanner is produced yielding a real-time two dimensional image of the scanned area. The measured voltages from the output of the microwave probe are normalized with respect to a predefined maximum, and different grayscale values are assigned to the normalized output voltage values. The images obtained in this way can be subsequently processed by passing the data through a desired filter to minimize the effect of noise and to produce a smoother image. Polarization direction of the incident microwave signals is also an important parameter. Unidirectional CFRP laminates, as used here, behave as a relatively lossy dielectric material when the carbon fibers are perpendicular to the signal polarization direction (i.e., perpendicular polarization). In this case, the incident microwave signal can penetrate through the laminate and exposes the presence of a delamination. However, when the polarization direction is parallel to the fiber directions (i.e., parallel polarization) the CFRP behaves as a good microwave reflector and no signal can penetrate inside of it. The former case is well-suited for detecting and evaluating delaminations, whereas the latter case only provides information about surface roughness, standoff distance variations, bulging of the CFRP, etc. [9-10]. Therefore, it is possible to produce two images, one at each

polarization, and then remove the effect of unwanted surface roughness and standoff distance variation using the data obtained with parallel polarization [11].

Figure 2: Schematic of the measurement approach.

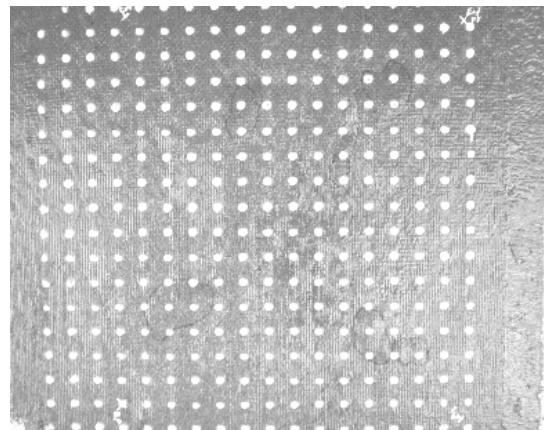
Results: The CFRP laminates that were bonded to the abutment and the girder of the bridge in Dallas County, Missouri were scanned using the method described earlier. A picture of one of the patches adhered to a section of the abutment is shown in the Figure 3. Several relatively small delaminated regions (some smaller than 20 mm by 20 mm) were produced in this patch using the air injection method described earlier. The scan area is marked in Figure 3 by the thick outer solid line along with six delaminated regions outlined with the thin solid lines. The white spots are paint spots used as a reference grid for another investigation. Figure 4a shows the microwave image of this scanned area using perpendicular polarization (the dimensions are in mm). As mentioned earlier the image is normalized with respect to a predefined maximum and minimum. The relative variation in intensity, from bright to dark, represents the areas of delaminations. The severity of the delaminations is also indicated by the relative brightness associated with the images of the six delaminated regions. The locations and sizes of the six delaminated regions, indicated by the microwave image in Figure 4a, agree well with their locations and sizes on the bonded CFRP laminate. These were verified using tap testing. In Figure 4a, there is a small region in the bottom of the picture that indicated the potential presence of an unintentional delamination that may have been produced during the placement of the laminate. The relative location of this delamination is shown by the dashed-line square in Figure 3. Originally, this region was not designated as a delaminated region on the CFRP laminate. Subsequent to obtaining its microwave image, it has been determined that this region is a potential delamination. This demonstrates the robustness of this method for detecting and evaluating small and relatively non-severe delaminations. A similar situation was also encountered in a previous study [9].

Figure 3: Picture of a CFRP patch bonded to the abutment of the bridge in Dallas County, Missouri with the boundary of the scanned area and the delaminated regions shown.

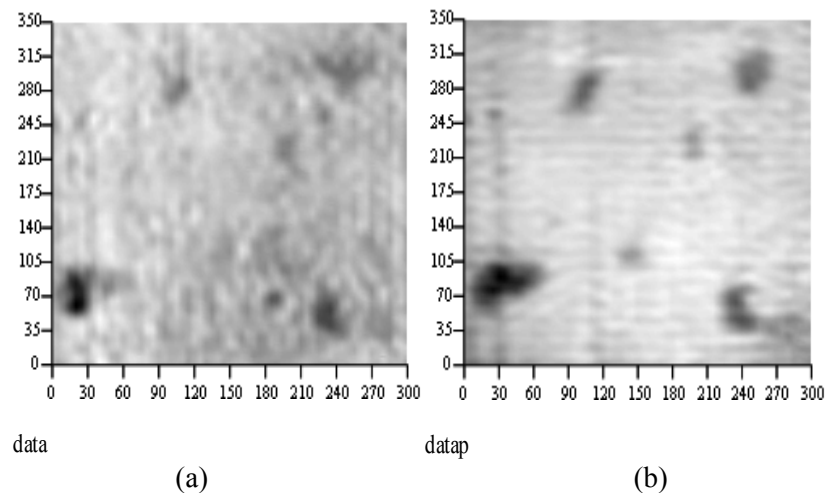
Figure 4: Microwave image of the scanned area in Figure 3 using: a) perpendicular polarization, and b) parallel polarization.

Next, the laminate was scanned using parallel polarization. This measurement is expected to provide information about the surface variation associated with the laminate including any standoff distance variations that may exist due to the scanning mechanism. Figure 4b shows the resulting microwave image. This image primarily shows the effect of surface roughness and standoff distance variation (caused by the surface roughness).
