THE APPLICATION OF LONG RANGE GUIDED ULTRASONICS FOR THE INSPECTION OF RISER PIPES

J. McGregor, B. Nooteboom, N. Ivory
PTAS-ITS Lot 1 and 2 Tapak Perindustrian Pekan Belait,
Jalan Setia Di-Raja, Kuala Belait, Brunei Darussalam

Abstract: Corrosion and other defects that reduce the cross-sectional area of pipes cause major problems in the oil, chemical and the other industries. Most standard NDT methods measure the remaining pipe wall accurately, but over a small area so it is almost always uneconomic to inspect 100% of the pipe. In practice a pragmatic approach is usually adopted where the wall thickness at a number of points is measured and this information is used to determine the fitness for purpose of the pipe. However, this approach generally requires unrestricted access to the outer surface of the pipe and this is not possible, if the pipe is insulated, has protective coatings or is buried. This means that even external corrosion cannot be seen so that accurate measurements of the remaining wall can be made at the correct location on the pipe. Ultrasonic guided wave inspection using the Wavemaker Pipe Screening System (WPSS) offers a novel solution to many such inspection pr

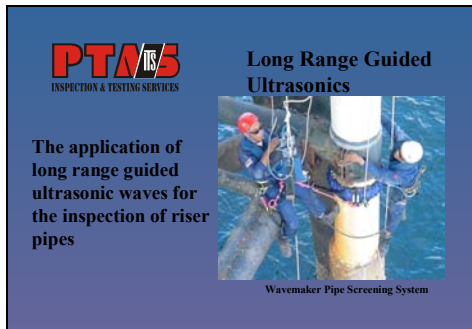
Slide
1

The slide features the PTAS-ITS logo (INSPECTION & TESTING SERVICES) in the top left. The main title is "Long Range Guided Ultrasonics". Below the title is a photograph of two workers in blue safety gear and hard hats working on a large vertical pipe. The caption below the photo reads "Wavemaker Pipe Screening System". The main text on the slide is "The application of long range guided ultrasonic waves for the inspection of riser pipes".

Guided Ultrasonics makes the Wavemaker pipe screening system. It is important to understand from the beginning that this is a screening tool. It is not a magic solution to all inspection problems. What it does do is provide a method of rapidly determining where there are problem areas on a pipe.

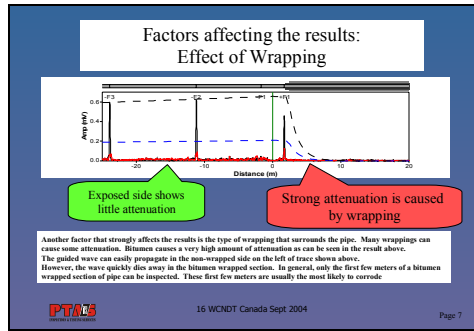
Slide
7

The type of wrapping that surrounds the pipe strongly affects the results. Bitumen causes a very high amount of attenuation as can be seen in the result above. The guided wave can easily propagate in the non-wrapped side. However, the wave quickly dies away in the bitumen wrapped section. Usually only the first few meters of a bitumen wrapped section can be inspected. These first few meters are usually the most likely to corrode.

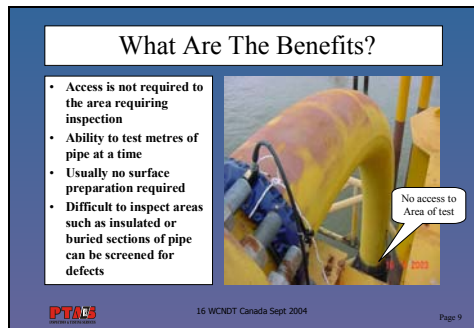
Slide
9

Access is not required to the area requiring inspection, it has the ability to test many metres of the riser at one time. Usually no surface preparation is required. Difficult to inspect areas such as splash zone or buried sections of the riser can be inspected.

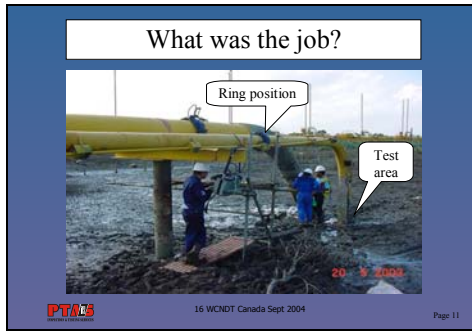
Slide
11

This slide is typical of the working conditions; this is in the tidal zone of a river estuary. For larger diameter pipes, an inflatable belt system is used. The system allows for a light flexible application of the technique to large diameter pipes. The normal range of inflatable rings is from 6 to 24 inches in diameter. (Larger pipes can be inspected, but on large pipes only large corrosion patches can be found.)

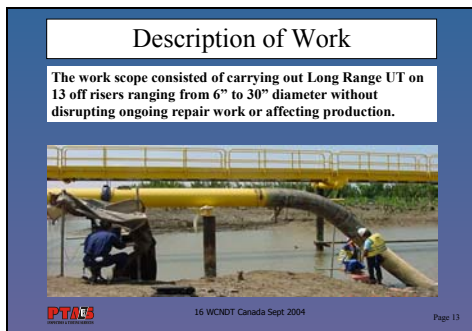
Slide
13

This slide shows another typical location of the worksite. The job entailed carrying out LRUT on 13 risers from 6 to 30 inch diameter in the splash and ground entrance area.

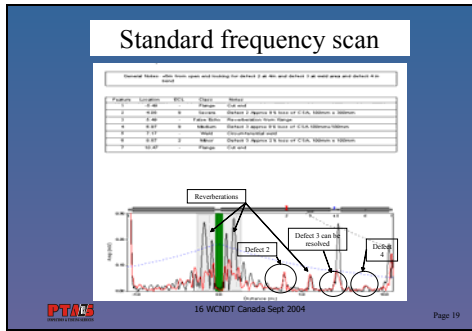
Slide
19

This slide shows the results of one of the final scans. The location of test is adjacent to defect 1. All the other defects can be clearly seen even defect 4 which is equivalent to a 2% change in CSA and defect 3 which is only 50mm to a weld.

- 1: 100mm x 300mm x 11mm deep = 9% change in CSA
- 2: 100mm x 300mm x 11mm deep = 9% change in CSA
- 3: 50mm x 300mm x 11mm deep = 9% change in CSA
- 4: 100mm x 100mm x 6mm deep = 2% change in CSA

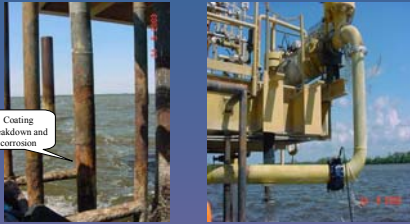
6" riser location

This slide shows the ring location and the vertical section of the riser.

- This riser was 6" diameter by 18mm thick. It was located on an offshore installation in shallow water.
- The bitumen type coating was severely broken down in the splash zone area. External corrosion could be seen visually on this riser but due to the heavy corrosion products the remaining thickness could not be assessed.
- Corrosion was detected up to 50% wall loss within a 10 metre test range. This test range was limited by the extent and severity of the corrosion present.

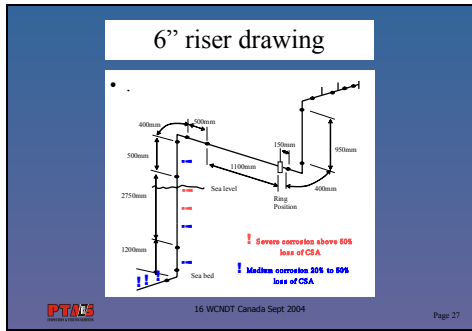
Slide
27

Shows a drawing of the layout of the riser with corrosion detected beyond the lower riser bend.

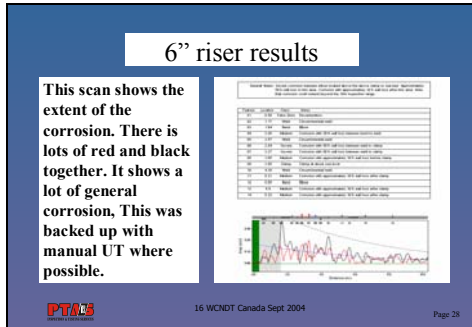
Slide
28

This scan shows the extent of the corrosion. There is lots of red and black together. It shows a lot of general corrosion, which was backed up with manual UT carried out by a diver. A good correlation was achieved between the results of the LRUT and the manual scanning.

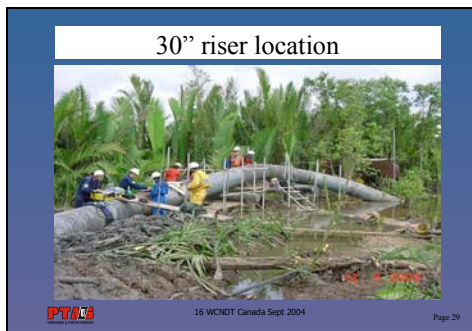
Slide
29

This slide shows another 30" riser location. We are shooting towards the ground from this ring location. It is typical of the working conditions in this area and is located at a river crossing and had a combination of coatings, Bitumen where it entered the ground and EPDM/Concrete where it entered the water.
