## LASER-BASED MAPPING TECHNOLOGY FOR THE INSPECTION OF ROCKET THRUSTERS

J. Doyle, Jr., M. Brinkman, Laser Techniques Company, LLC, Bellevue, USA

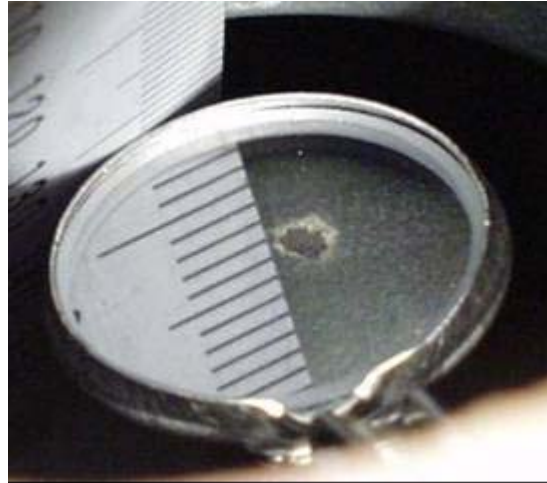
Figure 2. Chip in throat of PRCS thruster.

**Introduction:** The primary reaction control system (PRCS) thrusters on NASA's Space Shuttle (Figure 1) are subject to chipping in their protective ceramic coating. Technicians use a flashlight and mirror to inspect the combustion chamber and throat of the thruster after each flight. In the event that a chip is detected (Figure 2), measurement of flaw size is accomplished by creating a mold impression and measuring the features using an optical comparator. This visual inspection method is operator dependent and subject to human error. As part of its ongoing program to improve the inspection methods used on safety-critical Space Shuttle components, NASA recently funded a project to develop an automated, laser-based inspection system for PRCS thrusters. The objective of this program is to reduce the dependence upon the operator's visual acuity and judgment through the development of an automated, highly accurate and repeatable thruster scanning system.

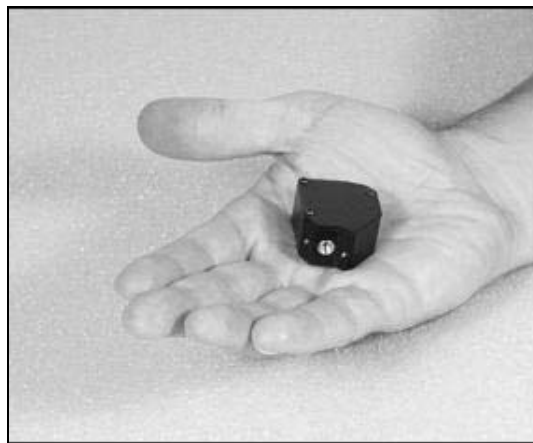
Figure 3. Miniature laser profile sensor developed for NASA

A Proof-of-Concept study was funded by NASA for the development of a miniature, high-performance sensor that could fit through the 50 mm diameter thruster throat and operate in the tight confines of the thruster combustion chamber. A prototype laser profile sensor (Figure 3) was designed, built and demonstrated to measure features to an accuracy of better than 0.01 mm (1). The sensor was evaluated on a retired PRCS thruster and was demonstrated to be capable of negotiating its geometry and the repeatable detection of chips in the ceramic coating. The successful demonstration of the prototype sensor resulted in the funding of a Phase II program, in which a full-scale scanning system would be developed and delivered to White Sands Test Facility in New Mexico, USA.

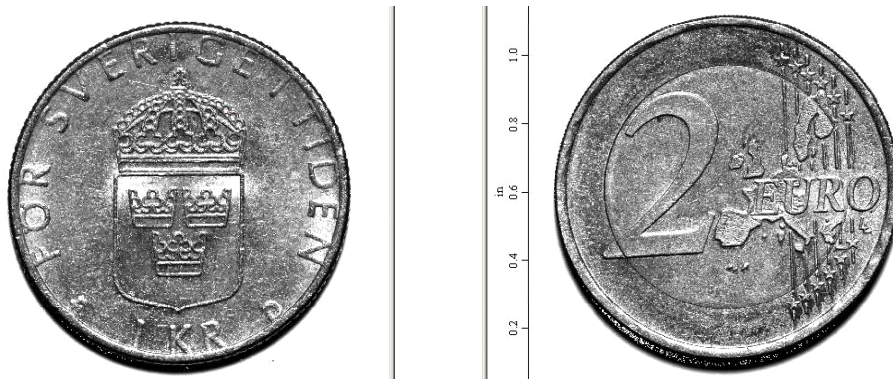
Figure 6. LaserVideo™ images of coins.

To illustrate the near-photograph quality of LaserVideo™ image, Figure 6 shows a pair of coins that were scanned with a laser sensor. The spatial sampling resolution used for this scan was 0.025 mm (0.001 inch) with a laser spot size of approximately 0.0125 mm (0.0005 inch) diameter. The LVI images reveals very fine features such as surface scratches that might, otherwise, be undetectable using other measurement methods.

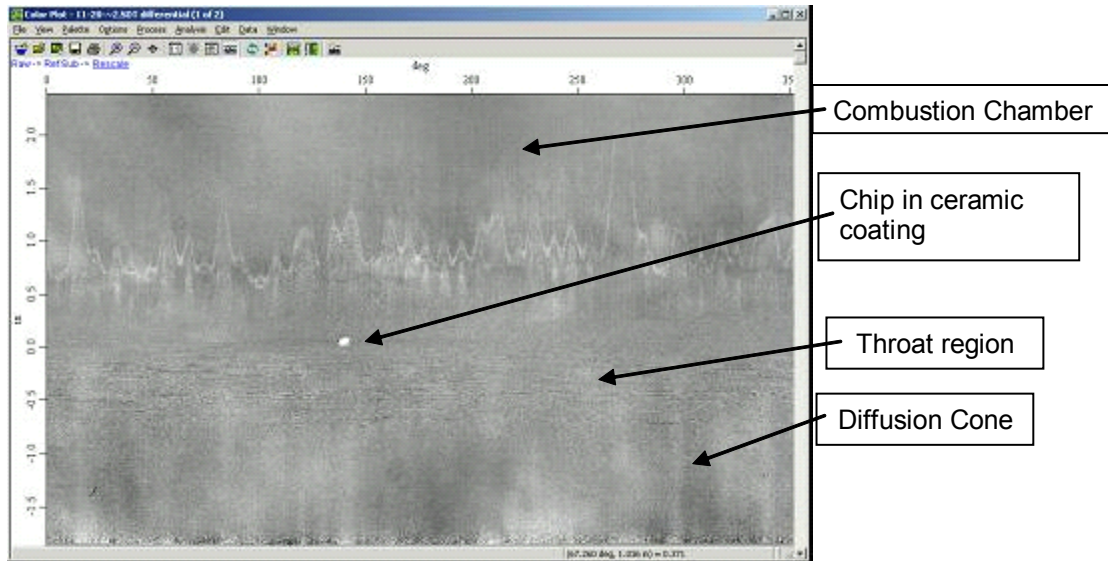
Figure 8. Full profile of thruster combustion chamber and throat area.

At the conclusion of a seven month development effort a full-scale, turn-key thruster scanning system was delivered to NASA White Sands Test Facility. The system was demonstrated to be capable of scanning nearly 100% of the thruster combustion chamber, and out past the throat by approximately 35 mm. The system was successfully tested on a number of thrusters with various sizes of surface chips. Figure 8 shows an example of a full thruster scan. The data can be displayed in full color, therefore making it quite simple to visually detect any chips. However, since this manuscript is printed in black and white, the chip is shown in white, against a grey-scale background.
