## LOCATION OF INTERNAL FAULTS IN ELECTRICAL EQUIPMENT USING DIGITAL X-RAY TECHNOLOGY

**Abstract:** This paper presents a new test methodology, based on digital X-ray technology, to observe the inside of several electrical equipments without the need of damaging it and shows internal faults making easy to take a decision about the necessity of replacing.

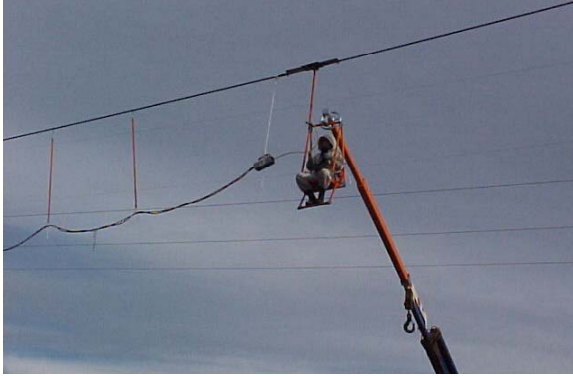
**Figure 7 :** Test arrangement on a 230 kV energized line

The advantage of the use of digital X-Ray technology can be greater if there is possible to apply this technology to energized equipments. The greater doubts were the insulation of the lead box, that is used to protect the persons against the effects of the radioactive particle, and the effect of the energized line electric field on the imaging plates used to capture the projection of the image of an object under test.

Several tests were made and the results obtained on an energized 230 kV line can be seen on Figures 7 and 8.
