NONDESTRUCTIVE TESTS OF PLASTERS

Krzysztof SCHABOWICZ, Bohdan STAWISKI
Institute of Building Engineering, Wrocław University of Technology, Poland

ABSTRACT

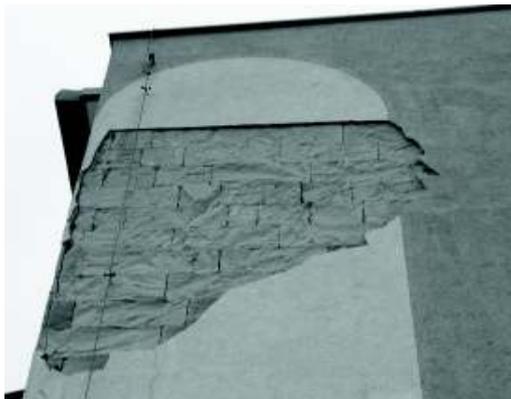
Questions about the strength of the mortar from which the plaster was made most often arise when some damage, e.g. plaster cracking or flaking, occurs (figs 2 and 3).

Fig. 2. Cement-lime plaster coming off gas concrete wall in area of few m².

It emerged from the obtained results that the mortar had a very high strength of 9.2-12.4 MPa as compared with the strength of gas concrete 0.5, ranging from 3.0 to 4.5 MPa. It was found that the strength of the plaster was about three times higher than that of the base and the difference between the elasticity moduli was even greater. The elasticity modulus for the gas concrete wall is $E = 800 f_k$ where:

The stresses cause the shearing of the contact between the plaster and the gas concrete. Actually the strains and stresses may be much higher since Δt can be much larger. As one can see they resulted in gas concrete shearing and plaster bulging (buckling since the plaster coat is strongly compressed). This process recurs many times (even during the day) and with wind suction added it results in the plaster coming off the wall.

The nondestructive tests of plasters and their results provide an explanation why the plaster in the investigated building structures does not interact well with the wall. The fact that the plaster deformed differently than the wall resulted in the shearing of the latter's thin layer of cellular concrete whereby the plaster fell off the wall.

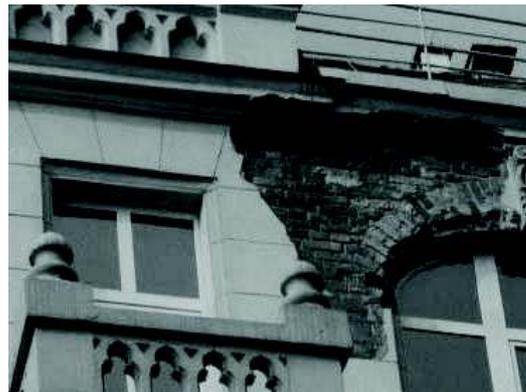
Fig. 3. Cement-lime plaster and mascarons falling off ceramic brick wall in area of 1.5 m².
