RESEARCHES REGARDING THE SOURCES AND IMPACT OF THE ATMOSPHERIC POLLUTION AND BIODEGRADATION ON THE TREI IERARHI MONASTERY OF IASI

The church is exposed in the exterior to the physical-chemical attack of the atmospheric exhaust gas correlated with the microclimatic factors. The effects of this physical-chemical attack but also of the biological attack are seen on the exterior walls, on the stone lacery (Albesti calcite) of the monument.

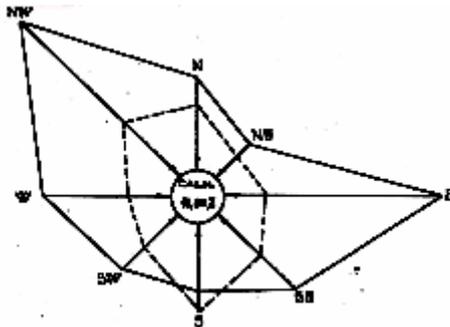
Figure 2

The outer walls of Trei Ierarhi church are not equally affected by the action of the climatic factors. Thus the Northern and Western walls are exposed to the action of the dominant winds from North-West that are full of humidity and whose increased annual frequency (19.55%) explains the high degree of humidity of the walls (Figure 2)

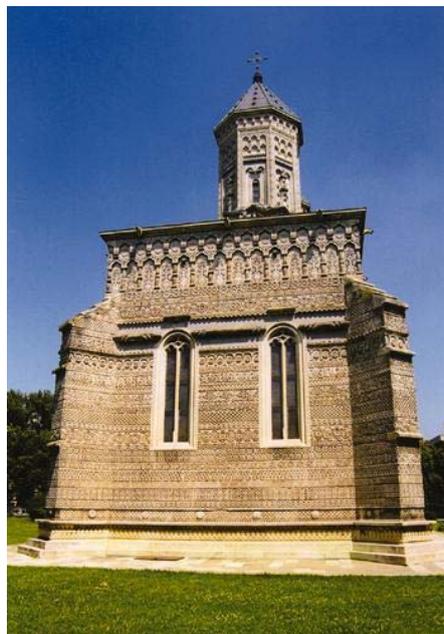
Figure 3

Because there is no higher building in this direction to protect it, the Western flank is exposed to the permanent action of the Western winds that have an average speed of 2.7 m/s. The consequence is a more intensified discoloration of the threshold in comparison to the rest of the building (Figure 3).

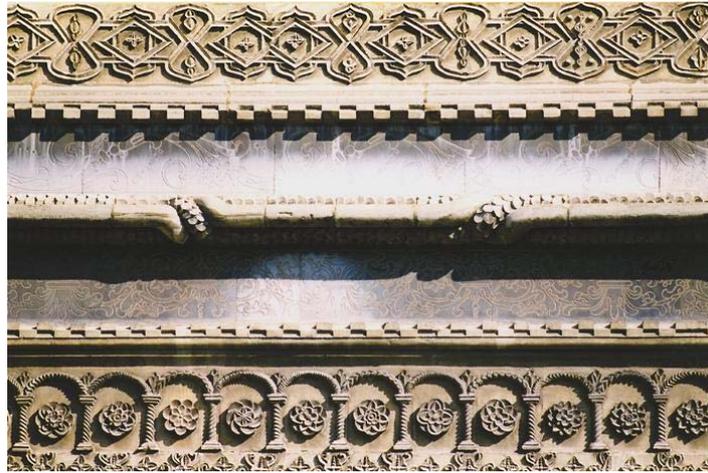
Figure 4

Effects degradation of the torsade band that surrounds the church, separating the lower range from the superior one, bordered by black marble plates carved in the baroque style (Figure 4)

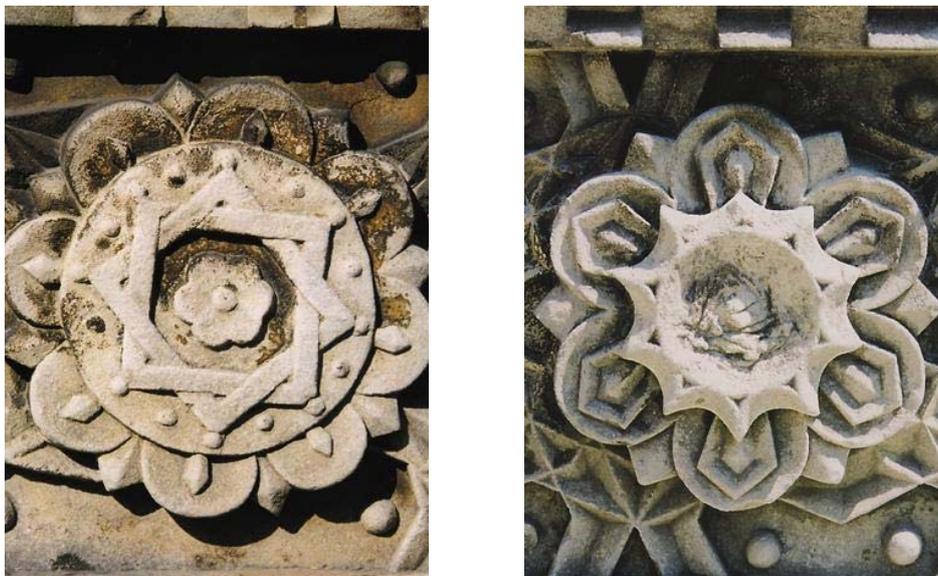
Figure 5

Analyzing the monument's walls we established extended areas with fragile calcite, with stained, disintegrated salts crystallizations. The solvable salts reach the surface where they are crystallized, forming hard deposits and filamentous crystals that seem to be pulled out of pores, producing a tension that determines the fragility and bucking of the surface and the degradation of the ornamental details. Solar disks degradation of the *Clorococcum humile* and *Lecanora muralis* (Figure 5)

- The action of the bioderm is advanced due to the fact that some species penetrated in depth and this action being favoured by the polluting agents.
- The acid rains favour the stone's dislocation and breakage; the solvable salts are crystallized, forming calcite hard deposits and filamentous crystals at the surface of Albesti.
- The monument is exposed to pollution even if we take into consideration only the exhaust gases from the traffic of the nearby street, Ștefan cel Mare și Sfânt, against which it could be protected by means of a high hedge that would hinder the gas diffusion found at the street's marginal level.
