HAND-HELD XRF FOR THE PRELIMINARY SCREENING OF EARLY ROMANESQUE FRESCOES IN SLOVAKIA

Within our study, hand-held XRF was used for the screening of a cycle of Early Romanesque frescoes in the single nave church of St. George at Kostol'any pod Tribečom, Slovakia. After the first stage of the pre-restoration research coming out from non-invasive measurements and microanalysis of very limited amount of samples, we were able to distinguish the relics of full-area 19th century re-paints by zinc and barite whites and also partly re-established the original colouring of paintings based namely on the detailed screening of Cu and Pb. Copper-based pigments were almost totally washed-out from the painting and the original green and blue colours turned to yellow and light grey, respectively. Low concentrations of Cu can now be detected only by portable XRF when integrating the measured area of ca 2mm² or more. Blackened parts containing lead was finally interpreted as conversion of red lead (Pb₃O₄) to plattnerite (PbO₂) and cerussite (PbCO₃).

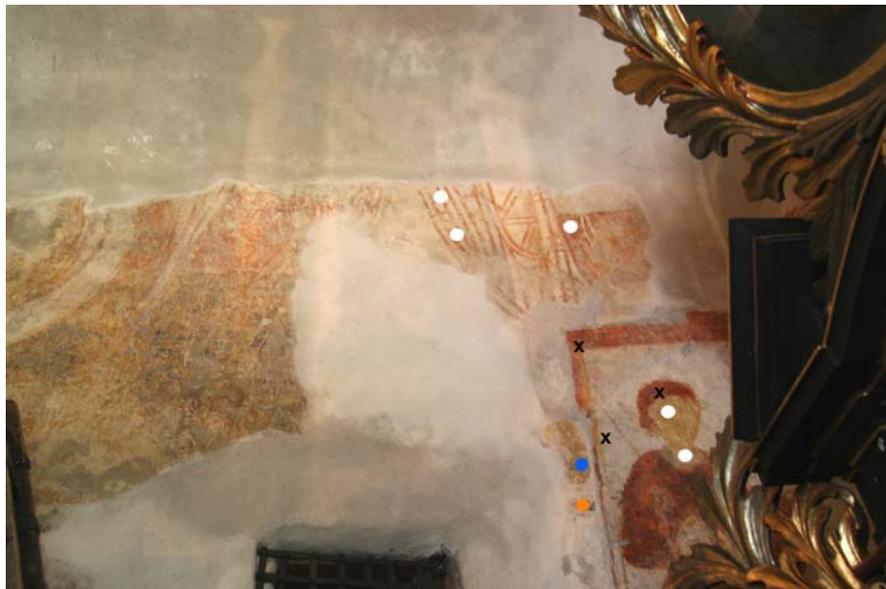
Figure 4. Increased concentrations of selected elements in the presbytery measured by portable XRF (blue points > 10 wt.% of Cu, white points > 10 wt.% of Pb, orange points > 90 wt.% of Pb, x – none or only very low concentration of all the selected elements)

In the Gothic overpainting in the right down corner of the figure the lead white is used in colour layer exclusively in the incarnate, while in the original painting, its concentration is varying only because of local repaints or retouches. No darkening of the lead white is visible.

plattnerite, cerussite, lead magnesium carbonate - $\text{PbMg}(\text{CO}_3)_2$, and unconsumed red lead. Thus we approved that the brown-black was originally orange, all the red lead has been converted to the mixture of plattnerite and cerussite under normal conditions of varying humidity. The presence of dissolved carbonate and magnesium ions caused the crystallisation of $\text{PbMg}(\text{CO}_3)_2$. No lead white was necessary to be added. We can imagine easily, that on the face of the Virgin Mary (Fig. 5), black contours of the neck, lips etc., could originally been rather orange than white. In other parts of paintings, the content of the lead is connected exclusively to the presence of the lead white but, because of much lower concentrations, present probably only in retouching. The lead white undoubtedly used as pigment in the colour layer is only visible in Gothic overpaintings where it is found in the incarnate (Fig. 4).

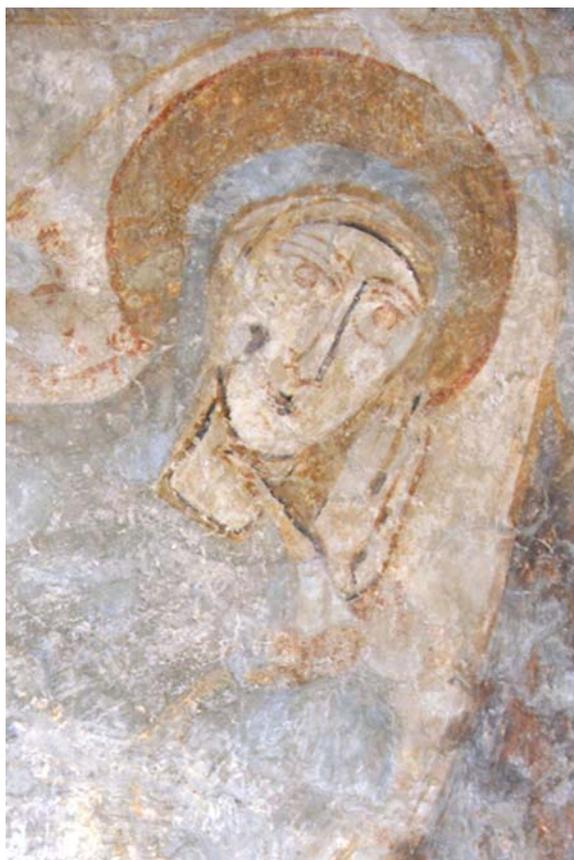
Figure 5. Thin contours of the Virgin Mary's face painted by the red lead, now converted to brown-black plattnerite
