## **A DIAGNOSTIC ANALYSIS OF AN OUTDOOR FRESCO: THE CASE OF "SANTA MARIA DEI BATTUTI" OF THE CONEGLIANO CATHEDRAL**

Vasco Fassina<sup>2</sup>, Marta Mazza<sup>2</sup>, Ilaria Carocci<sup>1</sup>, Stefano Ridolfi<sup>1</sup>

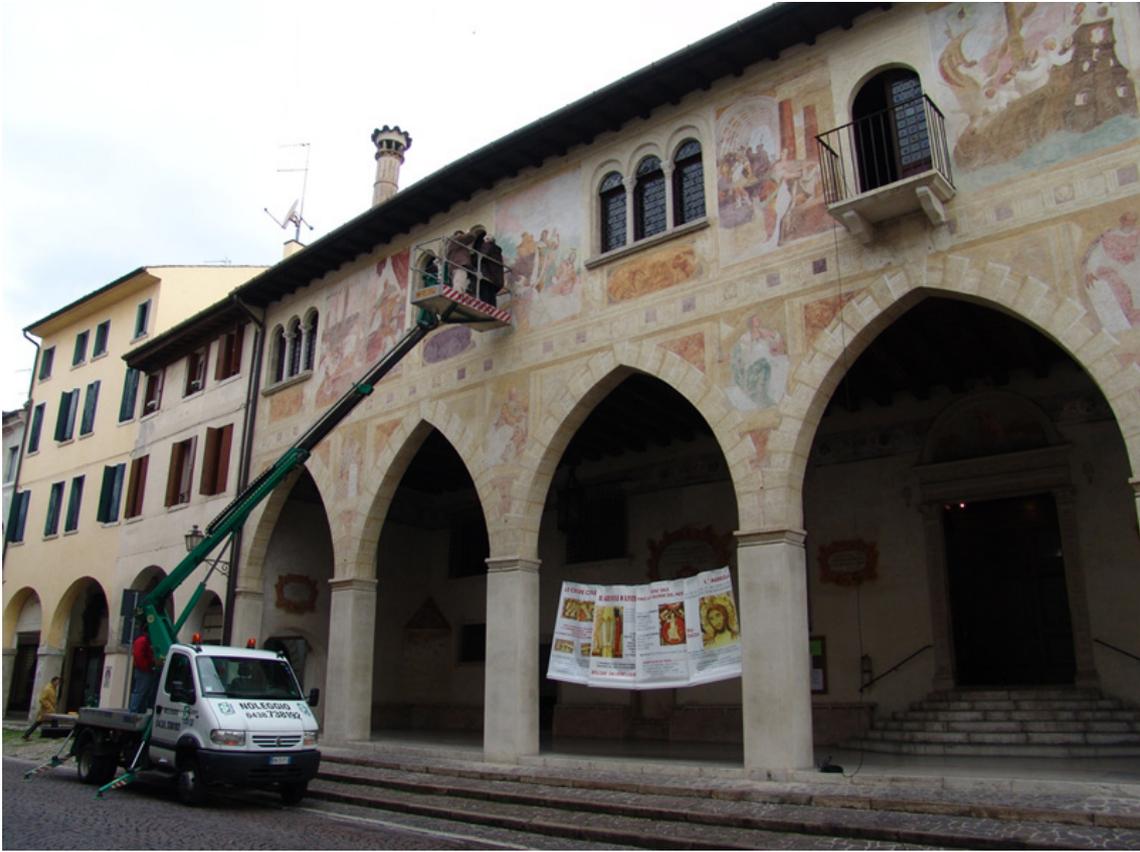
*Figure 1: Part of the frescos and a lift necessary to work at the last level with an EDXRF instrument*

In Figure 1 we report a moment of the measurements fulfilled in situ on a crane to reach the high frescos.

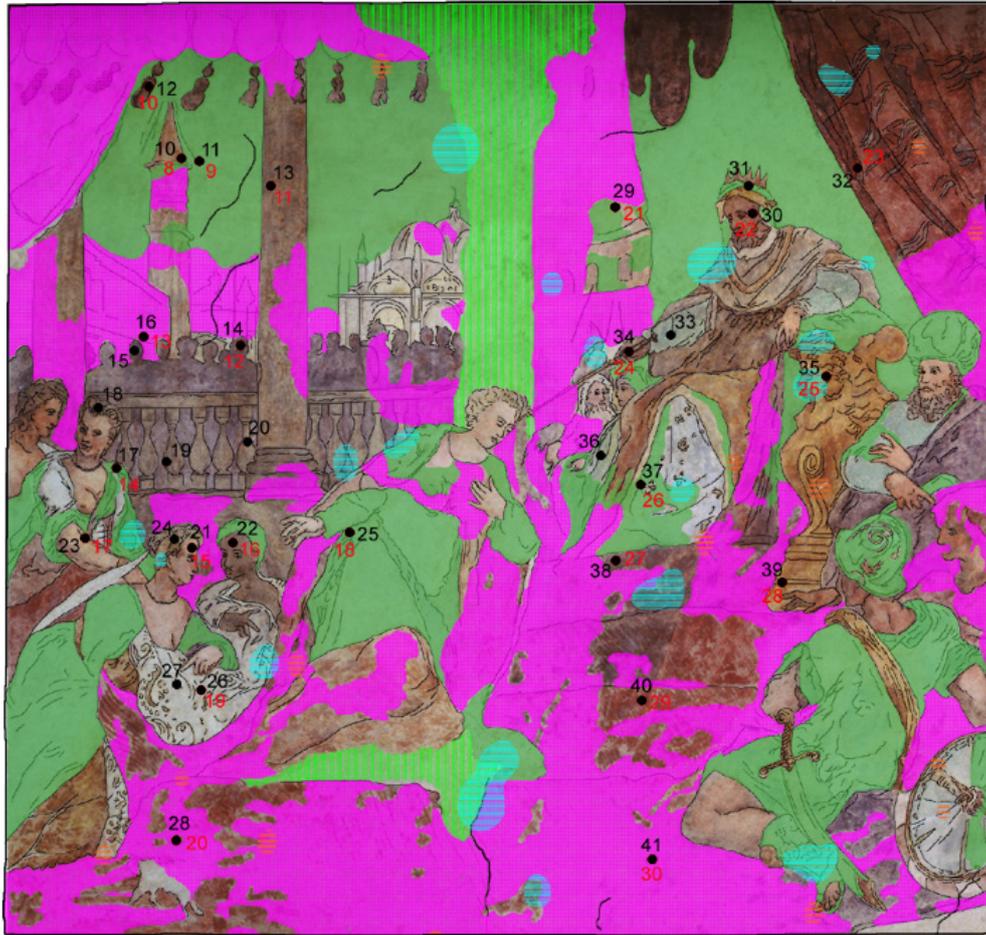
Tavola I - Ester supplica Serse

Figure 2: Ester implores Serse, diagnostic survey

In Figure 2 we show, as an example, the results on the section "Ester implores Serse" in which simultaneously are reported the visual data collected by a restaurateur (for example deposit, gap, adhesion defects etc.) and the EDXRF points on measurements.
