NON DESTRUCTIVE INVESTIGATIONS OF HISTORICAL PLASTER AND STONEMWORK IN SAN GIOVANNI DEI NAPOLETANI CHURCH IN PALERMO (ITALY): EVALUATION OF THE EXCHANGE BETWEEN ARCHITECTURE AND ENVIRONMENT BY THERMOGRAPHY AND RADAR SURVEY

Richard Ollig¹, Gaspare Massimo Ventimiglia²

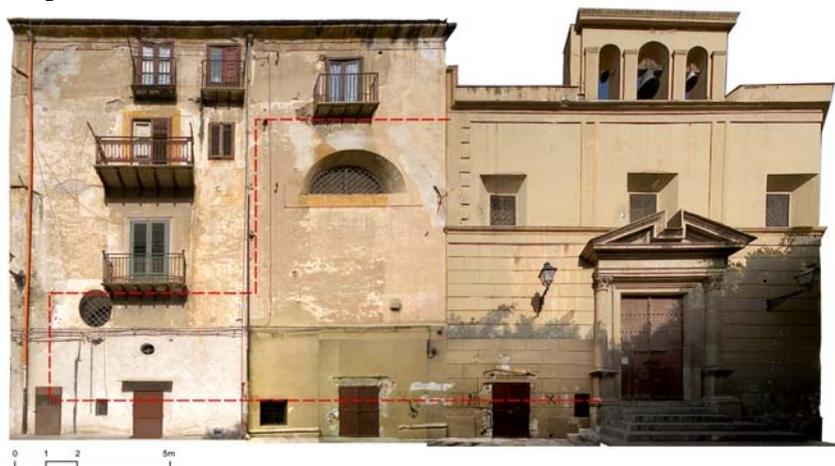
*Pict.1: The investigated facade of San Giovanni dei Napoletani church, Palermo.
The red line shows the interior space of the church*

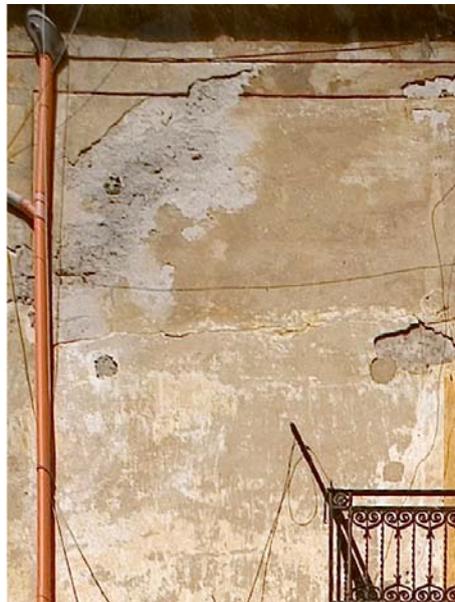
In the visual study it is possible to detect erosion, like the total loss of plaster and adherence loss. However the extend under and between the layers, as well as the cavity of plasterlayers is cannot be observed. The humidity cannot be observed either, due to its position. Improvements which have been made with another type of plaster, like cement, can be seen in small areas and in a larger area which has already been sanded.

Pict.2 Detail of the current status of the facade. IRT was made on 2007/09/17 at 20.30 p.m. after sunset in the direct cooling down phase temperature +31°C, relative humidity 34%

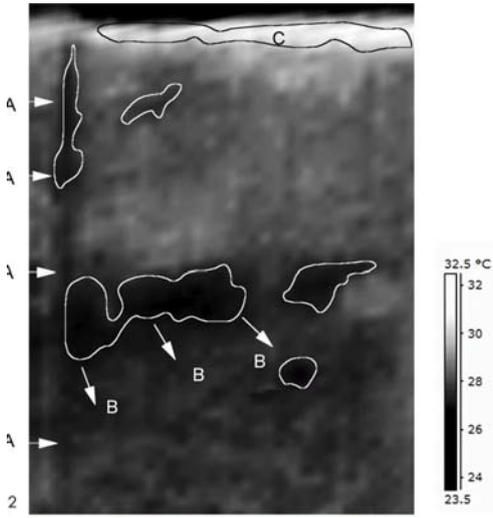
The thermogram Grey shows in the central position dark-gray tones, which are to be expressed in the cold temperatures of the scala. They indicate humidity on the surface, which may have been caused by the eaves gutter (A). Another reason could be the interfusion of the humidity from the inside to the outside, where it evaporates (B). In the infrared picture the humid parts on the surface have the lowest temperatures and are shown in the darkest colors.

The reason is, that the cooling down of H₂O is faster than that of the surrounding plaster and of the continuous process of evaporation from liquid into gaseous status.

*Pict.3 Scale Grey 100% opaque shows phenonema:
(A), (B) humidity
(C) adherence loss, cavities*

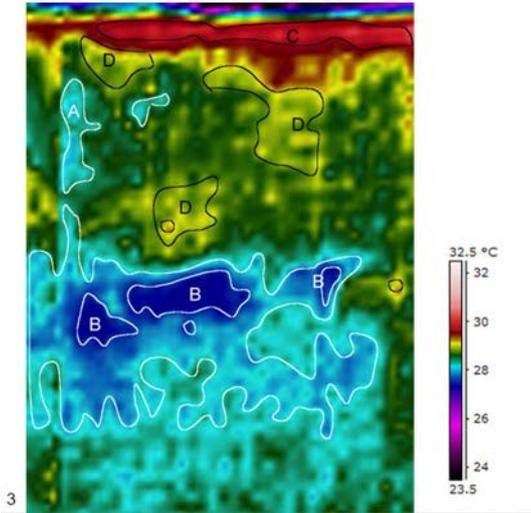
The thermogram Rainbow shows the extent of humidity in the whole lower area of the detail more clearly (B), which appears to be in good condition in the visual observation. There is also humidity near the gutter. The balanced temperatures in the scala are a symbol for parts which are still intact (D). In contrast flaking plaster, cavities and non adherent plaster are most probably in the hot parts (C), which can be seen in the warm colors and the high temperatures. Non-adherent plaster and cavities act as thermal barriers. These non-intact areas are like failings, which have a lower thermal conductivity under the surface area. This is the reason why the surface above this areas keeps warmer longer, which can be seen in the thermogram in the warmest colors and hottest temperatures.

*Pict 4 Scale Rainbow 100% opaque shows phenonema:
(A), (B) humidity
(C) adherence loss, cavities
(D) intact*

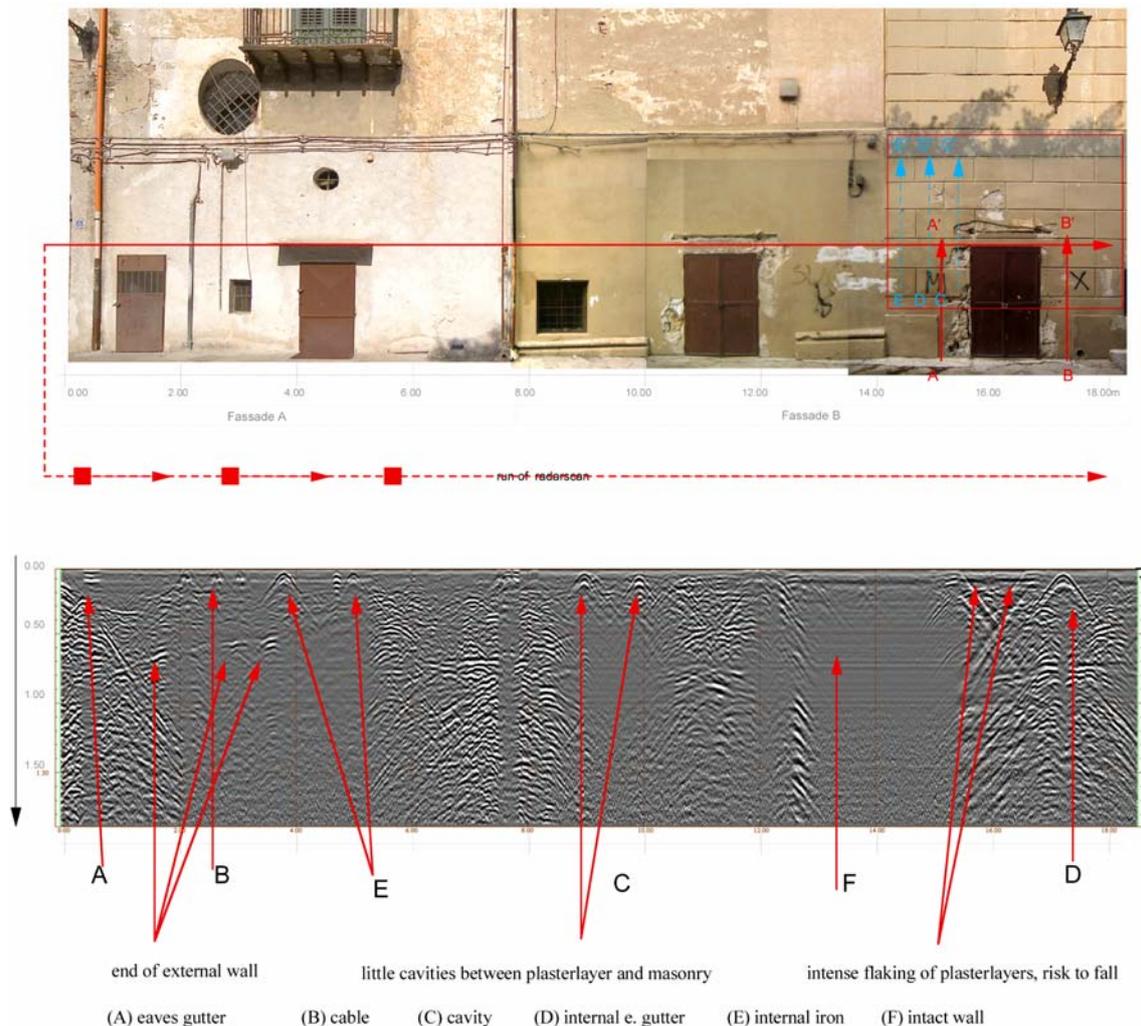
To get more information about the status and to test the potential combination of both methods the Radar survey was applied to the facade, which had already been investigated before by IRT. The high-quality Radar instrument RADAR IDS GRED with a 1600 MHz antenna was used for the measurement. The Radargram demonstrates different signal-reflexes in the form of Parabolcurves, which change to black and white colored curves and indicate variable phenonema. It was possible to measure a double-shell construction of the masonry, that is composed of one integrative compact masonry at the basement, exactly at the point of intersection of both facade-types. Other central signals in a profoundness of 90 to 100cm are refer to cavity or open splices.

Pict.5 Horizontal scan of Radar survey. The Radargram shows signal-reflexes, indicating variable phenonema
