MONITORING MARBLE CRACKING IN THE DAVID BY MICHELANGELO

Giovanni Pascale

DICAM, University of Bologna, Italy - giovanni.pascale@unibo.it

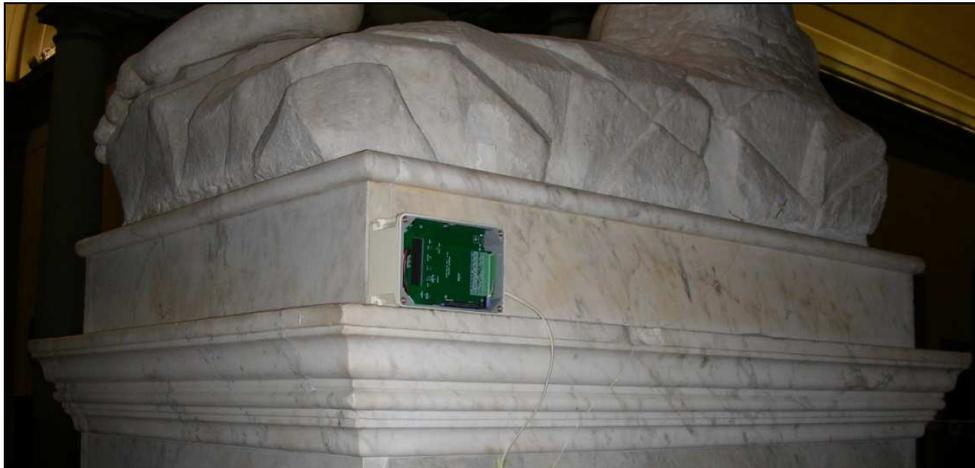
Figure 2 – The basement of David and the device Smartbrick

The Smartbrick device was installed on the back of David, resting on the basement, in order to place the instrument on a fairly large area and a flat surface (Figure 2).

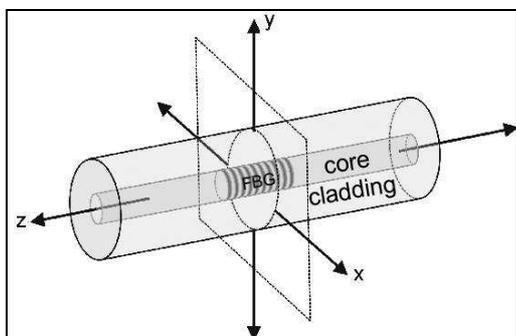
Figure 3 - Fiber optic Bragg grating

Fiber optic Bragg gratings (figure 3) are made by producing permanent periodic index variation along a short section in the core of a optical fiber. First introduced in later 1970s, fiber optic Bragg grating development increased steady and attracted widely attention since high reflectivity FBGs were manufactured by a transverse holographic method, which permits the use of FBGs in any wavelength attainable by the writing process. The FBG is a good sensing element for strain and temperature because it linearly responds to the measured magnitude (strain or temperature). Because the FBG sensors are based on the wavelength encoding of the signal information, multi-point sensing using wavelength multiplexing is possible. The wavelength of a FBG spectrum is related to the effective index refraction and the periodicity of the index variation in the fiber core. So small perturbations on FBGs cause wavelength shifts, which can be used to measure any physical magnitude, as strain or temperature. The wavelength-encoded signal is finally converted into electrical signal for easy and real-time reading.

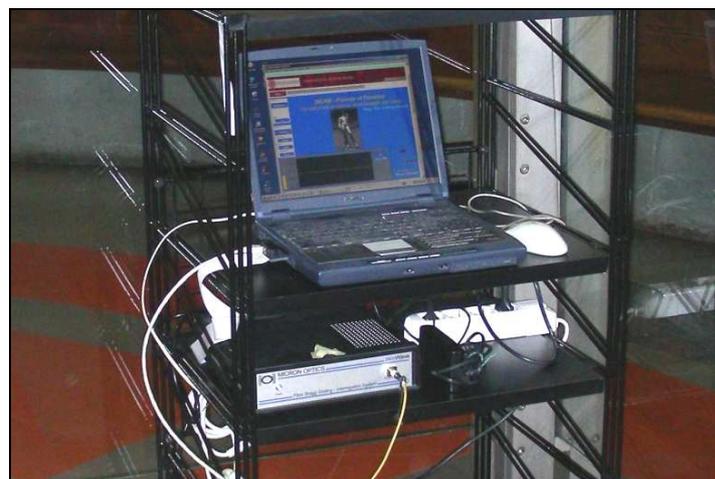
Figure 4 - Instrumental setup with FBG interrogation unit

The detection of Bragg wavelengths is performed using a commercial interrogation unit Micron Optics® FBG-IS. An optical coupler split the radiation generated by a 1550 nm LED. One arm of the coupler ends in a standard connector (FC), to which the FBG is connected. A fiber Fabry-Pérot tunable filter scans the back-reflected signals in a 40 nm wavelength range. The system is connected to a PC and is entirely controlled by a LabVIEW® program. The best resolution is 1 pm, and several gratings can be interrogated at the same time, with a sampling frequency of 50 Hz.

Figure 4 shows the cabinet where the interrogation unit was located together with a computer and a uninterruptible power supply.

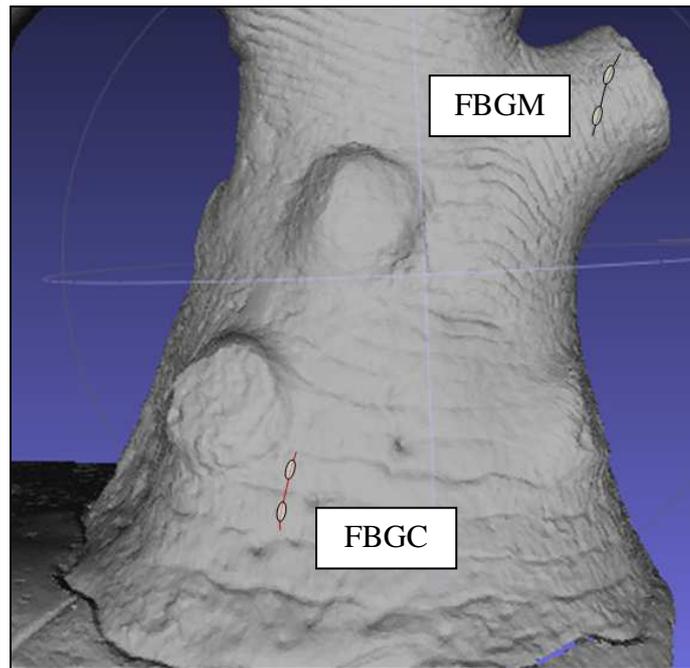
Figure 5 – Locations of FBG on the tree trunk

The two sensors were placed as shown in Figure 5:

- the sensor named FBGC across one of the more severe cracks, to measure the opening changes;
- the sensor named FBGM on the marble in a position not cracked and not subjected to mechanical stress, with only the function to measure the deformation of the marble due to changes in temperature.

A third sensor was used as a dummy sensor, not glued to the marble, positioned near the top of the tree trunk; the use of this sensor is necessary because, as the wavelength shift is caused by both strain and temperature variations, the shift due to temperature variations has to be subtracted by the total shift, in order to obtain only a strain measure.

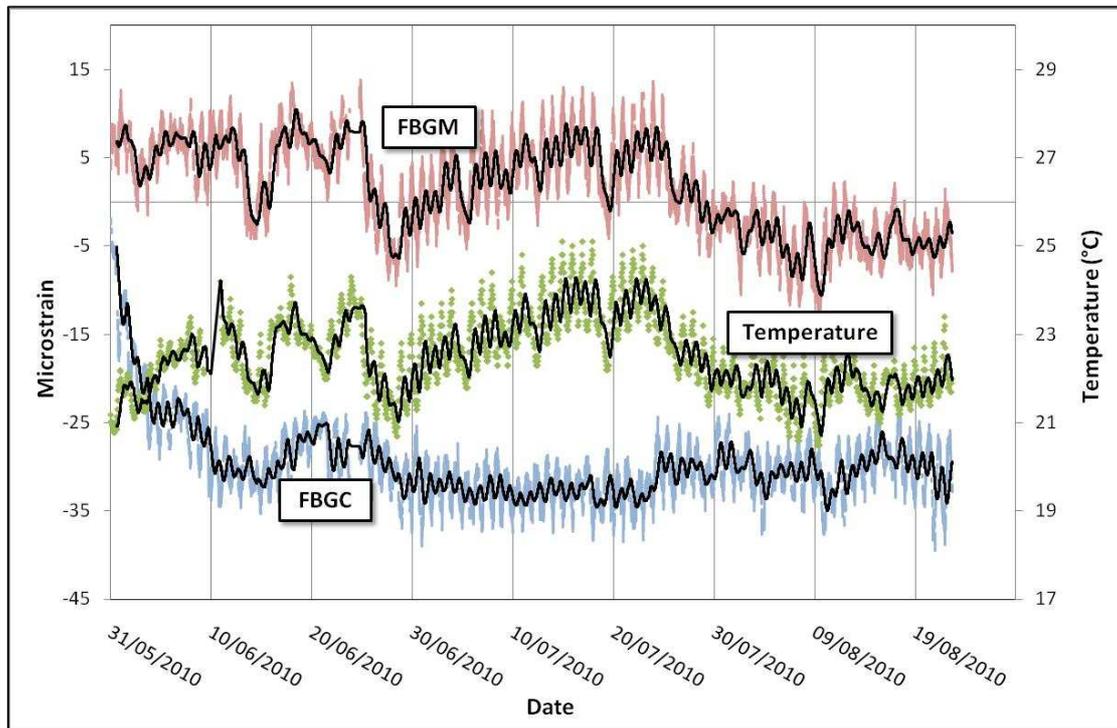
Figure 6 - strain measured by the two FBG's, compared with the temperature, for the period from day 0 (may 31, 2010) to day 84 (august 24, 2010) from the beginning of monitoring

The graph of Figure 6 shows the results in terms of strain measured by the two FBG's, compared with the temperature, for the period from day 0 (may 31, 2010) to day 84 (august 24, 2010) from the beginning of monitoring. Moving average lines have been superimposed to the graphs, in order to make them easier to interpreting.

As it can be noted, the marble strain (FBGM) is strictly related to temperature variations. This does not occur for the strain across the crack (FBGC).

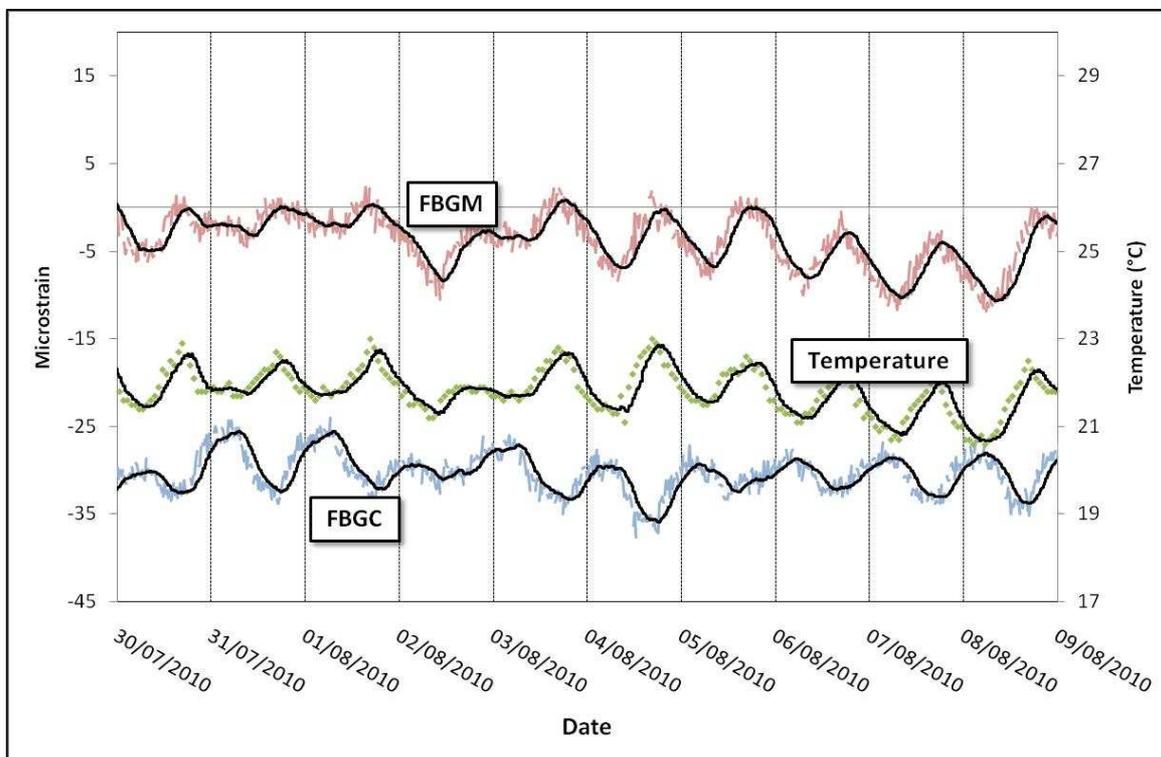
Figure 7 - strain measured by the two FBG's, compared with the temperature, for the period from day 60 to day 70 from the beginning of monitoring.

Figure 7 shows a window of the previous graph, for the period from day 60 to day 70.

We can observe that the variations of the strain measured by the two sensors are in opposite directions. Maximum values given by FBGC correspond to minimum values given by FBGM.

Across the crack, in fact, an increase in temperature causes an expansion of the marble in the vicinity of the crack itself, which causes a decrease of the crack opening. The order of magnitude of the variations of crack opening is about $0.10 \mu\text{m}$.
