# Development of a NDT method using thermography for composite material inspection on aircraft using military thermal imager

By : P. Servais<sup>1</sup> and N. Gerlach<sup>2</sup>

<sup>1</sup> Competence Center Flying Material, Non Destructive Testing Squadron, 1130 Brussel, Belgium

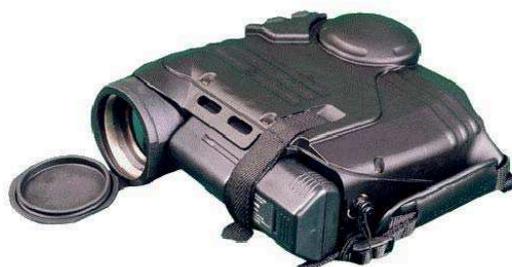
Figure 1 : military Thermal imager used by Belgian Defense

TNDT (Thermal Non Destructive Testing) is now an emerging method that comes out of laboratory since a few years. It is here proposed to investigate, compare and quantify the different possibilities to use thermography instead of radiography or ultrasonic testing on composite parts in maintenance of military aircrafts. The new idea is to use military thermal imagers also used by the infantry (see figure 1) because the detector is now an infrared focal plane array capable of measuring a very faint difference of temperature (less than 0.07 K)

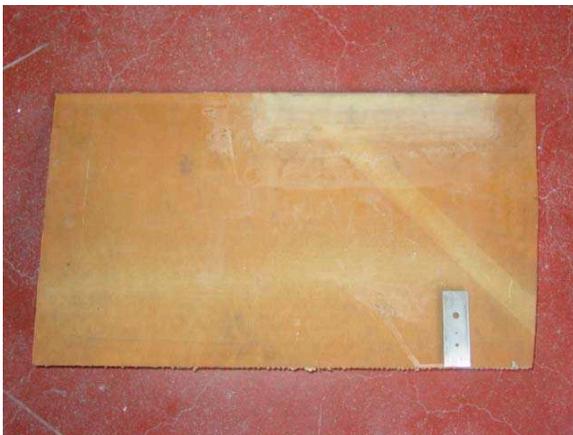
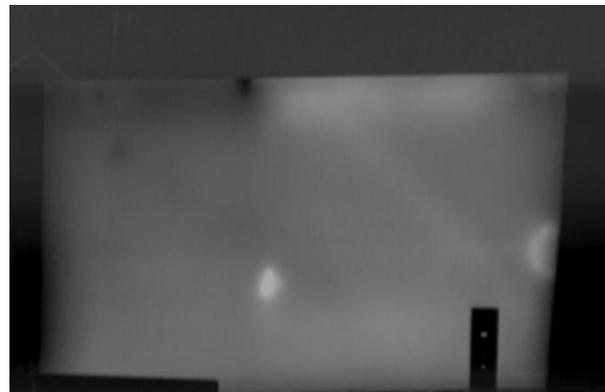
Figure 2 Left : composite part with hole type IQI,

Right : thermal image of composite part with water ingress

- porosity which reduces the compressive load carrying capability,
- water ingress or moisture which can degrade the mechanical properties of some resins or lead to freeze inside the part causing more and more damage (see picture 2 for honeycomb composite part with central view of hotter area in the centre of the piece viewed in white in picture 2)
- disbond or delamination resulting from low strength in the resin
- impact damage during the taxi or caused by bird strike or by a dropped tool during maintenance
- inclusions which can reduce strength by kinking the fibres around the inserted material

Some defects like water ingress cause high thermal difference on the surface as seen on Fig 2 below. This thermal difference depends on their characteristics, their dimensions and their depth in the piece part. So the camera should have good thermal resolution (NETD or Noise Equivalent Temperature Difference). [2] Recent work made by Italian Air Force showed that 0.1 ml water ingress in one cell of honeycomb flap of AMX aircraft could show a thermal difference of 1°C when surface is heated with a flow of 15000 W/m<sup>2</sup>. [3]
