Structural integrity assessment of materials by thermography

N.P. Avdelidis^{1*}, D.P. Almond², C. Ibarra-Castanedo³, A. Bendada³, S. Kenny⁴, X. Maldague³

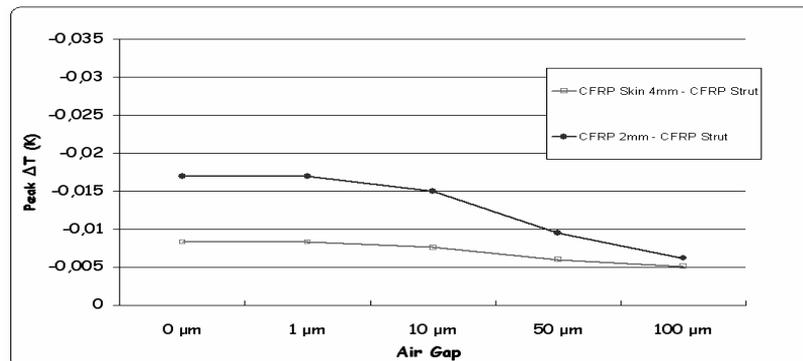
Figure 1: Thermal modelling results of peak strut contrast as a function of air gap for modelled structures

It was seen that the peak contrast of the 4mm CFRP skin over the CFRP strut is 2 times smaller than that of the 2mm CFRP skin over the CFRP strut, whilst its time scale (thermal transient phase) was four times longer. The modelling results gave also a good indication of how each tested structure responded to thermal heating. It showed the differences between two low thermal conductive materials (i.e. CFRP) with different skin thickness after being heated with a thermal excitation source uniformly. Furthermore, it was found that as the air gap between the two surfaces (poor contact) was increased, the thermal contact resistance was increased and therefore poorer results were obtained. This can be seen from figure 1, where the peak contrast ΔT values against the air gaps modelled are plotted for both tested structures.

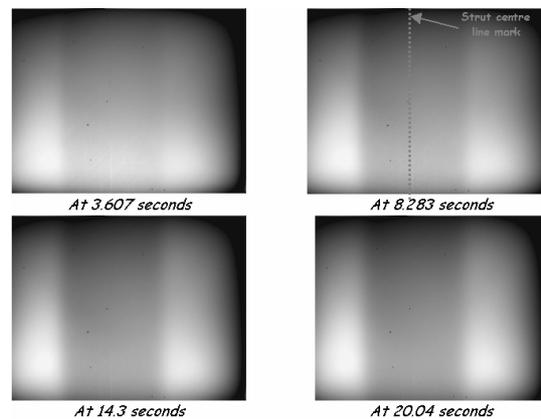
Figure 2: A selection of thermal images showing the strut beneath the 2mm CFRP skin

As far as the thinner CFRP panel is concerned (i.e. skin thickness of 2mm), it was found that the subsurface strut could be imaged satisfactorily, using the conventional thermal image. The images were very similar to the modelling simulations. The centre of the strut was taken as being mid-way between the two half minima locations of the contrast (from typical line profiles). Five line profiles along the X-axis at Y pixel values of 20, 74, 128, 182 and 236 were taken and the pixel values estimated to define the centre of the strut were attained. It was seen that at relatively early times (i.e. up to 5.344 seconds) the best results were accomplished, since there was no variability. The greatest variability was seen at the longest transient time (i.e. 30.06 seconds). However, the overall result showed great consistency, as the largest variability was 1 pixel (i.e. ~ 0.465 mm).

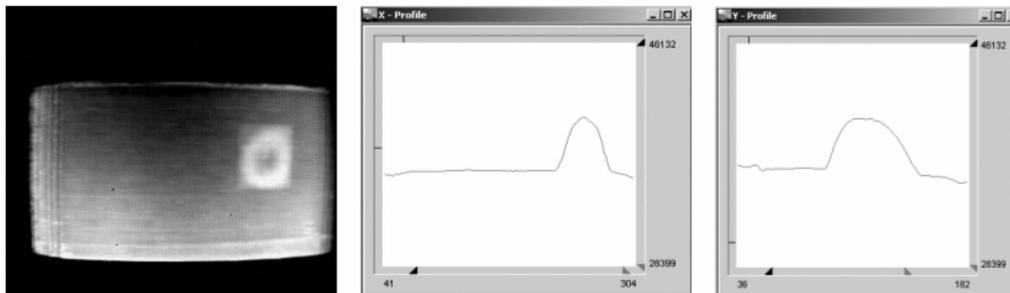
Figure 3: Thermogram and representative line profiles of the investigated composite panel

In figure 3, a thermogram with representative line profiles from the investigated panel are presented. The delamination was detected by thermography. Line profiles (on both axes) at various times from the obtained thermal images were plotted in order to obtain information about the size of the delamination in relation to the thermal transient time (e.g. possible shrinkage due to thermal diffusion). From the line profiles it was possible to calculate the size of the delamination employing the Full Width Half Maximum (FWHM) approach.

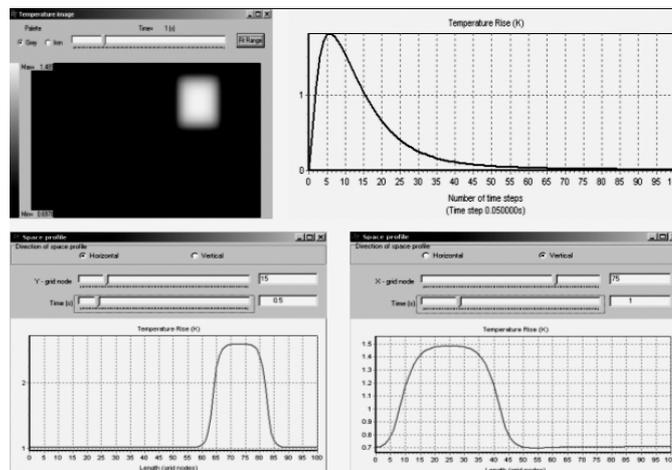
Figure 4: Thermal modelling results of composite panel. Upper graph shows development of contrast, Delta T, over defect with time. A thermal image and spatial profiles in both axes (X and Y) are also shown.

Thermal images, spatial profiles and thermal contrast curves of the panel from the thermal modelling run are presented in figure 4. The results give a good indication of how the composite material responds to thermal heating. It shows the behaviour of a delaminated composite material after it was heated with a thermal excitation source uniformly in order to detect a sub-surface defect by means of pulsed thermography.

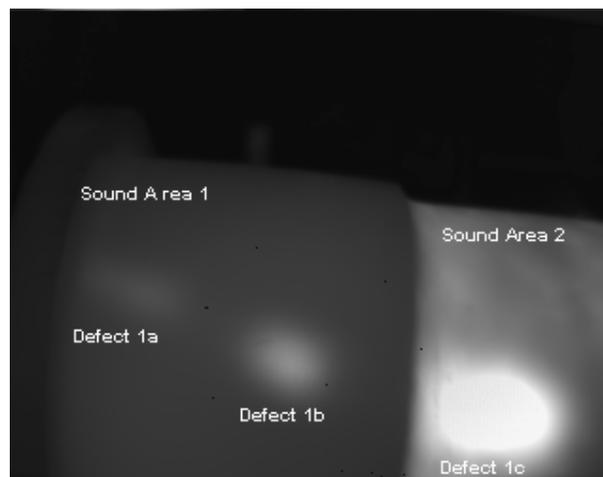
Figure 5: Thermal image of investigated pipe after 0.935 seconds of heating

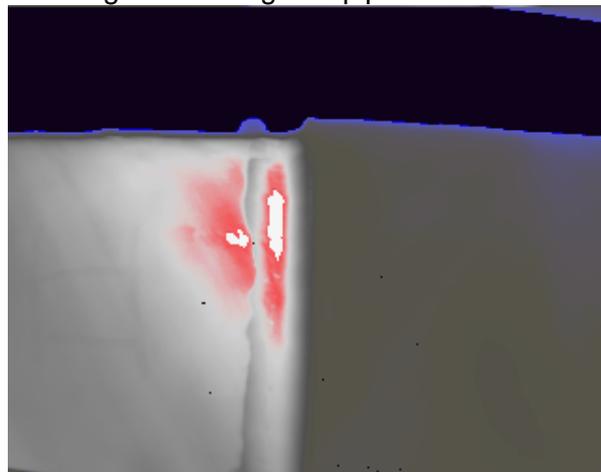
Figure 6: Thermal image of investigated pipe after 13.560 seconds of heating revealing kissing bond defect on the pipe

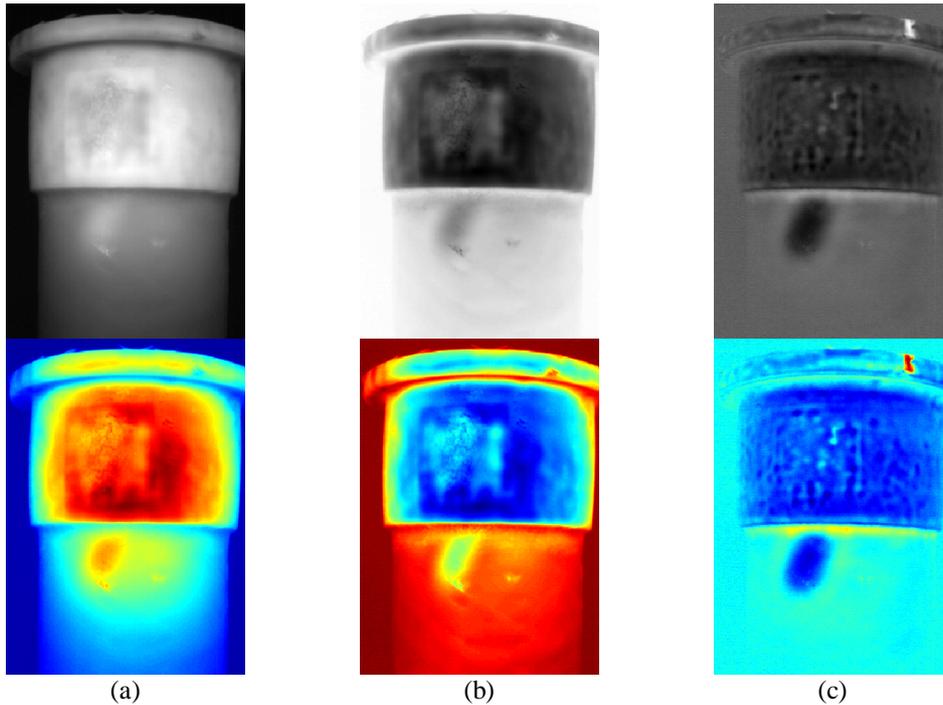
Figure 7: Defect 'A': (a) gray (top) and 'jet' (bottom) raw thermograms at $t=0.92$ s; (b) first time derivative image (from a 7th degree polynomial fitting) at $t=2.85$ s; (c) second derivative at $t=1.49$ s.

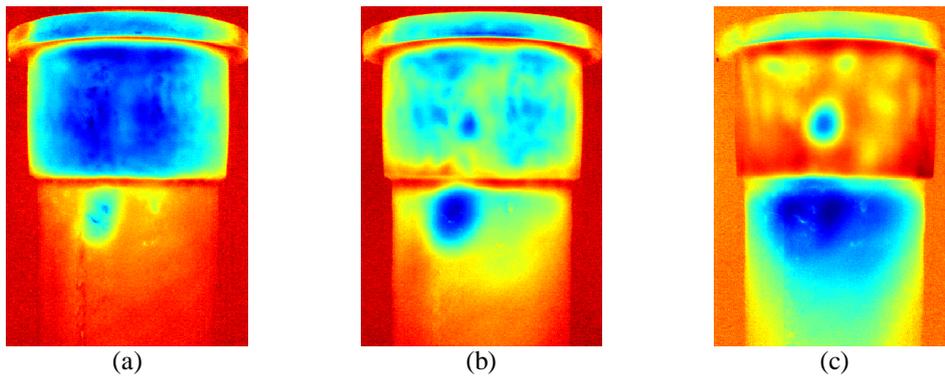
Figure 8: Defect 'B' second derivative images (from a 7th degree polynomial fitting) at $t=(a) 1.26$ s; (b) 3.19 s; (c) 7.51 s.

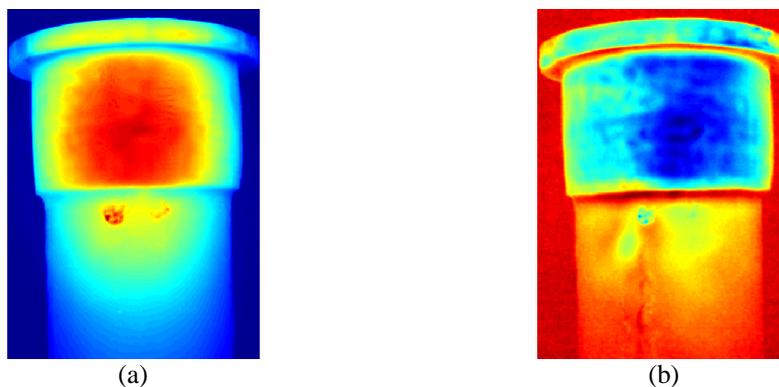
Figure 9: Defect 'C'. (a) raw thermogram at $t=1.26$ s; (b) second derivative image (from a 7th degree polynomial fitting) 2.17 s.

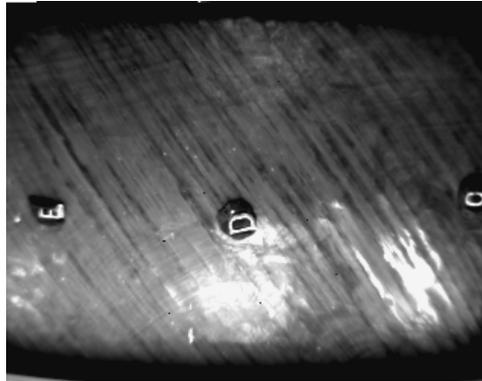
Figure 10: Thermal image of investigated impact damaged area after 0.017 seconds of heating

was used; with the exception of the pipe that presented impact damage, where a higher frame rate (60 Hz) was needed. Furthermore, in order to avoid the high reflectance of the pipes during investigation and so record thermal images, the samples were either painted with black colour water based paint or even polished by applying a silver polishing substance (i.e. silvo).
