# Mobile Computer Tomography for In-Service Inspection in Nuclear Power Plants

**Abstract.** COMPRA GmbH, a member of the RTD Group, developed together with BAM Berlin the TomoCAR system for the mechanized digital radiography and planar X-ray tomography. The system is able to accurately size cracks in welds with a COD (crack opening displacement) of only 25  $\mu\text{m}$  independent of its orientation. The system has a very high reliability of recognizing planar defects and the integrated TomoCar software modules are able to produce a 3D-view of the cracks. It is the first time these kinds of results are achieved on site with radiography equipment.

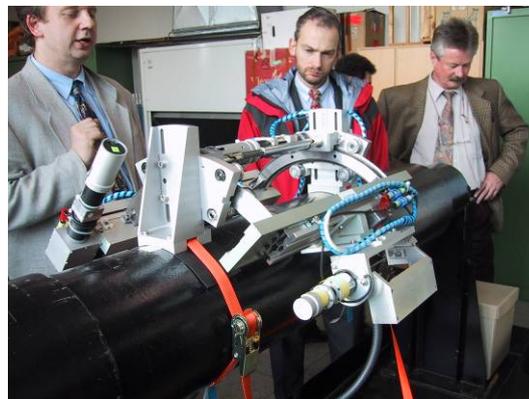
**Fig. 5:** View on the actual TomoCAR manipulator.

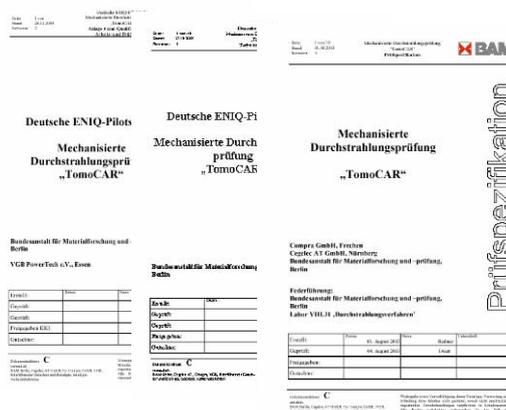
**Fig. 8:** View on some documents of achieved during the ENIQ qualification.

In the course of the VGB project the power station operators expressed a wish that the project should be used as a pilot project for the first German qualification according to ENIQ (Fig. 8). The project was extended for a further year through the qualification processes and documents specified in ENIQ. Weld seams with natural faults on demantled piping were investigated in a power station as an additional qualification step (Fig. 9 and 10). The results showed that the readings could be displayed and described with an accuracy of  $\pm 1$  mm. The VGB project 'mechRAD' and the ENIQ pilot study could thus be brought to a successful conclusion.

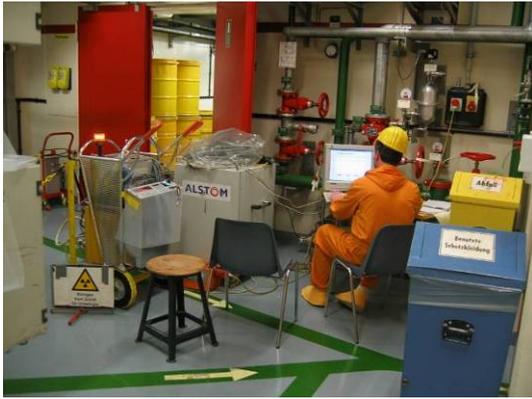
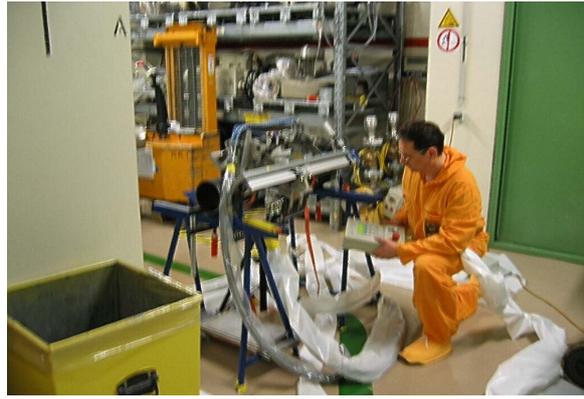
**Fig. 9: and 10:** Installation of the mini-scanner.

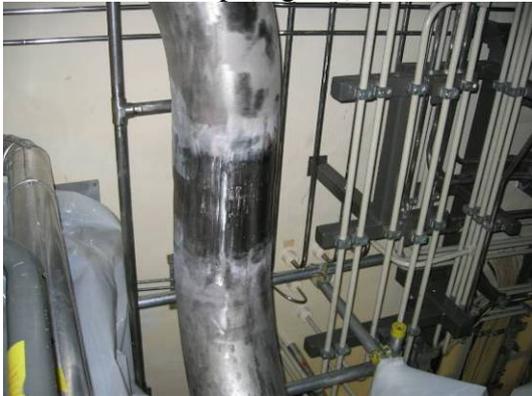
**Fig. 11:**Typical pipes investigated by the TomoCAR unit

Not all piping sections displayed the necessary clearance of 200 mm around the piping with the given outer diameter of 270 mm so that in these cases he tests could only be performed with restriction (e.g. piping course Fig. 11). Because of the 20 m feeding pipes to the casing heads and manipulator the control units could be installed 15 m away from the objects in the reactor's sump (Fig. 11).

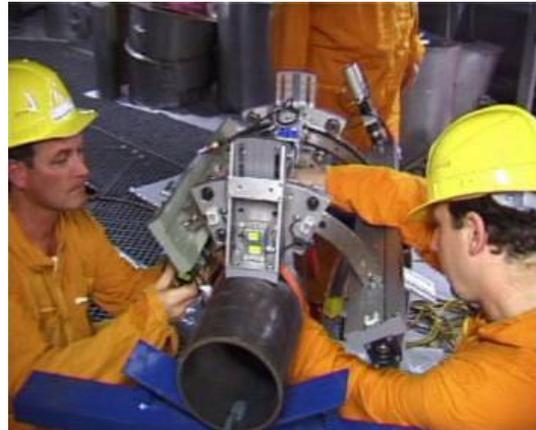
**Fig. 12:** Adjustment of the TomoCAR unit on a client installation.

The 4-man team needed one working day to assemble the system, to transport this to location and protect it against contamination. The manipulator adjustment and system calibration on site to the actual dimension ranges took a further 4 hours (Fig. 12).

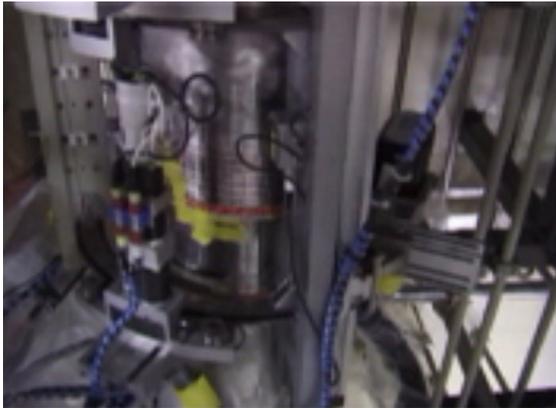
**Fig. 13:** The TomoCAR unit mounted on a pipe of a nuclear power plant.

On completion of the preliminary work, the weld seams can be tested virtually in an hourly rhythm if the dimensions are the same (Fig. 13). Preliminary tests should serve to define an analysis range in which a general digital plot is taken. The evaluating parties define the exact co-ordinates for the points of analysis in the general plot. Over 500 projections with the various angles of irradiation are plotted transverse to the direction of welding and then overlapped so that the tomography that is performed allows the inspection and evaluation of the weld seams and neighbouring areas from all directions and in layer intervals of 0.1 mm. The various interesting pictures and viewing directions can be compiled and viewed on the PC and the cracks can be measured and interpreted (Fig. 14 and Fig. 15).

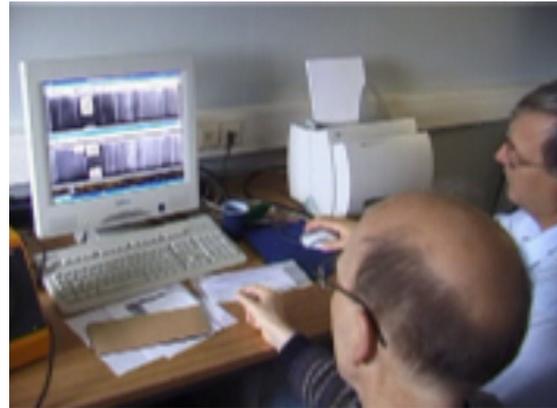
**Fig. 14:** Evaluation. During ENIQ qualification the evaluation was carried out by experts from TÜV, BAM and COMPRA.
