# Testing Technology of Fire-Resistant Objects using Ultrasonic Low-Frequency Antenna Arrays

Andrey A. SAMOKRUTOV, Viktor G. SHEVALDYKIN, Alexander V. BISHKO,  
Association "SPEKTR-GROUP", Moscow, Russia  
Anatoly I. PLUZHNIKOV, Alexey S. LOBACHEV, JSC "OAO «Industrial Complex  
«Magnezit», Sadka, Russia

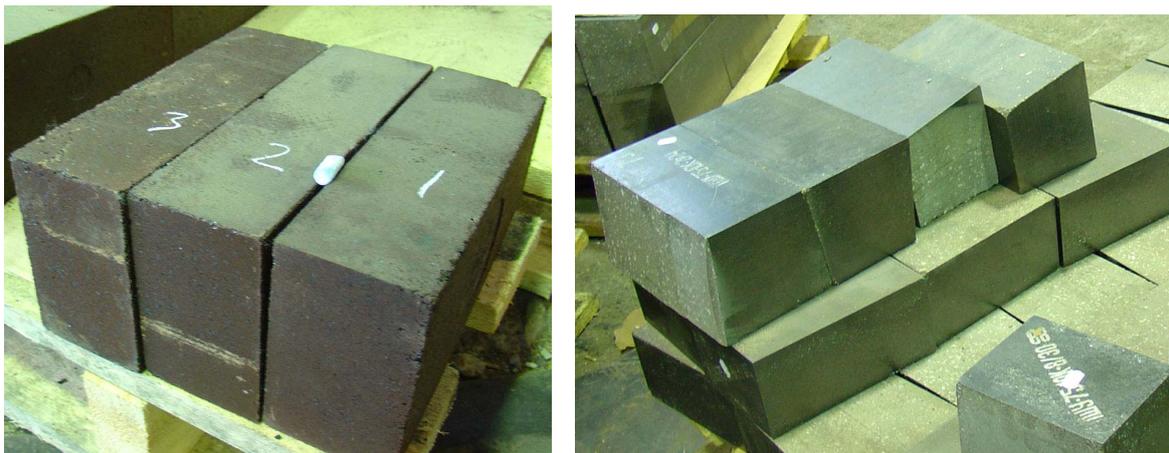
Fig. 1 Fire-resistant blocks, produced by JSC “Magnezit”

The object of testing is the pressed from special compound blocks with thickness of 100-200 mm and side-length of 200-400 mm, the sides of these blocks are not always parallel. (Fig. 1)

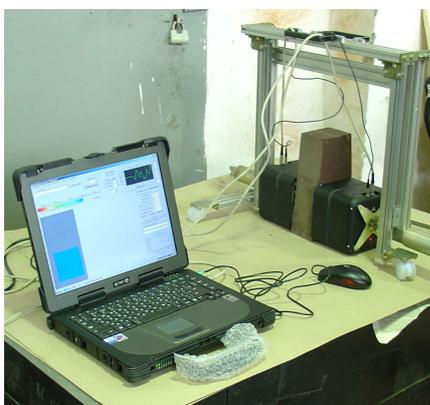
Fig. 2 System in operation.

Basing on the results of made researches the portable equipment for technological testing of fire-resistant blocks was developed. This equipment is based on two matrix (6x6 elements) antenna arrays. The elements of these arrays are the transducers with dry-point contact with longitudinal vibration of wear pin and operation frequency of 100 kHz. The antenna arrays are mounted to the frame opposite to each other. The frame allows exact positioning and quick pressing of the arrays to the testing block. The system is controlled from the computer (laptop type) with the installed software for data reception and procession.

The system was developed as portable equipment, which can be operated by one person, Fig. 2.
