The Inspection of Tube Fitting Systems in use for Drinking Water Supply by Means of Neutron Imaging Methods

Eberhard H. LEHMANN, Gabriel FREI, Paul Scherrer Institut, Villigen PSI, Switzerland
Roland WIDLER, H. MATERNA, D. GLAUSER, Geberit International AG, Jona, Switzerland

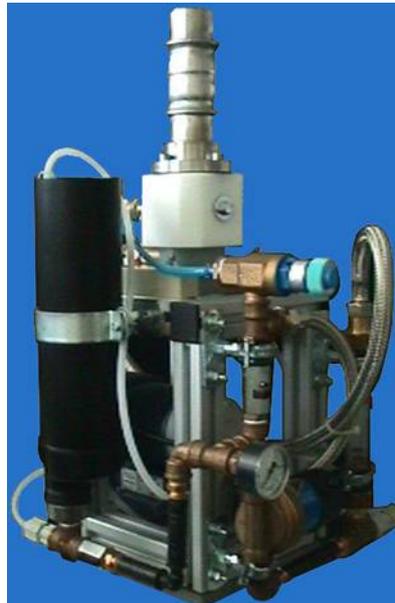
Fig. 3: Test facility for the on-site diagnostics of the water flow in the fitting region, based on the scheme in Fig. 2. The dimensions become clear if the tube (on top) diameter of 8 cm is taken into account.

Because neutron imaging (details see below) is a locally fixed method due to the size of the neutron source, the test assembly has to be transported to the facility and adapted to the given conditions in respect to beam geometry and detector performance. For this purpose, a design was created as shown as principle in Fig. 2. It contains a pump for a controlled pressure up to 0.6 MPa and diagnostics units for flow rate and pressure. In the upper part the fitting is open for inspection from all sides, which is a requirement for neutron tomography. The real setup is shown in Fig. 3.

The same setup is used for tomography investigations [2], where the object is rotated around its vertical axis stepwise from 0° to 180° and about 300 projections are produced. Based on this data set, the whole sample volume can be reconstructed with the help of

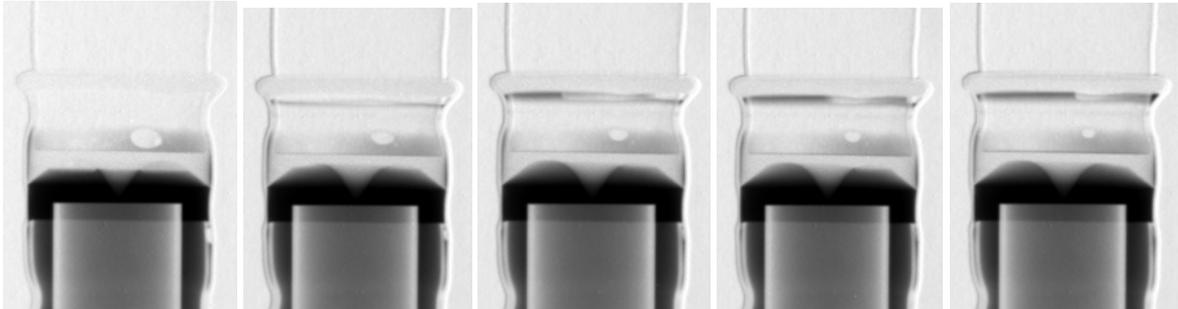
Fig. 5: Filling process of the asymmetric steel fitting with normal water in a sequence of images. Obviously, the residual air content plays a role how and where the water can migrate. The first image was taken directly after starting of the pressure application. The final state was reached after about 15 minutes.

As the results in Fig. 5 can demonstrate, the water can migrate into the fitting structure if sufficient pressure is applied. This process starts relatively early but a complete filling is impossible due to encapsulated residual air which is trapped by the water itself.
