Acoustic Emission: a Modern and Common NDT Method to Estimate Industrial Facilities

Gerald LACKNER, Gert SCHAURITSCH, Peter TSCHELIESNIG
TÜV Austria, Vienna, Austria

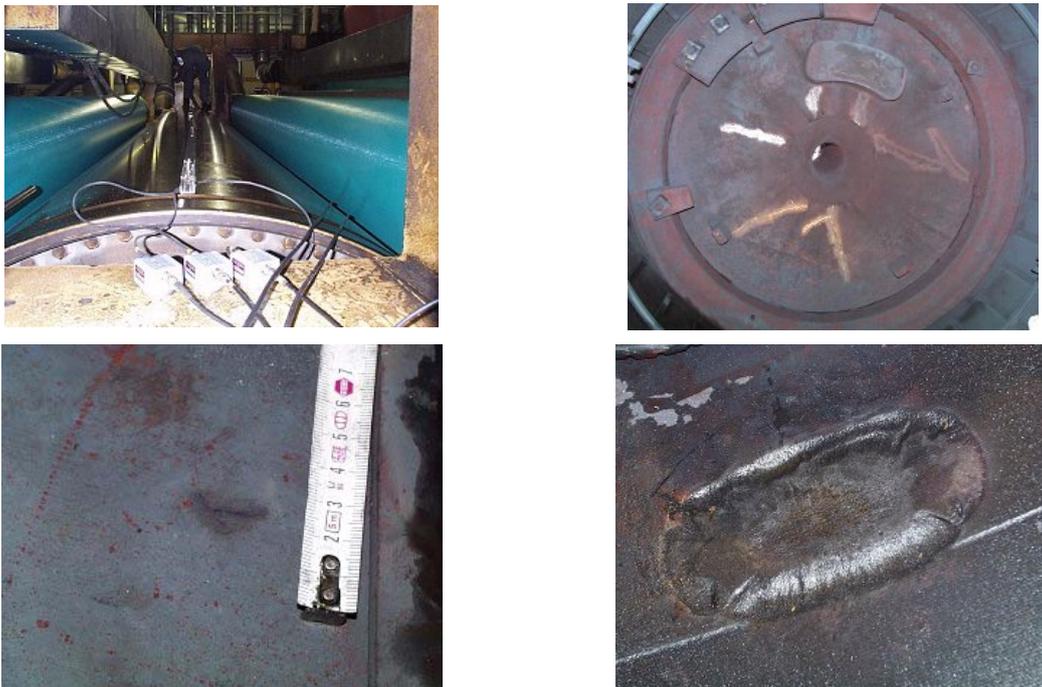
Figure 3: AT on drying cylinders (steam drums) in paper mills. Application of sensors on cylindrical shell (top left) and defects found at follow-up inside inspections: casting defect (top right), crack like defect (bottom left) and erosion (bottom right).

The drying cylinders of paper mills made from cast iron are tested with AT by pressurisation with compressed air. Performing a hydrostatic test on a built-in drying cylinder would lead to damage of the bearings and deformation of the cylinder. With AT there is no need to disassemble the drying section (typically consisting of about 40 cylinders) of the paper mill and the balance of the drying cylinders is not affected. There have been found casting defects, crack like defects as well as erosion. These defects are shown in figure 3.

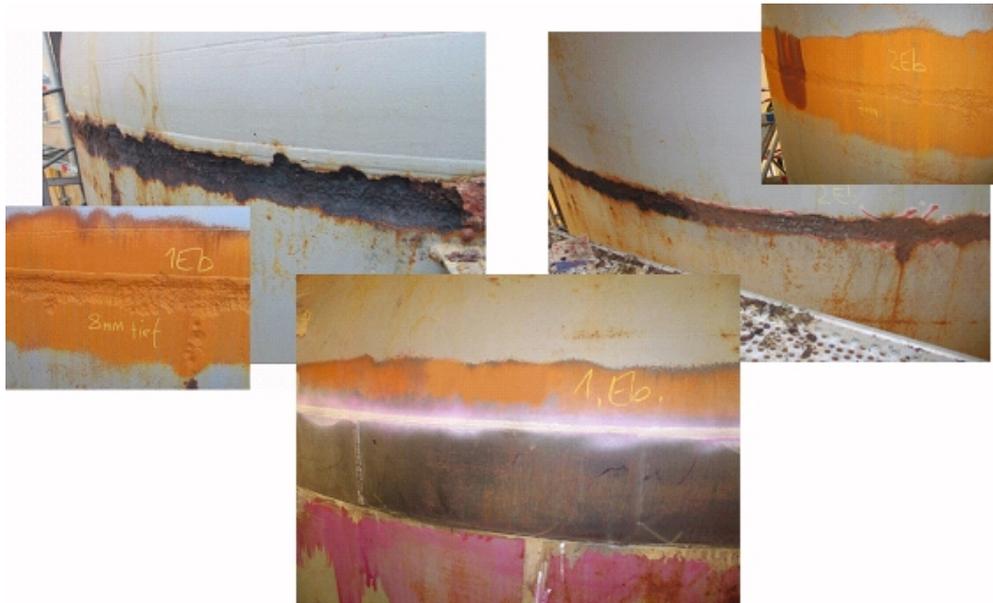
Figure 7: Follow-up NDT to the AT indications and performed repair, top left side photo - corrosion damage with depth up to 8 mm near to circular weld seam of the upper head, top right side photo – next corrosion damage near to structural ring element of thermal insulation with depth up to 7 mm, photo at bottom – repair of corrosion damage with reinforcing segments.

Repair was performed by welding reinforcing segments onto the shell at the top three positions of circumferential aligned corrosion damage like given in figure 7, bottom. After completion of repair works the entire shell was grit blasted, a protective coating was applied, a state-of-the-art thermal insulation was mounted and finally the vessel was set into operation again.
